Fire Risk Assessment

Alfred Gunn House

**Thompson Road,
Oldbury, B68 8RW**

Date Completed: 4th December 2025

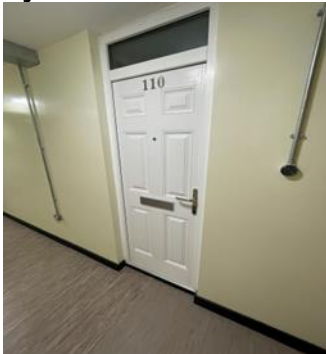
- 5) Individual flat entrance doors are self-closing certified 30-minute composite fire door sets with intumescent strips and cold smoke seals. Preoccupation inspections confirmed flat entrance doors are fitted to a high standard. (Neuma FD30s, GRP composite fire door system is certified by BM Trada)

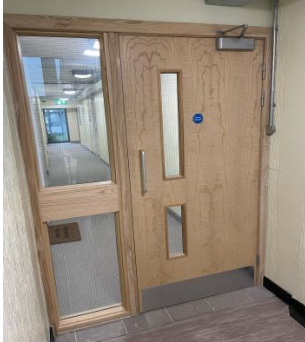
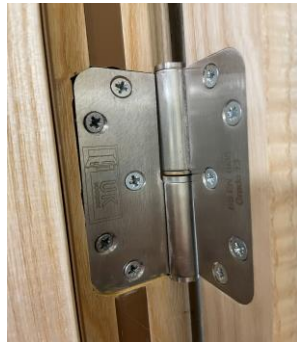
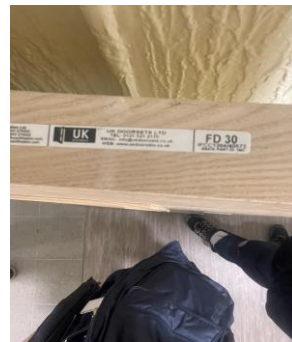
12) The communal landing / staircases are protected by use of self-closing 44mm certified timber 30-minute fire doors with vision panels & intumescent strips and cold smoke seals.

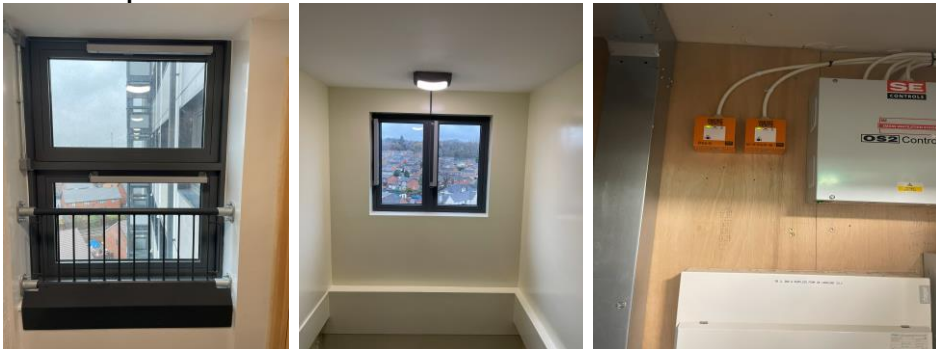
19) Automatic smoke ventilation is installed to all communal corridors. This is activated by the smoke detection located within the corridors. All protected stairs have an automatic opening vent at the head of the staircase. In the event of an ignition and smoke entering a corridor the automatic vent within that corridor will open along with the staircase vent that relates to that zone. The re-set switches for the automatic opening vents are located within the riser cupboards located within blocks A and C.

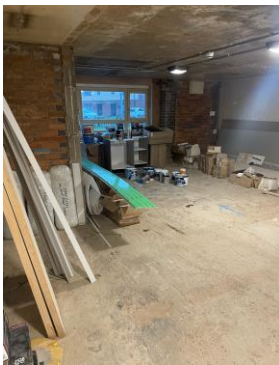
- 24) The fire strategy states that the lower ground floor should be free of combustibles. If future intention is to store items, then approval should be sought from the fire engineer with regards structural fire protection. A further consideration would also be means of escape in case of fire. It would not be acceptable to create an “inner room situation” and compromise protected escape routes. The building should be used as directed by the fire strategy with the lower ground floor being an empty space. Any deviation from this would require consultation with the fire safety team. Presently combustible items are being stored, and they do require removal. E-mail communication has been sent to Urban design requesting removal.

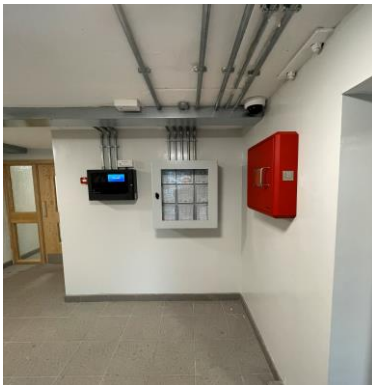
Both lifts come to ground on activation of this alarm. The alarm panel is presently only indicating an ignition on floor 10 and requires re programming. Fire Alarm Engineer currently rectifying situation.

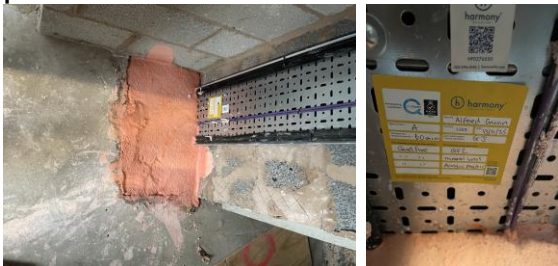
- 5) A variety of methods / materials have been used to achieve fire-stopping including Rockwool, fire rated sponge and intumescent pillows.

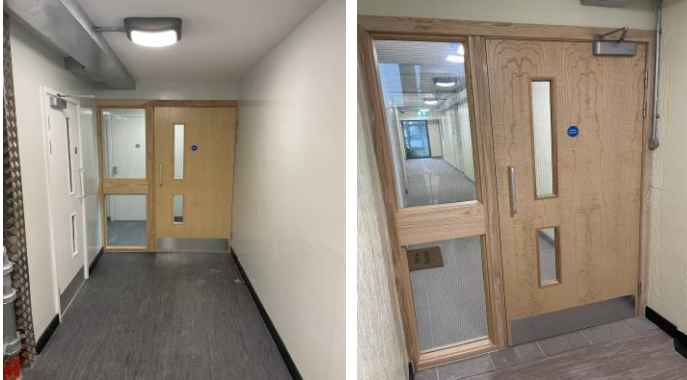
- 7) **Cracked glazing noted to door set adjacent to flat 14 in block C. Glazing to be replaced.**

10/7	Cracked Glazing to be replaced. Block C adjacent flat 14

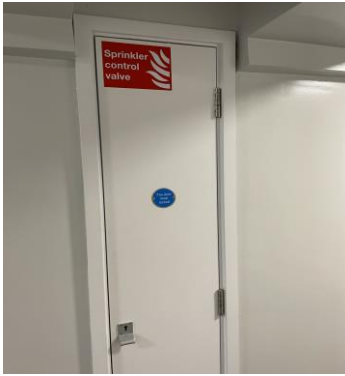
- 11) All service cupboards are locked with suited 54 mortice locks.
- 12) **Fire doors to the server room and the room behind the electrical intake room require adjustment as not closing into the frame.**

P3	Repairs 3-6 months	
10/12	Fire doors (2) to the server room and the room behind the electrical intake room require adjustment as not closing into the frame.

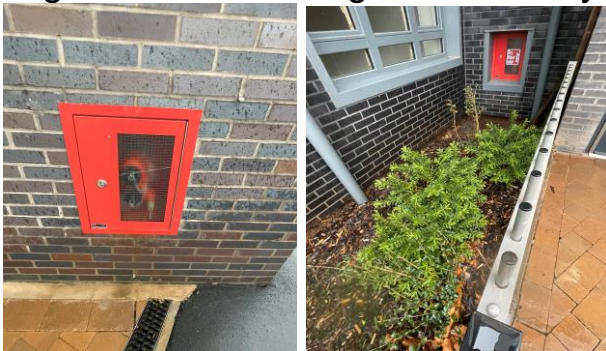
- 1) The building has two dry risers located at the front of the building. Identified as A and B internally to aid firefighting operations. Keys for the dry riser inlet are located within the secure premise information box. Estate services have agreed to remove the vegetation obstructing access to dry riser A.

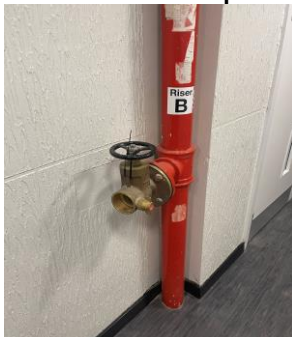
- 2) The dry riser outlets are exposed and located on the lift lobby of each floor. Each exposed valve is secured with a cable tie. The caretakers check the cable tie is intact as part of their weekday inspections. The locations of the dry risers ensure a 45m hose length is satisfactory for any flat however, a hose length of sixty metres would be required to the furthest point of the plant room. Various end caps were missing and should be replaced (Riser B, floor numbers: 10, 6 and 4). This will be rectified during the next scheduled inspection of the dry risers.

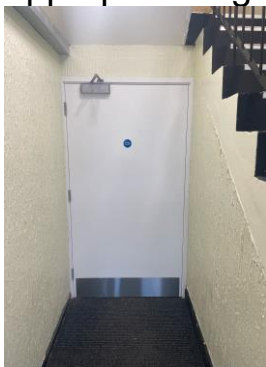
- 10) The door into the lower ground floor from staircase B cannot be opened staircase side. Building Safety Manager has confirmed appropriate signage is to be installed.

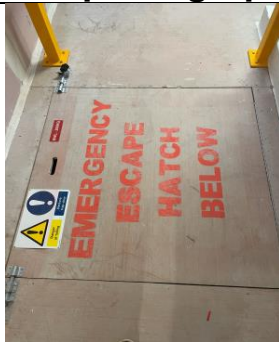
Question/ Ref No	Required Action	Supporting photograph	Priority	Timescale and Person Responsible	Date Completed
7/1	Both escape hatches require floor joists (under emergency escape hatch) to be trimmed to allow for ease of removal.

P2	Fire Rapid Response 1-3 Months

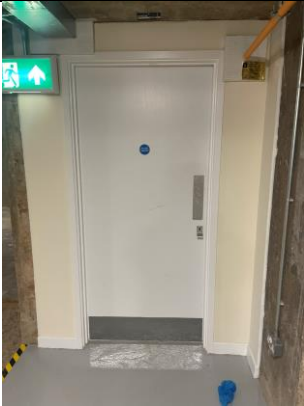
7/3	Break glass box required in lift motor room furthest from metal stair to keep escape hatch keys.	N/A	P2	Fire Rapid Response 1-3 Months	
7/23	Lower ground door opening into staircase B - Remove escusions and fit blanks to prevent door being locked.

P2	Fire Rapid Response 1-3 Months	
8/5	Smoke detection within both bin rooms to be repositioned as within 300mm of down stand.

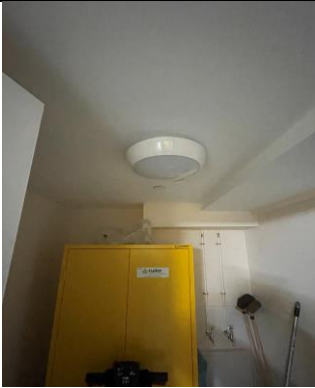
8/6	Sluice room within Caretakers room requires linked smoke detection to caretakers' room.

P3	Electrical 3-6 Months	
8/7	Creation OF ARC (Alarm receiving Centre)	No Photograph	P3	Urban Design 3-6 Months	
10/2	Confirmation required of fire resistance of fire stopping within Bin rooms (Boarded Construction with fixings exposed)

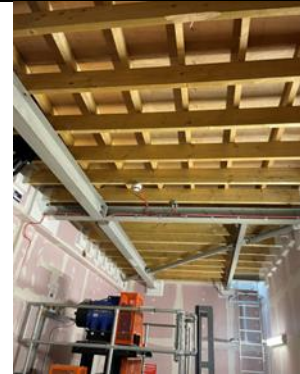
The combustibility of the flat timber roof construction covering the lift motor room and the timber floor decking within the plant room should be improved by application of an intumescent paint by a specialist contractor (eg Envirograf).
