Fire Risk Assessment

2-4

**Springfield Lane,
Rowley Regis,
B65 8PS**

Date Completed: 12/01/2026

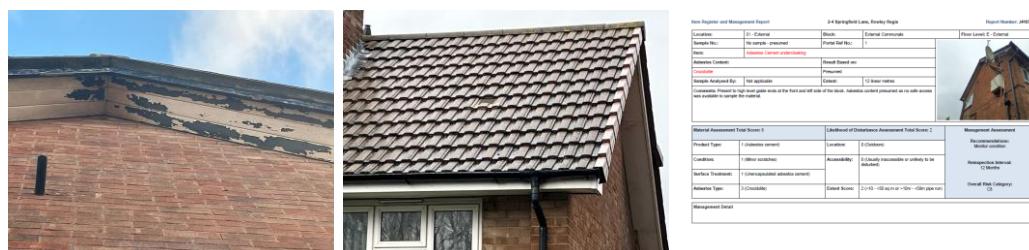
The low-rise, two-storey block (inclusive of the ground floor) was constructed in 1968 using traditional brick cavity and concrete construction. The roofs are pitched and finished with concrete interlocking tiles. Around the roof line timber fascia boards are fitted with asbestos cement soffit boards.

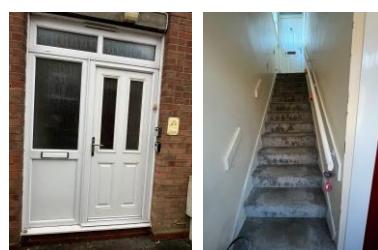
The building is a semi-detached block adjoining 1-3 Cromwell Close. Access is gained via a side entrance secured with a residential key. The entrance/exit is a uPVC door set within a uPVC frame and side panel, incorporating glazed sections. Beyond the entrance, there is a ground-floor flat (No. 2) and a carpeted concrete staircase providing access to Flat 4.

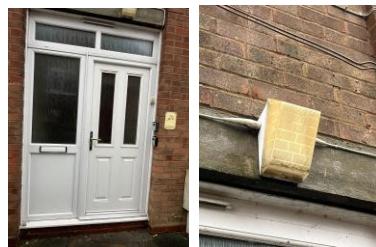
Above the front entrance door is a safety/security light installed.

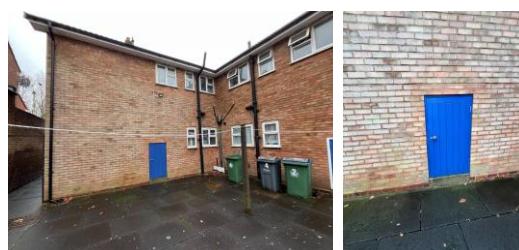
At the rear of the premises the courtyard is shared with 1-3 Cromwell Close. Within the building at the rear of 2-4 Springfield is a small storage cupboard which is kept locked with a residential key.

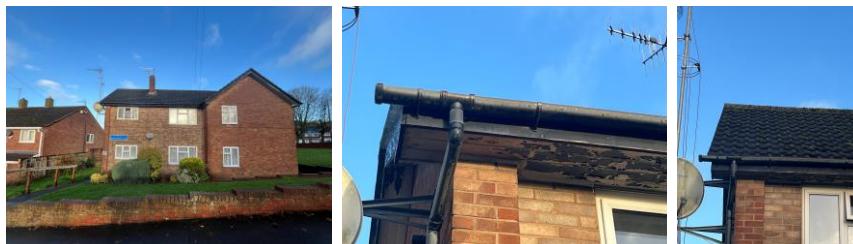
- 1) The external surface of the building is predominantly brick structure with timber fascia and asbestos cement soffits. The roof is pitched and fitted with concrete interlocking roof tiles on the roof.

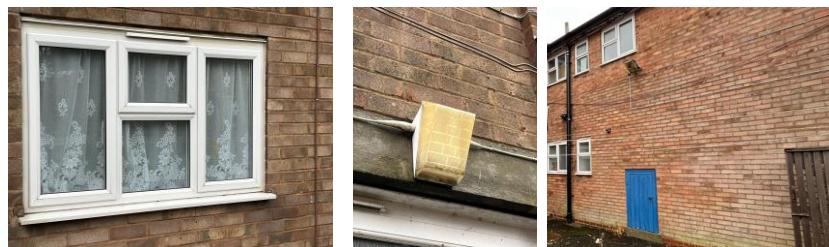
- 2) uPVC double-glazed units have been installed in each flat and one at the top of the communal stairway. A security light is fitted above the access door and one at the rear of the property. The entrance door is uPVC with glazed panels.

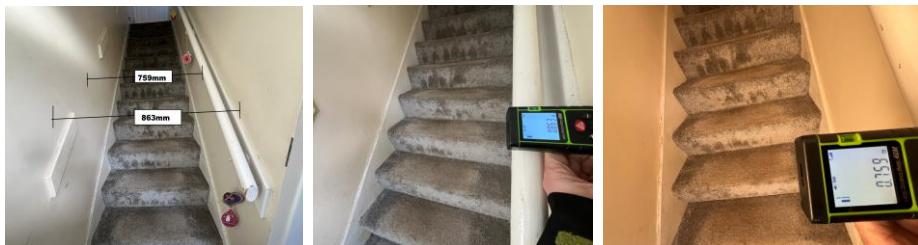
9) Within this block the first floor is accessed via a single staircase that provides a means of escape for flat 4 and has a width of a minimum of 759mm between the handrails, and 863mm wall to wall.

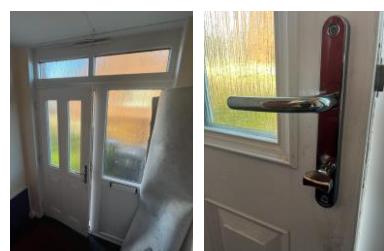
13) The final exit door is fitted with a thumb turn lock for ease of egress from within the property.

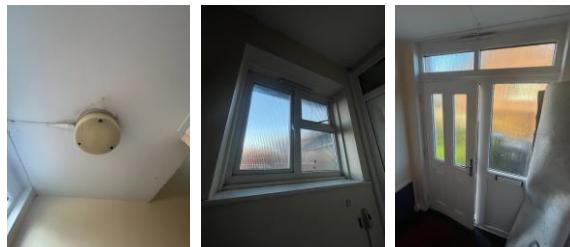
15) No emergency lighting is provided to communal landings and stairs. Adequate lighting comes from standard lighting also from the door and window areas.

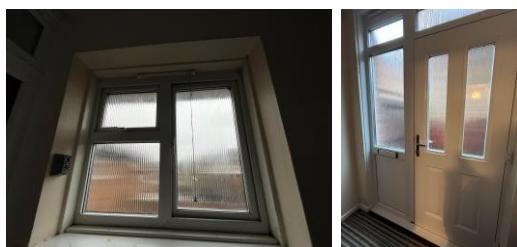
- 1) The premise is not fitted with emergency lighting
- 2) There is standard lighting within the communal area also landing window and final exit door to assist in lighting the communal areas from outside

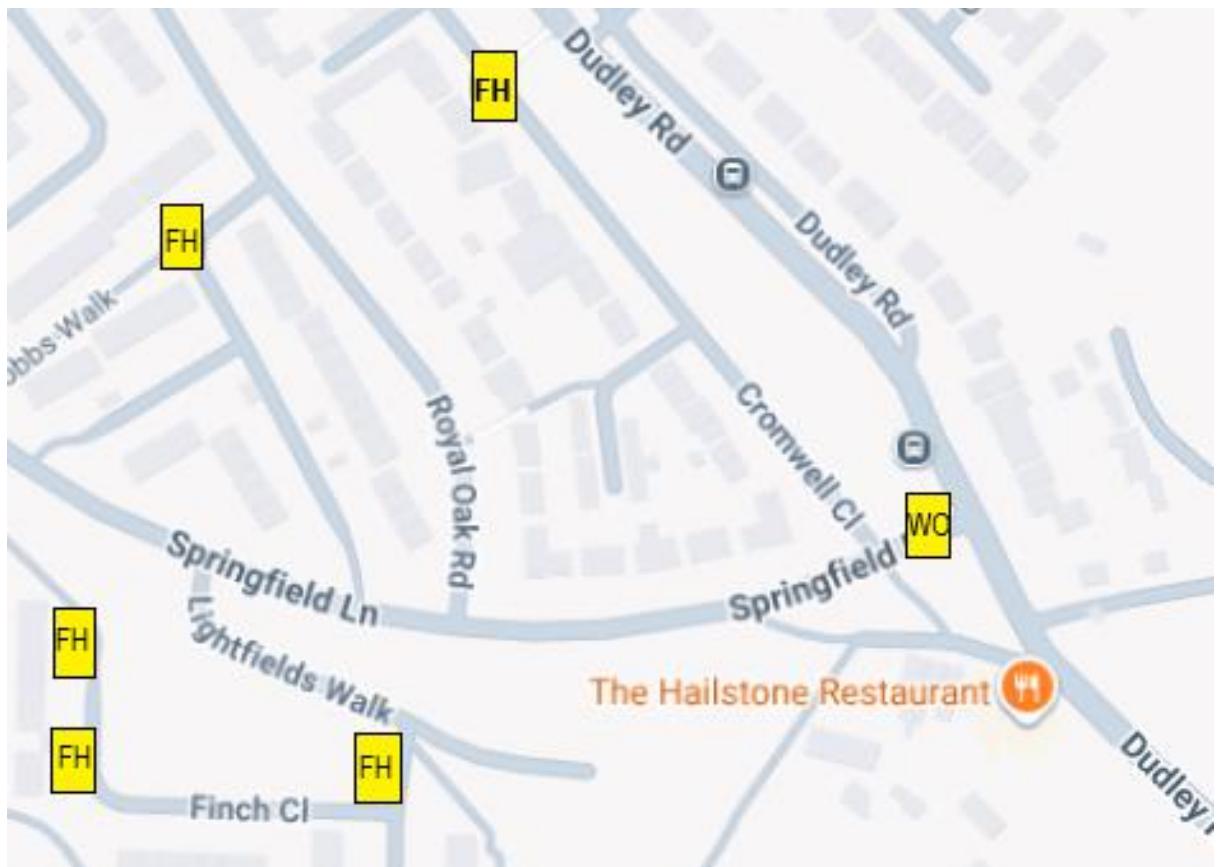
- 1) There is no firefighting equipment on this premises.
- 2) Nearest fire hydrant is indicated within the attached plan. Information from <https://dataservices.riscauthority.co.uk/map/index>

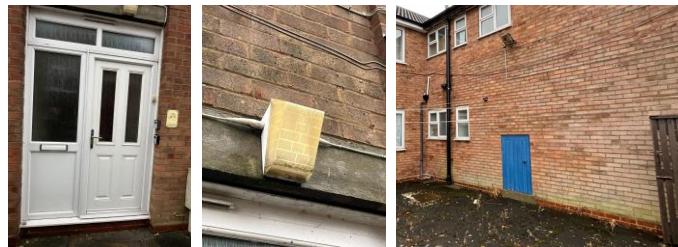
- 1) Regular checks are undertaken by Caretakers / Cleaning Team(s) 365 days per year which helps reduce the risk of arson.
- 2) Access to the premises is by means of a key that only residents have.
- 3) Perimeter is covered by external lighting
