Fire Risk Assessment

18-20

**Springfield Lane,
Rowley Regis,
B65 8PS**

Date Completed: 06/01/2026

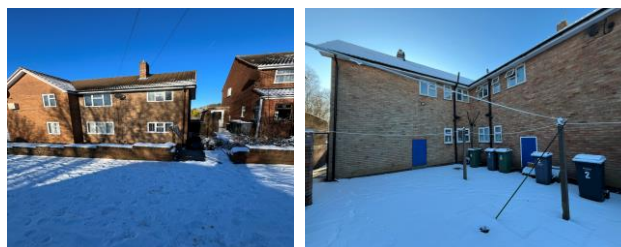
The low-rise, two-storey block (inclusive of the ground floor) was constructed in 1968 using traditional brick cavity and concrete construction. The roofs are pitched and finished with concrete interlocking tiles. Around the roof line uPVC fascia boards are fitted with cement fibre soffit boards.

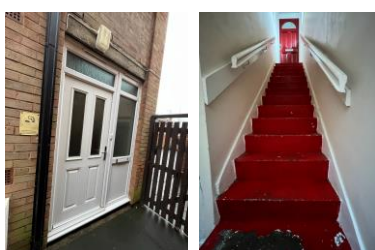
Above the front entrance door is a safety/security light installed.

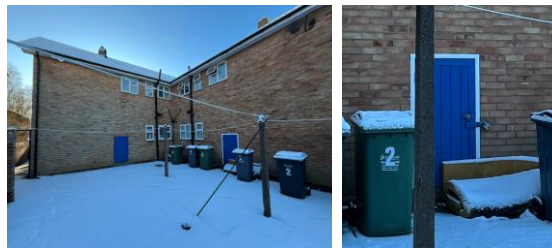
At the rear of the premises the courtyard is shared with 2-4 Royal Oak Road. Within the building at the rear of 18-20 Springfield is a small storage cupboard which is kept locked with a residential key.

Bins are situated at the rear of the premises within the courtyard. A number of these bins are kept close to the premises and will recommend they are relocated away from the building, and a purpose-built bin area is installed with future refurbishments.

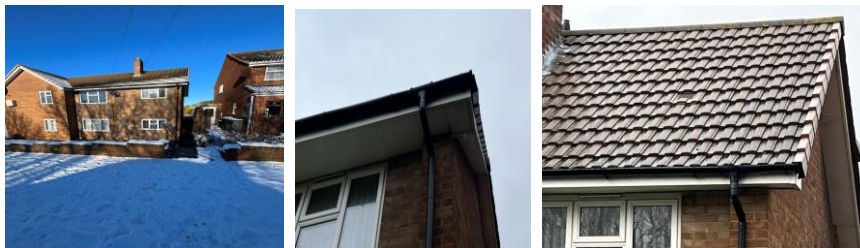
- 1) The external surface of the building is predominantly brick structure with uPVC facia and cement fibre soffits. The roof is pitched and fitted with concrete interlocking roof tiles on the roof.

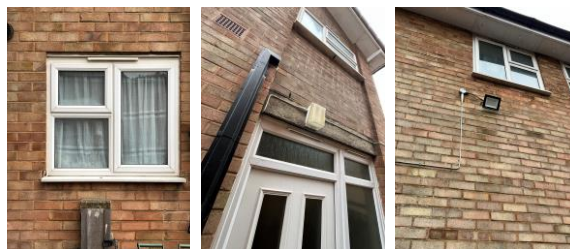
- 2) uPVC double-glazed units have been installed in each flat and on the communal stairway. A security/safety light is fitted above the access door and at the rear of the property. The entrance door is uPVC with glazed panels.

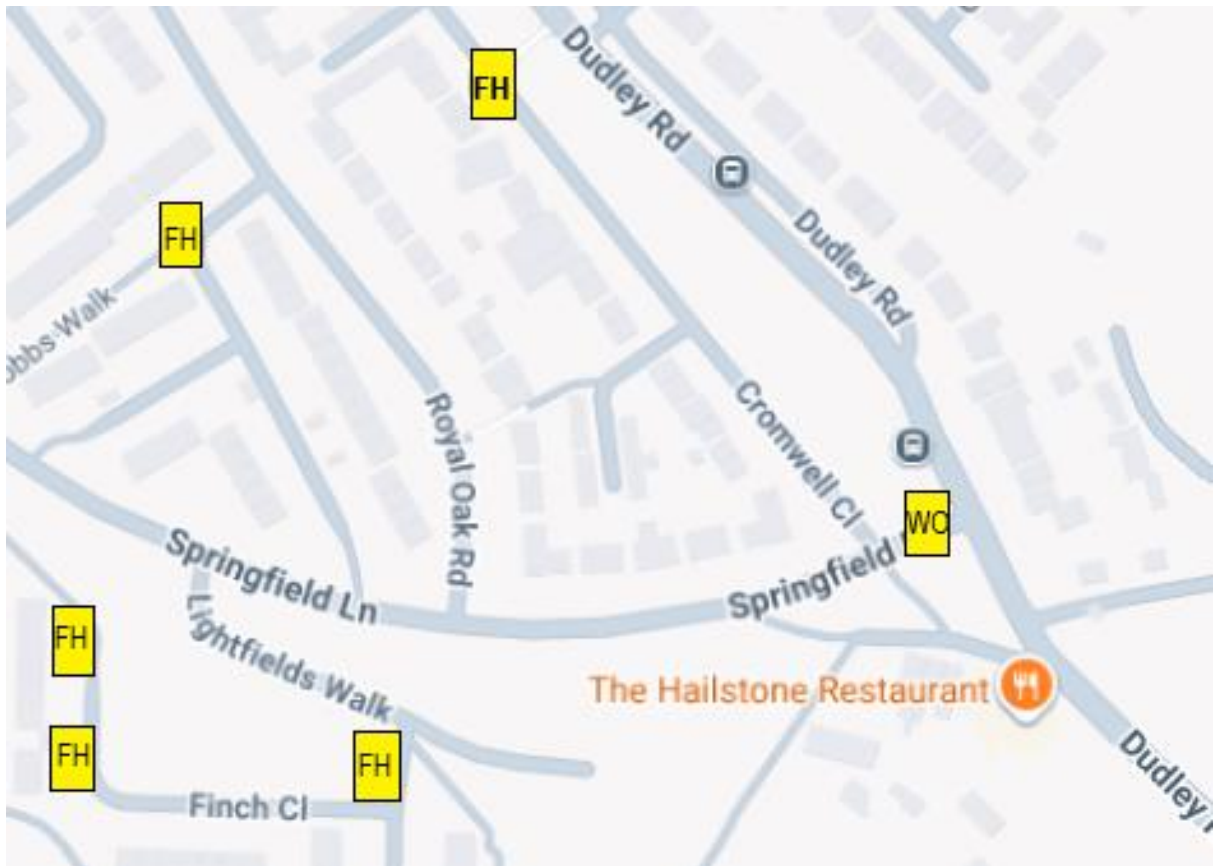
- 1) There is no firefighting equipment on this premises.
- 2) Nearest fire hydrant is indicated within the attached plan. Information from <https://dataservices.riscauthority.co.uk/map/index>
