Fire Risk Assessment

2-8

**Bluestone Walk
Rowley Regis,
B65 9DG.**

Date Completed: 07/01/2026

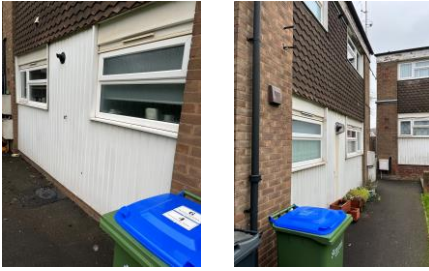
Part of the front and rear elevations have Timber and UPVC shiplap cladding to ground floor flats.

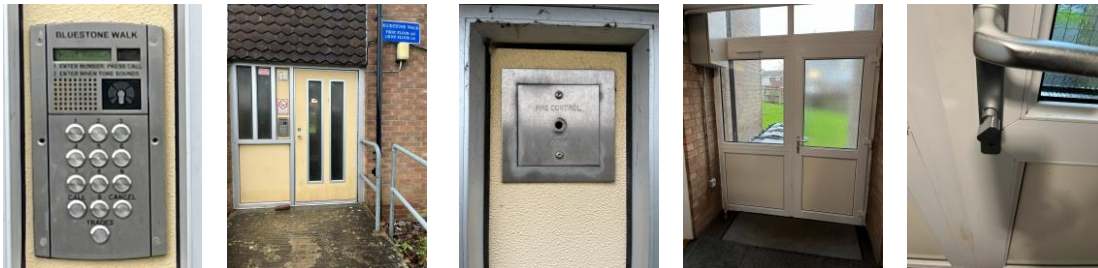
The block has a front entrance, which has a door entry system, with a fob reader installed, and a further exit located on the rear elevation, fitted with a cylinder lock with a thumb turn. Local authority employees and the fire & rescue service can use a drop latch key to gain access.

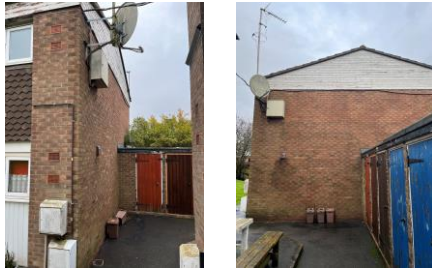
4. The building has Timber fascias and Plastic guttering just below the roof line.

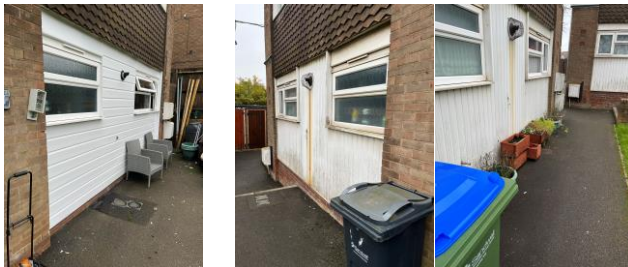
6. UPVC double glazed units have been installed to each flat.

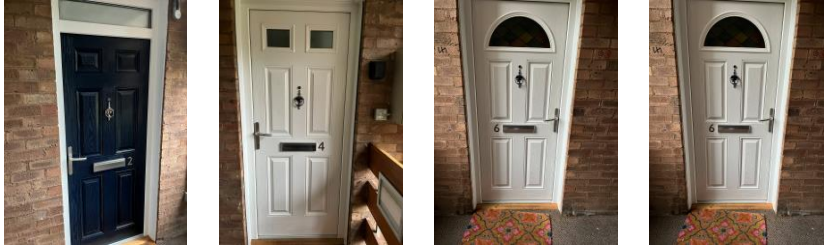
- 1) All Individual flat doors are FD30s rated composite fire doors.

- 2) Access was attempted to a sample some of the properties as part of the risk assessment. This was to ensure the doors have not been tampered with by residents.
- 3) **Flat 8 Door was inspected and does not reliably fully self-closes on latch, requires adjustment. See Action 7/3**

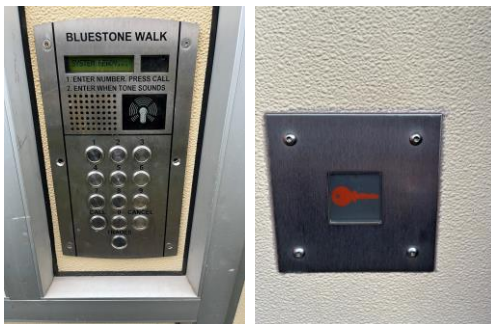
- 1) Regular checks are undertaken by Caretakers / Cleaning Team(s) 365 days per year which helps reduce the risk of arson.
- 2) Restricted access to the premises by means of a door entry system to the front and the rear.

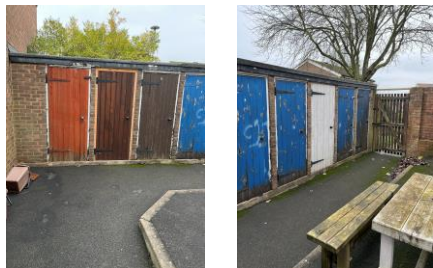
- 1) Residents instructed not to bring L.P.G cylinders into block.
- 2) Residents have individual storage sheds externally which are secured by means of own keys.
