Fire Risk Assessment

57 -59 Cromwell Close

Rowley Regis, B65 8NT

Date Completed: 6th January 2026

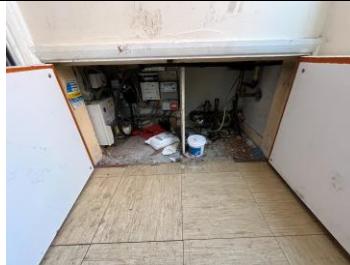
4) Electrical service cupboard is missing combined intumescent strips.

Upgrade service cupboard doors containing electrical installation to 44mm FD30s lockable doors with mandatory signage
