# Fire Risk Assessment

**50-52 Royal Oak Road**

**Rowley Regis, B65 8NX**

**Date Completed: 13th January 2026**

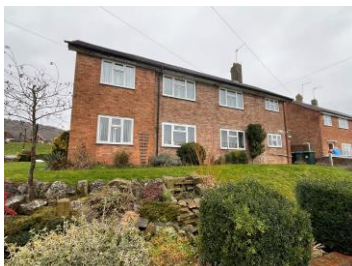
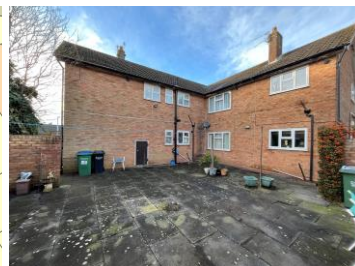
It is also noted that the block at 50-52 Royal Oak Road is physically attached to an adjacent residential building, which is accessed separately via Warren Drive. Although conjoined, the neighbouring block is served by its own independent entrance and access arrangements and does not share internal common areas with 50-52 Royal Oak Road. To the rear there is a courtyard which is shared with the neighbouring block.

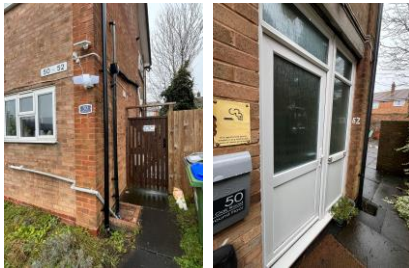
The main entrance to the building is through a timber gate on the side elevation which leads to the entrance to the block.

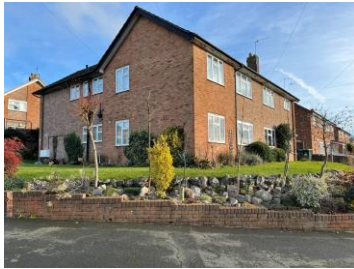
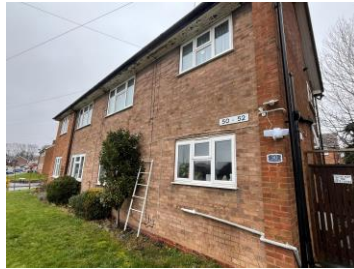
- 3) UPVC double-glazed window units have been installed in each flat and in the communal areas within the block.

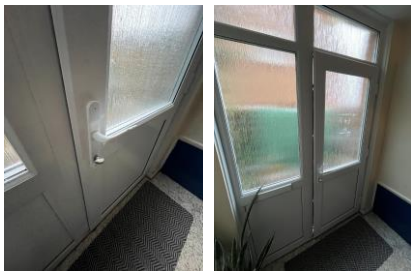
- 7) The building has sufficient passive controls that provide effective compartmentation to support a Stay Put-Unless Policy. Therefore, residents are advised to remain in their flat unless the fire directly affects them.
- 8) The final exit door is installed with a thumb turn lock, this aids easy and safe evacuation out of the building in an event of a fire.
