Fire Risk Assessment

54 - 56 Royal Oak Road

Rowley Regis, B65 8DU

Date Completed: 13th January 2026

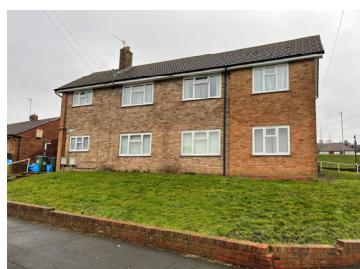
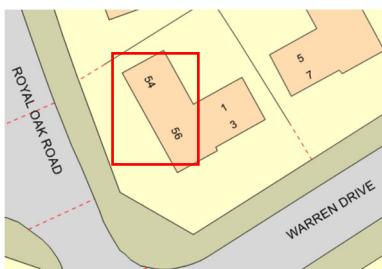
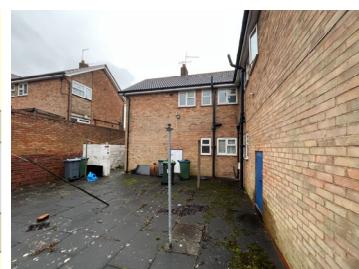
It is also noted that the block at 54 - 56 Royal Oak Road is physically attached to an adjacent residential building, which is accessed separately via Warren Drive. Although conjoined, the neighbouring block is served by its own independent entrance and access arrangements and does not share internal common areas with 54 – 56 Royal Oak Lane. To the rear there is a courtyard which is shared with the neighbouring block.

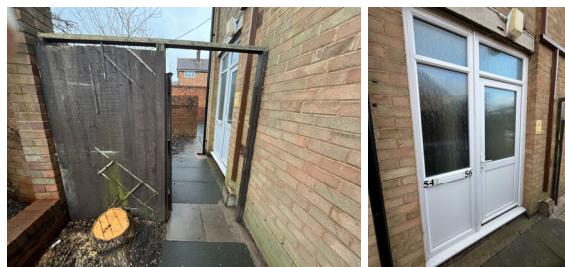
The main entrance to the building is through a timber gate on the side elevation which leads to the entrance to the block.
