# Fire Risk Assessment

## Meadow Avenue (Aspen House)

**Charlemont Farm, West Bromwich,  
B71 3EF.**

**Date Completed: 02/02/2026**

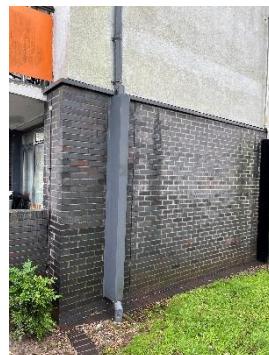
- 1) The external wall at Aspen House has 3 separate areas of cladding. The external wall system was upgraded in 2017/18 and comprises of:
  - Brickwork from ground to 1ST floor. Fire classification A1.

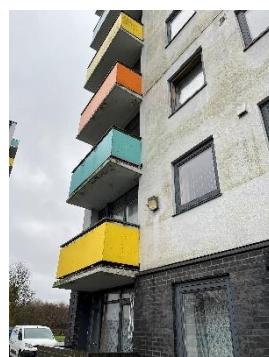
- Wetherby EW1 render system 1st to 8th floor. Fire classification A2

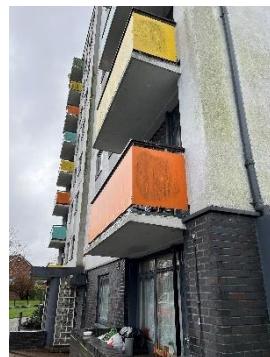
- Trespa HPL panels to balconies. Fire classification B-s1, d0.

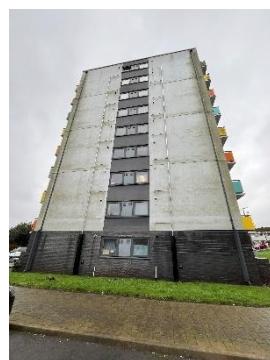
- Aluminium panels. Fire classification A1.

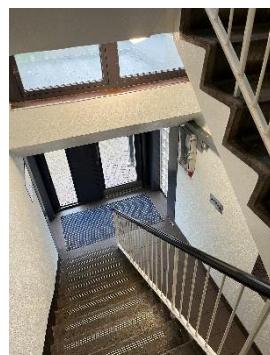
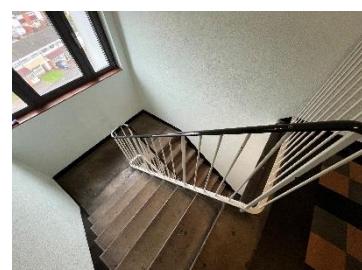
- 1) The building has two protected staircases that provide adequate means of escape. The staircase is 1030mm in width. The staircases are of concrete construction from the ground floor up to top floor.

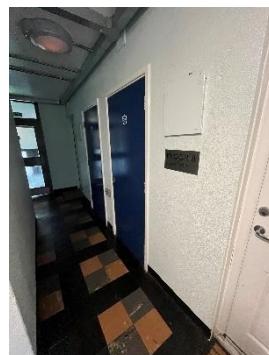
- 2) All corridors are of adequate width (at least 1070mm) and will be maintained clear to that width as a minimum.

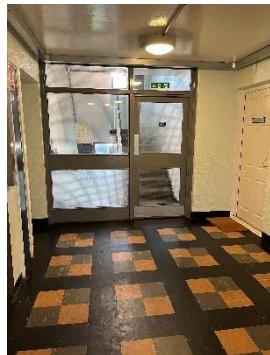
6) The communal landing / staircases are protected by use of notional FD30s fire doors with vision panels. These doors have been upgraded with a combined strip consisting of a cold smoke seal and intumescent strip.

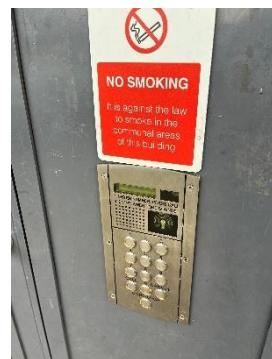
14) The final exit doors have door entry systems installed. These systems are designed to fail safe i.e. door unlocked in the event of a power failure. This prevents residents being locked in or out of the building.

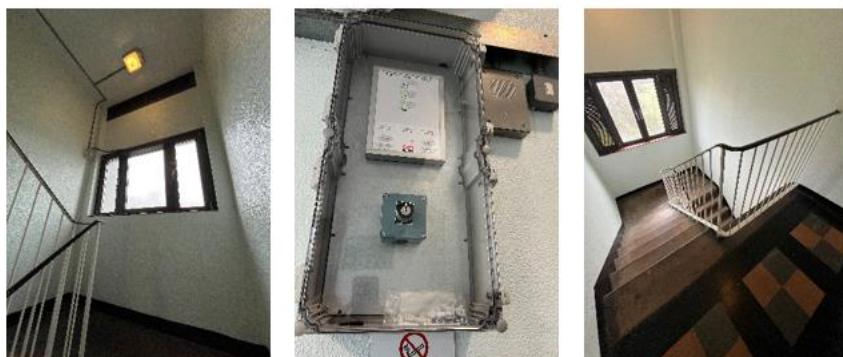
15) Automatic smoke ventilation is employed in the front protected staircase, on half landings on floors 1, 5 and 7. This is tested, inspected, and maintained by a competent procured contractor in accordance with BS7346. The frequency for the maintenance checks is twice per year. (April and October). The rear staircase has louvre ventilation on all floors. Windows can be opened with use of a key.

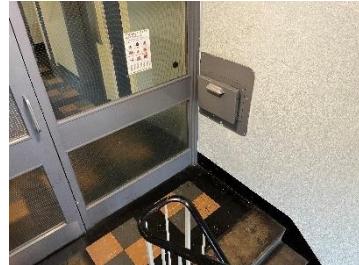
16) Refuse chute hoppers are available on each floor, within the rear stairwell. The chute system is connected to the bin store at the rear of the building.

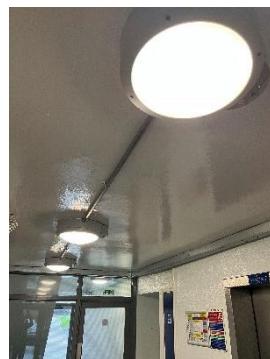
17) Emergency lighting is provided to communal lobbies and stairs. Checks are done monthly by Sandwell MBC in house electrical team or approved contractor.

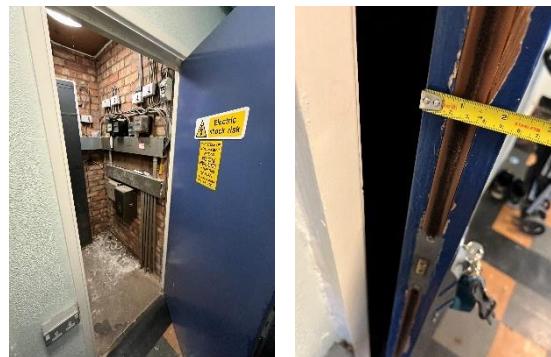
18) Residents' electrical meters are situated in the cupboards on all floors, protected with FD60s doors.

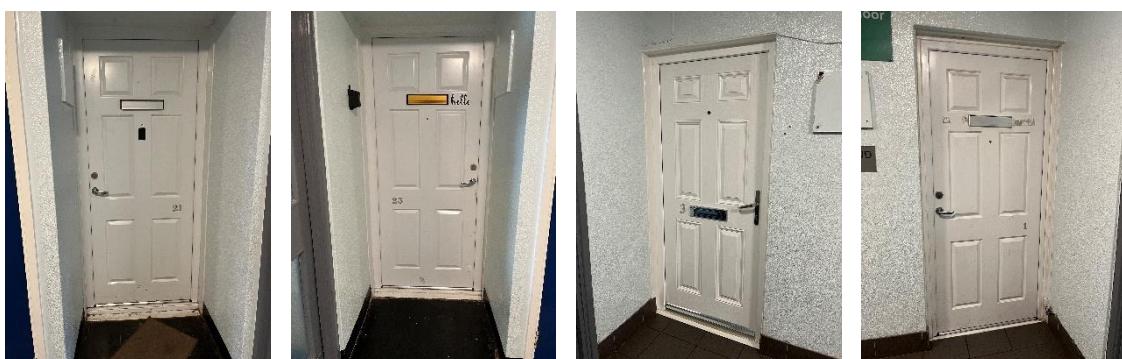
21) Individual flat entrance doors are FD30S rated Permadoor of composite construction.

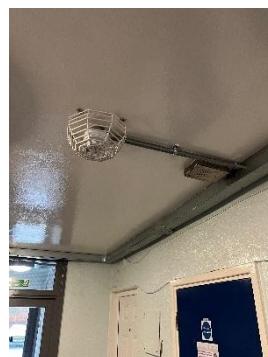
- 3) There is no effective means for detecting an outbreak of fire to the remaining communal areas. Automatic fire alarm systems are not usually required in the common areas of residential blocks as this can compromise the 'Stay Put' evacuation policy.
- 4) Smoke detectors linked to the automatic opening vent have been installed on stairwell and landing lobbies. The vents in the front stairwell will automatically open when smoke has been detected.

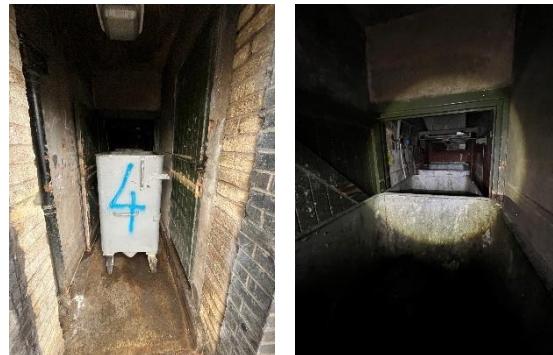
5) A deluge system is provided to the refuse chute bin store. Detectors for actuation are sited within the bin store. An approved contractor maintains the system. The frequency for the maintenance checks is twice per year (April and October).

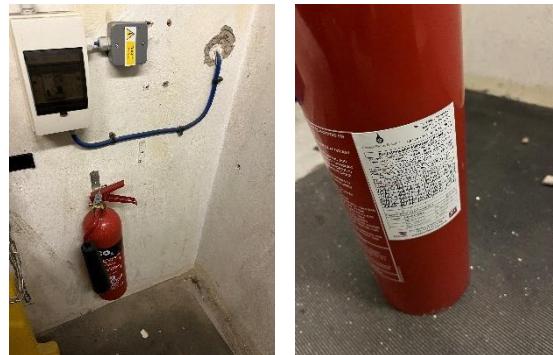
4) A portable fire CO2 fire extinguisher is provided in the lift motor room. A contract is in place for maintenance of the extinguisher. The frequency for the maintenance checks is once (October) each calendar year. There is no extinguisher information sign. A CO2 extinguisher information sign is required to be fitted. See action 11/4.
