# Fire Risk Assessment

## Meadow Avenue (Beech).

**Charlemont Farm, West Bromwich,  
B71 3EJ.**

**Date Completed: 03/02/2026**

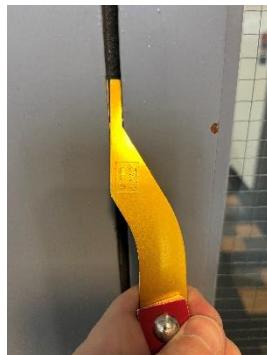
10) The 6<sup>th</sup> floor rear stairwell fire door has a 6mm latch-side gap, requiring adjustment. See action 7/10.

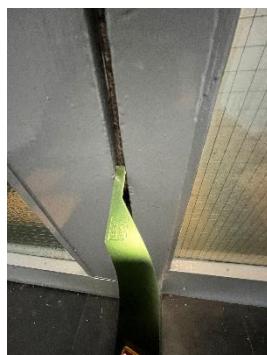
11) The 5<sup>th</sup> floor front stairwell fire door has an 8mm latch-side gap, requiring adjustment. See action 7/11.

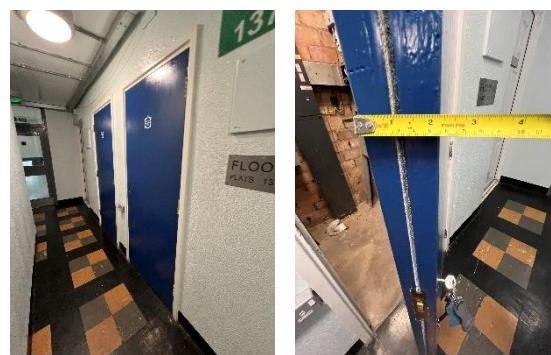
17) Residents' electrical meters are situated in the cupboards on all floors, protected with FD60s doors.

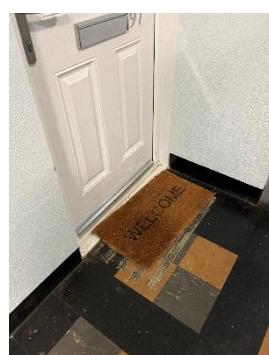
19) Individual floor mats were noted outside some flats. Fire rating of the mats is unknown but deemed to be of low risk.

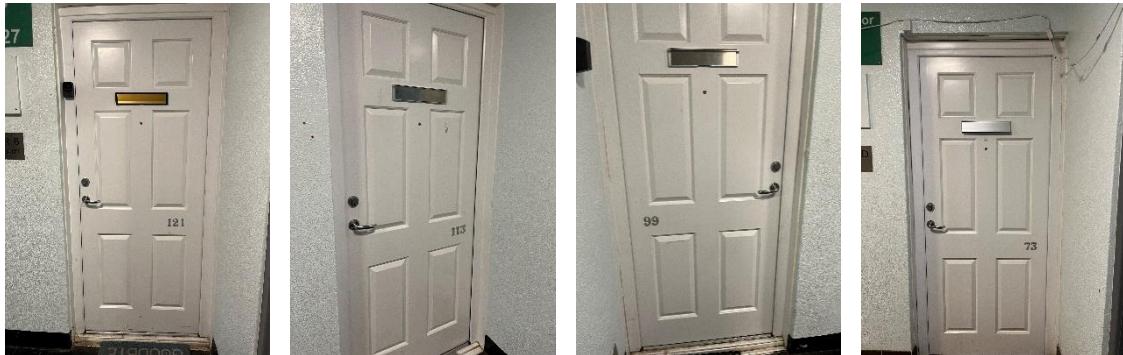
20) Individual flat entrance doors are FD30S rated Permadoor of composite construction.

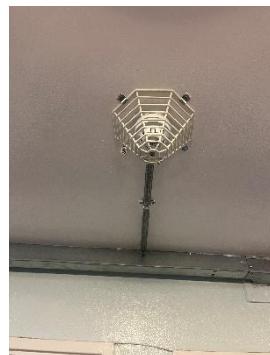
- 3) There is no effective means for detecting an outbreak of fire to the remaining communal areas. Automatic fire alarm systems are not usually required in the common areas of residential blocks as this can compromise the 'Stay Put' evacuation policy.
- 4) Smoke detectors linked to the automatic opening vent have been installed on stairwell and landing lobbies. The vents in the front stairwell will automatically open when smoke has been detected.

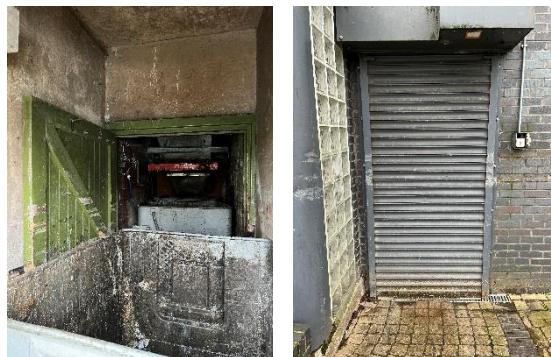
- 5) A deluge system is provided to the refuse chute bin store. Detectors for actuation are sited within the bin store. An approved contractor maintains the system. The frequency for the maintenance checks is twice per year (April and October).

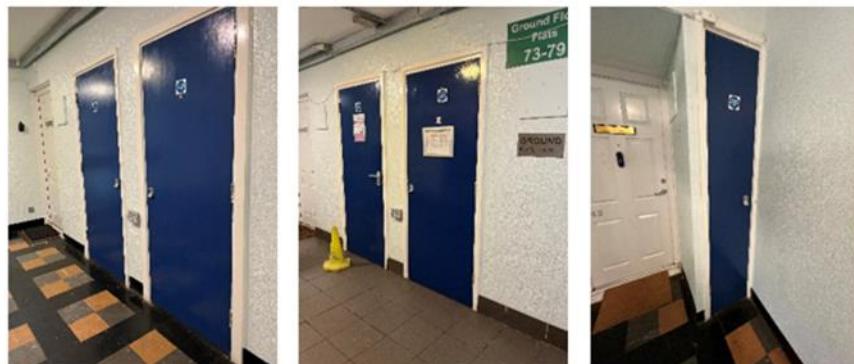
6) All floor service cupboards are notional, upgraded, FD30s or FD60s timber fire door sets. The keys are held centrally at SMBC Roway Lane, and within the firefighter's white box.

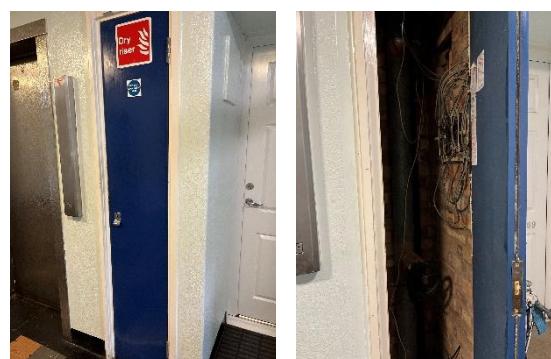
8) Dry riser cupboards on all floors are behind upgraded FD30s fire doors.

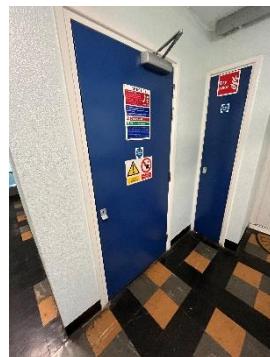
9) The lift motor room door is a notional FD60s timber fire door set. The keys are held centrally at SMBC Roway Lane, and within the firefighter's white box.

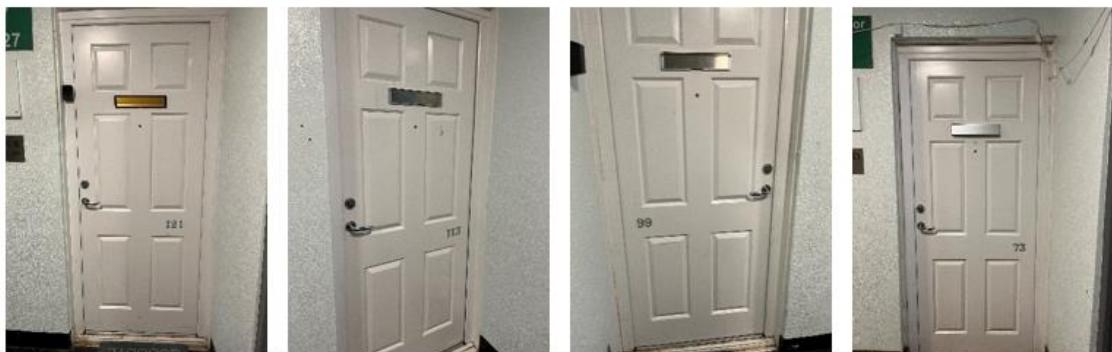
10) Individual flat entrance doors are FD30S rated Permadoor of composite construction.

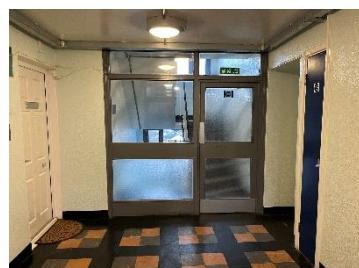
11) The communal staircase, lobbies and corridors are protected by use of notional FD30s self-closing timber fire doors with vision panels. The vision panels are georgian wired glass.

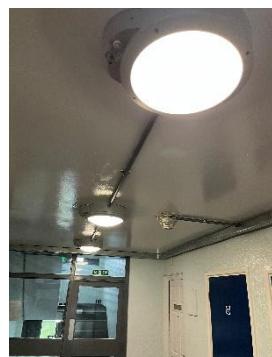
12) Cabling from service cupboards / risers to individual meter cupboards and AOV controls is housed in metal trunking.

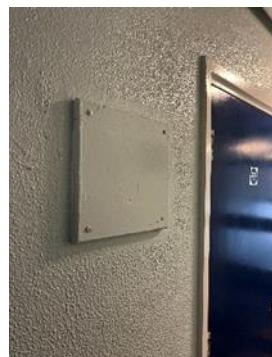
13) Access panels to stop taps are secured behind a panel cupped and screwed above the meter cupboards.

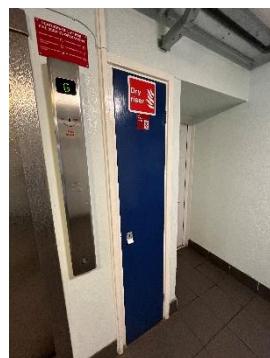
- 1) The dry riser inlet is internal, within a cupboard in the ground floor lift lobby. Secured with a type 54 suited mortice lock.

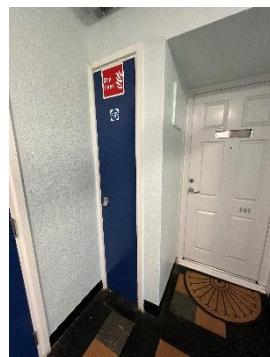
- 2) The dry riser outlets are located within cupboards on all floors, secured with a type 54 suited mortice lock. The dry risers are checked regularly as part of the caretakers' duties.

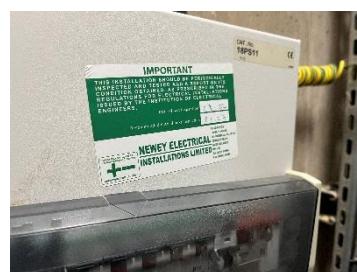
- 2) Hot works are not usually conducted. If essential maintenance requires the use of hot work processes, then corporate policies and procedures are to be followed.
- 3) The electrical installation shall be tested every 5 years. Labelled evidence shows the last inspection was January 2022.

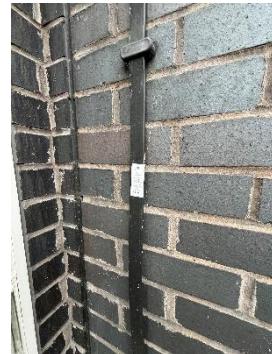
- 5) There is a lightning protection system installed to the building. Maintenance contracts are in place for lightning conductor testing in accordance with BS 6651.
