# Fire Risk Assessment

**48 – 50 Hawfield Road**

**Hawfield Rd, Tividale, Oldbury, B69 1LD**

**Date Completed: 5<sup>th</sup> February 2026**

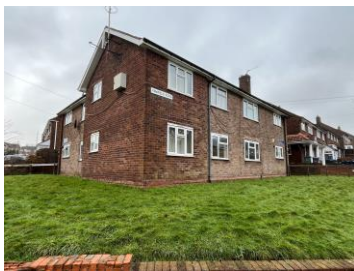
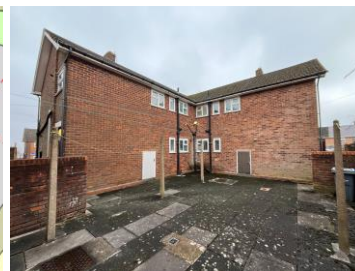
It is also noted that the block at 48-50 Hawfield Road is physically attached to an adjacent residential building, which is accessed separately via 104 Tower Road. Although conjoined, the neighbouring block is served by its own independent entrance and access arrangements and does not share internal common areas with 48 -50 Hawfield Road. To the rear there is a courtyard which is shared with the neighbouring block.

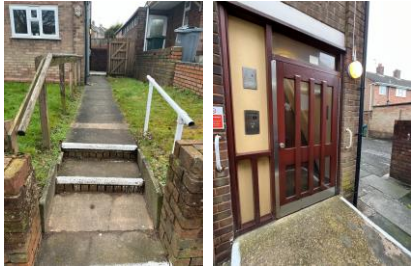
The main entrance to the building is through a timber gate on the side elevation which leads to the entrance to the block.

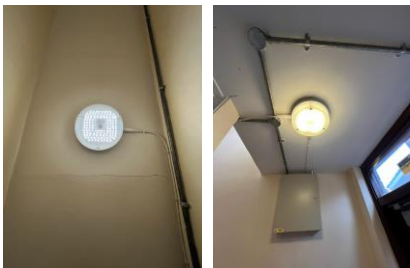
- 5) Sufficient lighting installed over the staircase and over the small hallway by the final exit door.

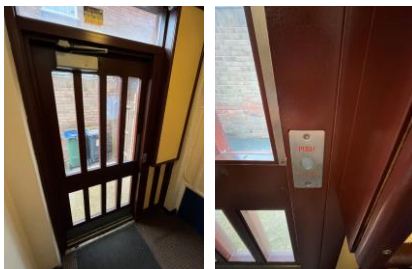
- 9) The final exit door is installed with a push button system; this is made to fail safe in an emergency which aids easy and safe evacuation out of the building in an event of a fire.

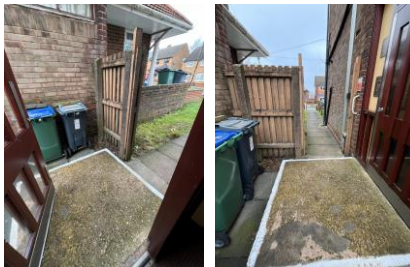
- 10) Ultimate safety is ensured through access via a timber gate. The gate is intentionally left without a key lock mechanism, allowing for immediate, unobstructed egress.

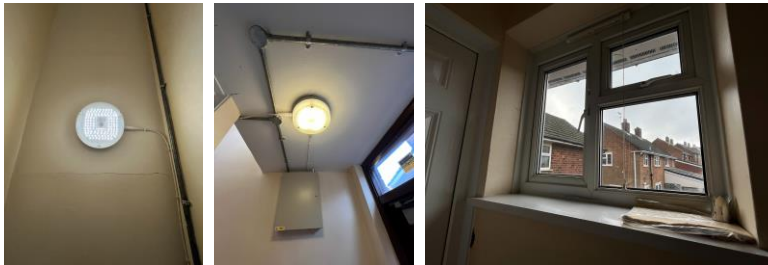
- 1) While dedicated emergency lighting has not been installed on the premises, the existing illumination is deemed adequate. This is due to the strategic placement of lighting units above the stairs and by the final exit, supplemented by sufficient borrowed lighting from the externally facing window on the staircase landing.

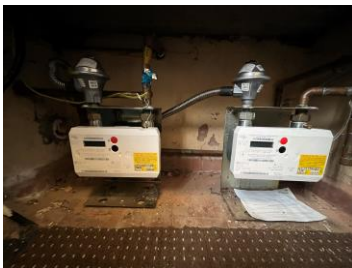
- 6) Gas appliances and pipework (where installed) are subject to annual testing and certification. This contract is managed by the in-house Gas team. Gas supply to these premises is internal. This cupboard is kept clear of any combustible items.

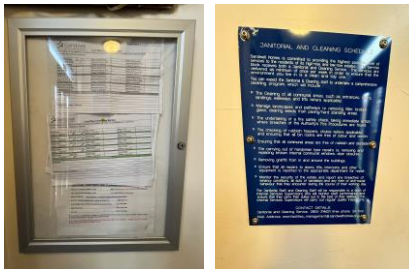
- 1) Sandwell Cleaning services and caretaking teams are employed at this block; there is a scheduled plan in place for cleaning teams to attend site.

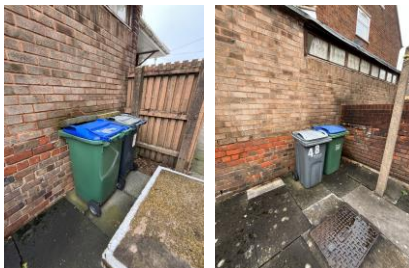
- 2) Refuse bins are located at both the front and rear of the building, bins both at the front and rear are positioned away from the building envelope and therefore pose no risk.
