# Fire Risk Assessment

**49 – 51 Hawfield Road**

**Hawfield Rd, Tividale, Oldbury, B69 1LD**

**Date Completed: 5<sup>th</sup> February 2026**

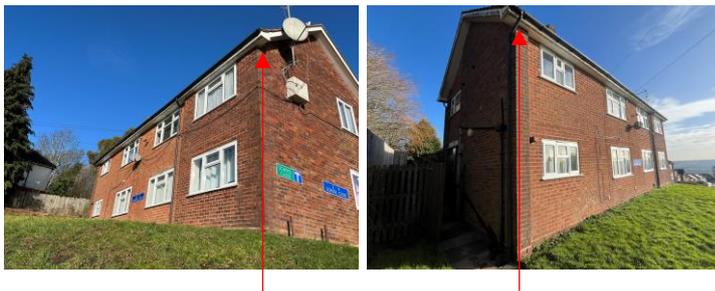
- 1)The exterior of the building is primarily traditional brick construction with a pitched roof design. The roof features concrete tiles and laminated fascia boards along the roofline and underside

Laminated boards on the underside & fascia

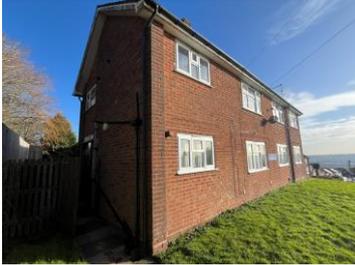
- 3) UPVC double-glazed window units have been installed in each flat and in the communal areas within the block.

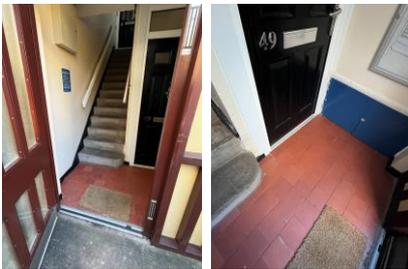
- 1) Each flat is equipped with, as a minimum LD3 fire detection to facilitate means of escape and provide sufficient response time.
- 2) The small section of the entrance hallway floor is installed with clay tiles, there is small door mat at the entrance, the sizing and condition of the mat is acceptable. This area is kept clear of any obstruction and combustibles promote maintain safe exit in an event of fire.

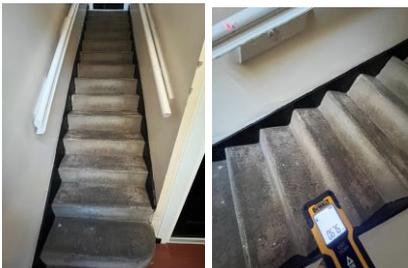
- 3) 49 - 51 Hawfield Road contains a single concrete staircase, positioned at the entrance of the block, which provides an adequate means of escape. The width of the staircases, measured from handrail to handrail, is 676 mm respectively, this is acceptable as the staircase serves a single flat. This staircase is kept clear to ensure a safe means of escape.

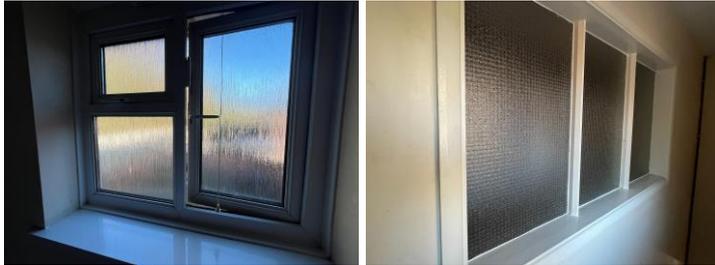
- 4) A UPVC window unit has been installed on the staircase landing which is openable without the use of key. This installation provides sufficient borrowed lighting and ventilation, while an incorporated Georgian wired glazing unit has been installed on the flat side to protect the means of escape and prevent the spread of fire and smoke. It should be noted that there is currently no automatic smoke ventilation system installed on the premises.

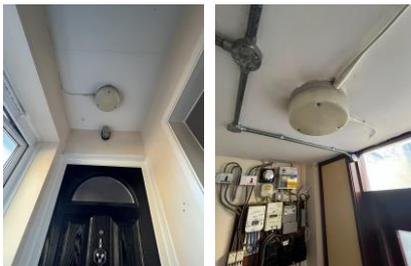
- 5) Sufficient lighting installed over the staircase and over the small hallway by the final exit door.

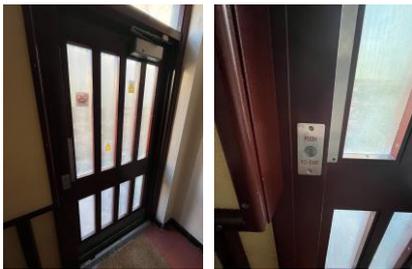
- 9) The final exit door is installed with a push button system; this is made to fail safe in an emergency which aids easy and safe evacuation out of the building in an event of a fire.

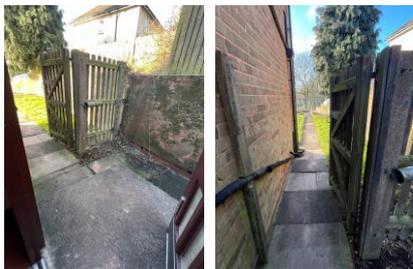
- 10) Ultimate safety is ensured through access via a timber gate. The gate is intentionally left without a key lock mechanism, allowing for immediate, unobstructed egress.

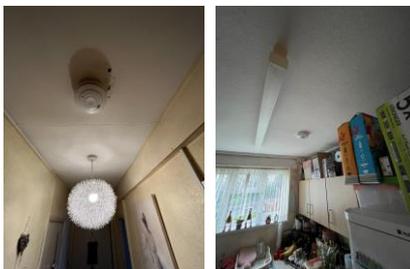
Flat 49 – Detection in hallway, kitchen, living room – LD2

Flat 51 – No access gained.

- 5) SMBC's Job Manager system confirms detectors to LD2 standard were checked as part of the most recent annual gas service for both flats 49 -51

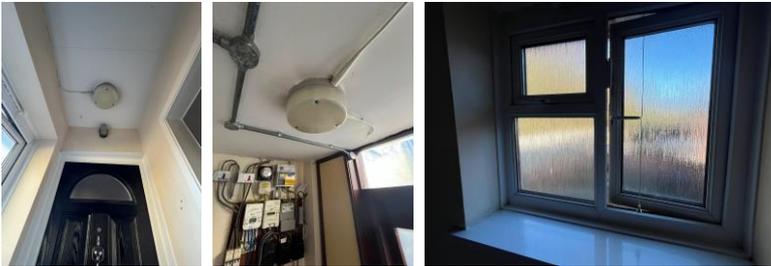
- 1) While dedicated emergency lighting has not been installed on the premises, the existing illumination is deemed adequate. This is due to the strategic placement of lighting units above the stairs and by the final exit, supplemented by sufficient borrowed lighting from the externally facing window on the staircase landing.

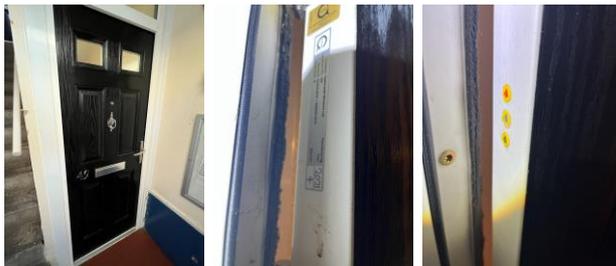
7) Flat 49 has been fitted with a certified composite FD30S fire door assembly. Could not gain access to inspect flat entrance door to flat 51.

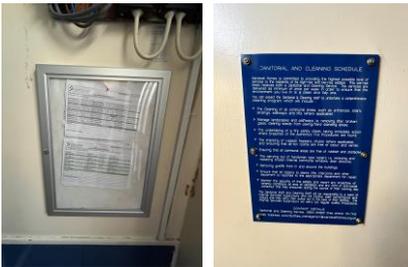
- 1) Sandwell Cleaning services and caretaking teams are employed at this block; there is a scheduled plan in place for cleaning teams to attend site.

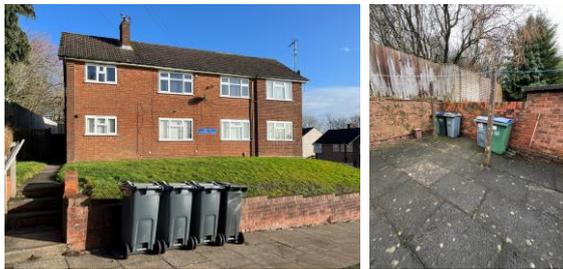
- 2) Refuse bins are located at both the front of the building

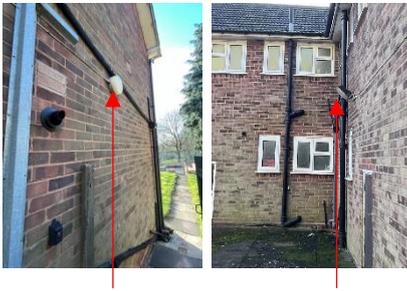
- 1) There is no current evidence of arson.
- 2) The perimeter of the premises is well illuminated with the installation of external lighting.

Front and rear external lighting
