Fire Risk Assessment

1-3

**Hawfield Close,
Tividale,
B69 1LH**

Date Completed: 11/02/2026

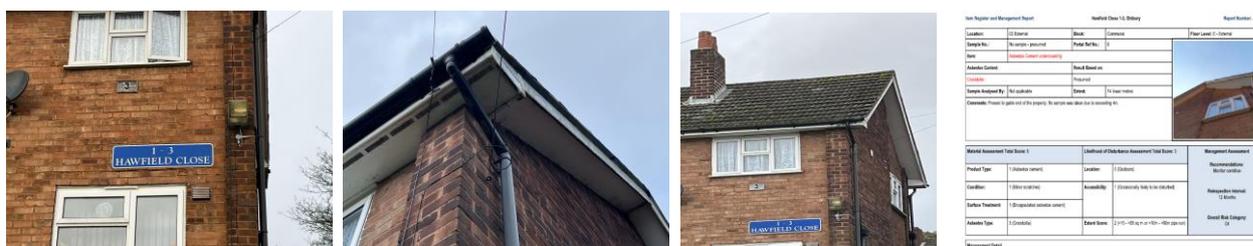
The low-rise, two-storey block (inclusive of the ground floor) was constructed in 1966 using traditional brick cavity and concrete construction. The roofs are pitched and finished with concrete interlocking tiles. Around the roof line uPVC fascia boards are fitted with asbestos cement underclotting soffit boards.

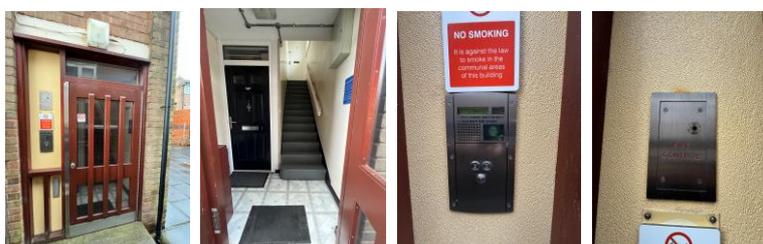
The building is a semi-detached block adjoining 65-67 Hawfield Road. Access is gained via a secured side entrance. The entrance/exit door is timber construction with glass panelled inset. Access is gained with fob, flat call button and fire service drop key. Beyond the entrance, there is a ground-floor flat (No. 1) and a concrete staircase providing access to Flat 3

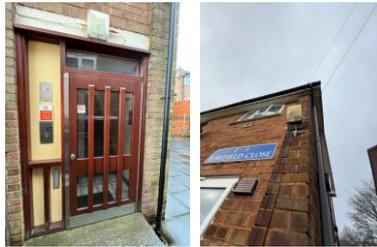
Above the front entrance door and at the front of the premises a safety/security light is installed.

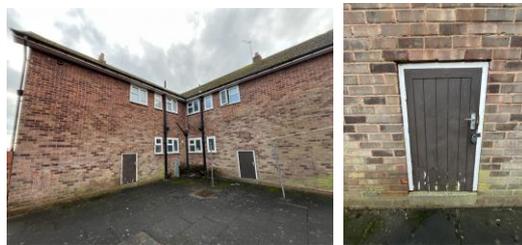
At the rear of the premises the courtyard is shared with 65-67 Hawfield Road. Within the building at the rear there is a small storage cupboard which is kept locked with a residential key.

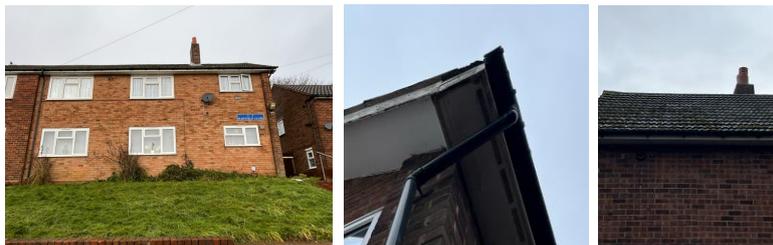
- 1) The external surface of the building is predominantly brick structure with uPVC fascia and asbestos cement undercloaking soffits. The roof is pitched and fitted with concrete interlocking roof tiles on the roof.

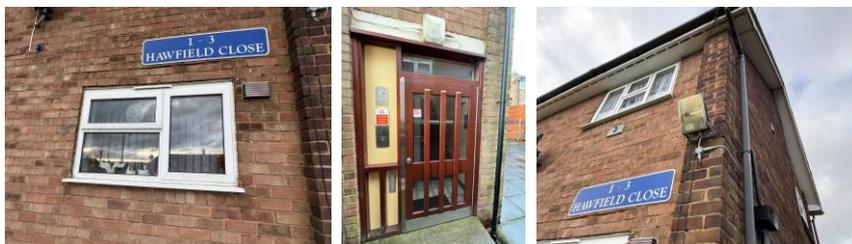
- 2) uPVC double-glazed units have been installed in each flat and one at the top of the communal stairway. A security/safety light is fitted above the access door and one at the front of the property. The entrance door is timber construction with glazed panels.

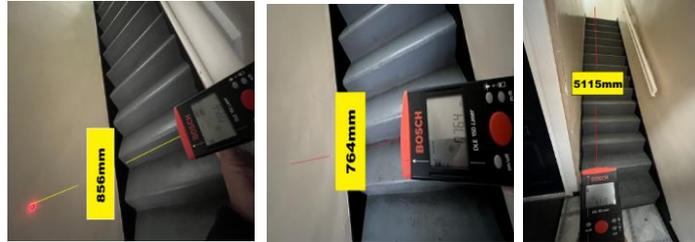
9) Within this block the first floor is accessed via a single staircase that provides a means of escape for flat 3 and has a width of a minimum of 764mm between the handrails, and 856mm wall to wall.

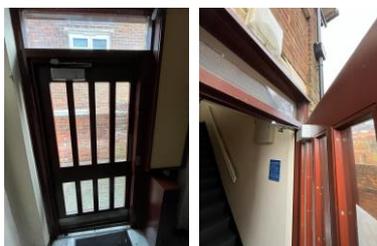
15) The final exit doors are fitted with a push button to egress the building and are also fitted with automatic closing devices that are checked on a regular basis by caretaking teams as part of their checks. Defective closing devices are replaced either by the Caretaking Team(s) or the in-house repairs team(s). The final exit doors have door entry systems installed. These systems are designed to fail safe i.e. door unlocked in the event of a power failure. This prevents residents being locked in or out of the building.

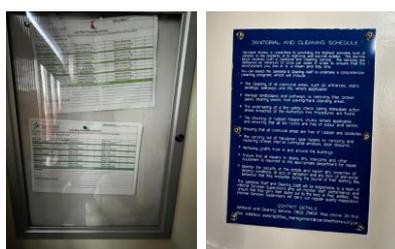
16) Communal areas are kept free of flammable items. The communal areas are checked on a regular basis by Caretaking / Cleaning teams 365 days per year and all items of rubbish are immediately removed. There is also an out of hour's service that allows combustible items of furniture / rubbish to be removed.

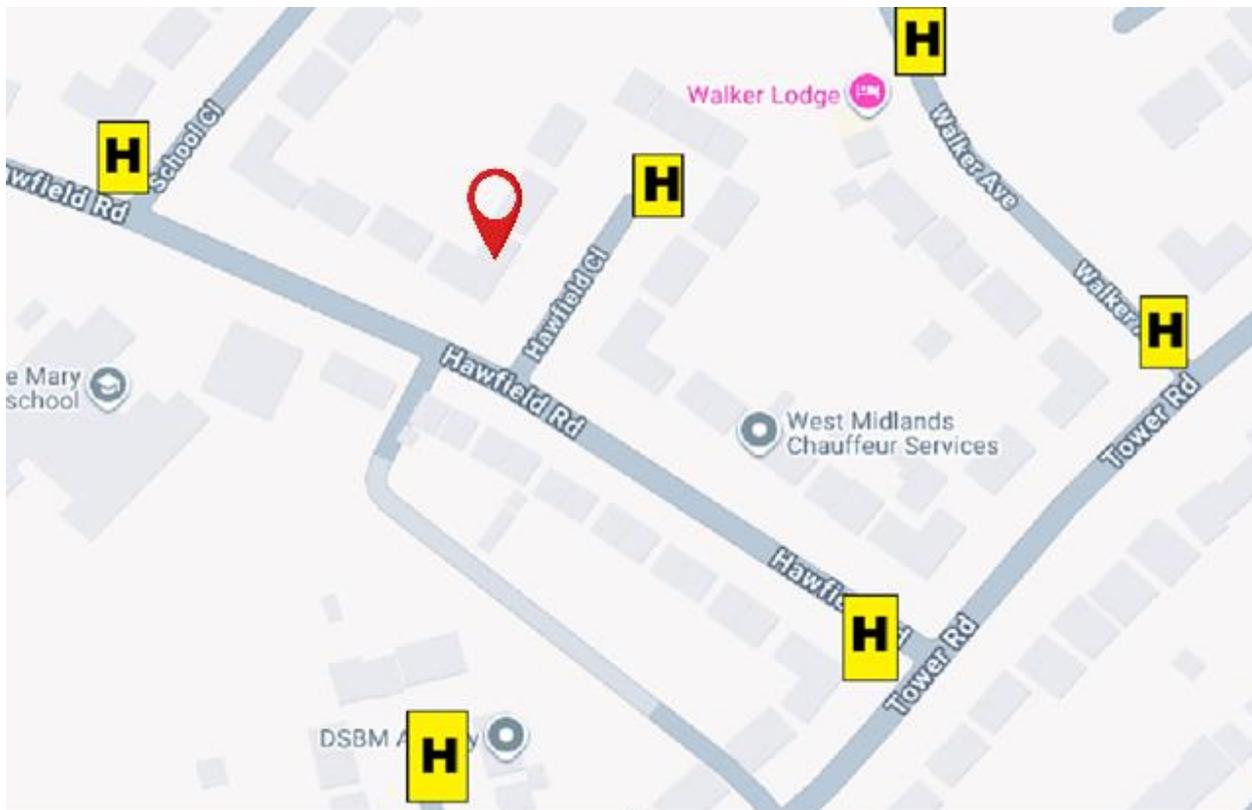
- 1) There is no firefighting equipment on this premises.
- 2) Nearest fire hydrant is indicated within the attached plan. Information from <https://dataservices.riscauthority.co.uk/map/index>

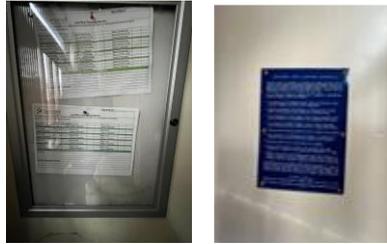
- 1) There is a regular Cleaning Service to the premises.

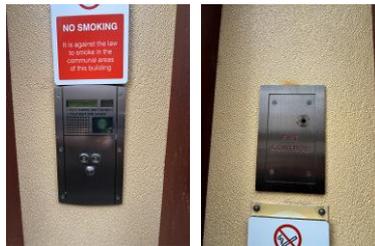
- 1) Regular checks are undertaken by Caretakers / Cleaning Team(s) 365 days per year which helps reduce the risk of arson.
- 2) Access to the premises is by means of a key, fob that only residents or using a fire fighters drop key.

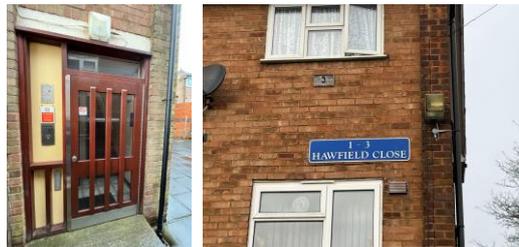
- 3) Perimeter is covered by external lighting

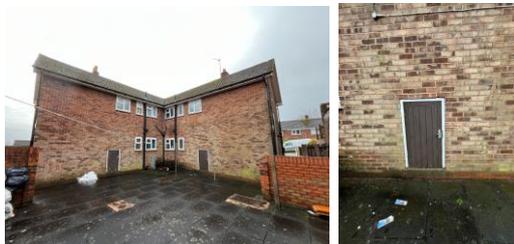
- 1) Residents instructed not to bring L.P.G cylinders into block.
- 2) The tenancy conditions, Section 7 – Condition 5.6 stipulates “If you live in a flat or maisonette, you, people living with you and any visitors to your property must not keep or use paraffin oil, petrol, bottled gas appliances or any other explosive, FLAMMABLE or dangerous material in the property. This restriction also applies to any storage facility situated in or attached to the block, which has been provided for your use.”
- 3) Residents should not store flammable liquids or gas cylinders on site.
- 4) No Flammable liquids stored on site by Caretakers / Cleaners.
- 5) There is one storage cupboard in the rear courtyard, which is built within the building and is locked by a tenant only key.
