Fire Risk Assessment

**104-104a
Tower Road,
Oldbury,
B69 1PE**

Date Completed: 02/03/2026

Current Risk Rating = Tolerable

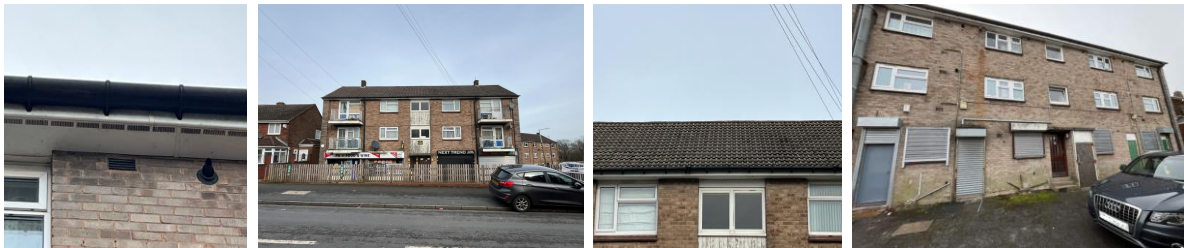
- 1) The external surface of the building is predominantly brick structure with uPVC fascia and asbestos cement undercloaking soffits. The roof is pitched and fitted with concrete interlocking roof tiles on the roof.

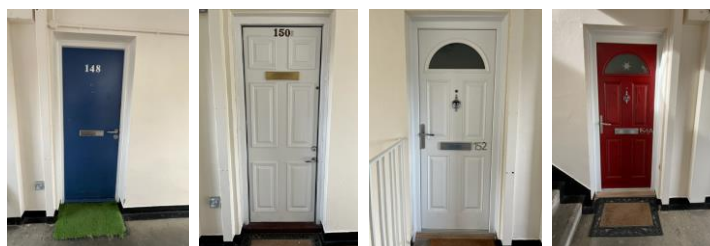
- 4) None of the corridors that form part of the means of escape are dead ends.
- 5) Four flats within the block, flat numbers 148, 150A, 152, 154A. These are a minimum of upgraded timber notional FD30s fire door sets.

a) Flat 148: No self-closer was fitted. Damage on the inside of the door frame and around the thumb lock. The inside door handle is missing screws. Gaps in between the door and frame: Top of the door 5mm, slam side 6mm. Would recommend a new door set.

Question/ Ref No	Required Action	Supporting photograph	Priority	Timescale and Person Responsible	Date Completed
7/6a	Flat 148: Replace flat entrance fire door set

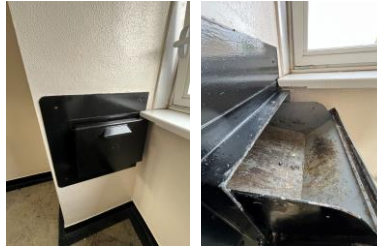
- 8) On the first and second floor you can find an Intake Hopper Door for residents to dispose of their refuse in to and down the chute, and into the waste bin.

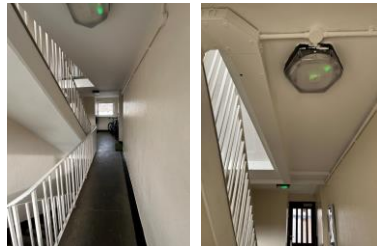
- 9) Emergency lights are fitted upon each floor x2 per floor. This lighting helps illuminate the escape route along with the addition of communal uPVC windows sited on the first and second floor. The wiring for these units is secured within metal trunking.

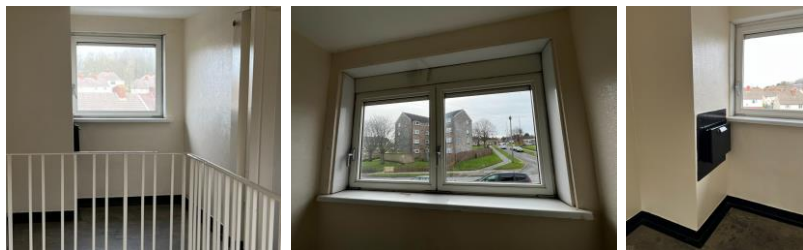
13) Automatic smoke ventilation is not employed. Window at the top of each stairway is fitted with a manual opener; the window will assist in additional lighting and any ventilation required.

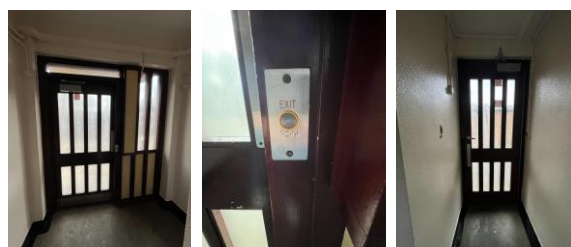
15) The final exit doors are fitted with a push button to egress the building and are also fitted with automatic closing devices that are checked on a regular basis by caretaking teams as part of their checks. Defective closing devices are replaced either by the Caretaking Team(s) or the in-house repairs team(s). The final exit doors have door entry systems installed. These systems are designed to fail safe i.e. door unlocked in the event of a power failure. This prevents residents being locked in or out of the building.

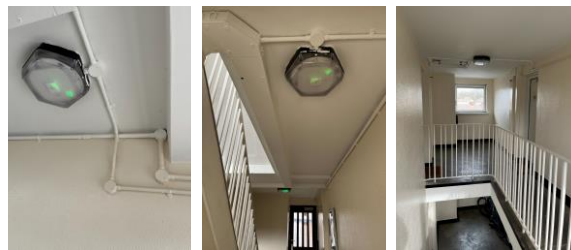
17) Emergency lighting is provided to communal landings and stairs. Additional lighting comes from communal windows and doors. The wiring for the lighting is protected within metal tubular trunking.

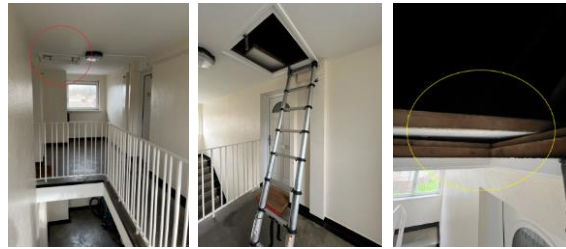
10) Access to the roof void on the top floor is provided through a hard timber loft hatch. While the exact fire rating is not confirmed, the construction suggests it offers a degree of fire resistance. The hatch remains padlocked to restrict unauthorised entry. An inspection of the roof void was carried out during the fire risk assessment, and a number of actions were noted. These are detailed below.

a) Within the roof void, there is no compartmentation separating the areas above the flats from the communal spaces. This has been included as a recommendation for future refurbishment works, as compartment walls must extend through the roof void to separate flats from each other and from the common parts. This is essential to prevent a fire in one flat from spreading through the roof void and affecting neighbouring flats or communal areas. *Added to observations to be carried out in future refurbishment.*

- Within the roof void, there is no compartmentation separating the areas above the flats from the communal spaces. This has been included as a recommendation for future refurbishment works, as compartment walls must extend through the roof void to separate flats from each other and from the common parts. This is essential to prevent a fire in one flat from spreading through the roof void and affecting neighbouring flats or communal areas.
-

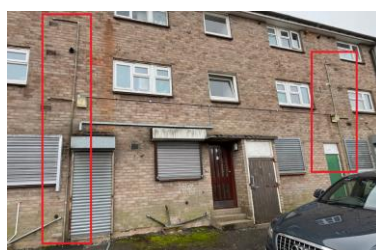
- 5) Portable heaters are not allowed in any common parts of the premises.
- 6) Gas appliances and pipework (where installed) are subject to annual testing and certification. This cyclical contract is managed by the in-house Gas Team. There are external gas risers on the property.

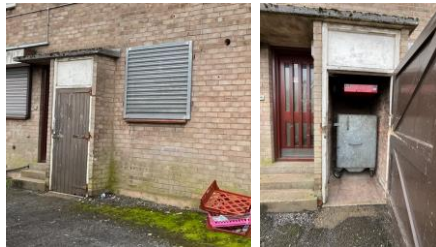
- 1) There is a regular Cleaning Service to the premises.
- 2) The refuse bin is located to the rear of the main building, within a purpose-built brick/concrete room. Rubbish is disposed of via a bin chute.
