Fire Risk Assessment

94-94A Tower Road

Tower Road, Tividale, Oldbury, B69 1LD

Date Completed: 5th February 2026

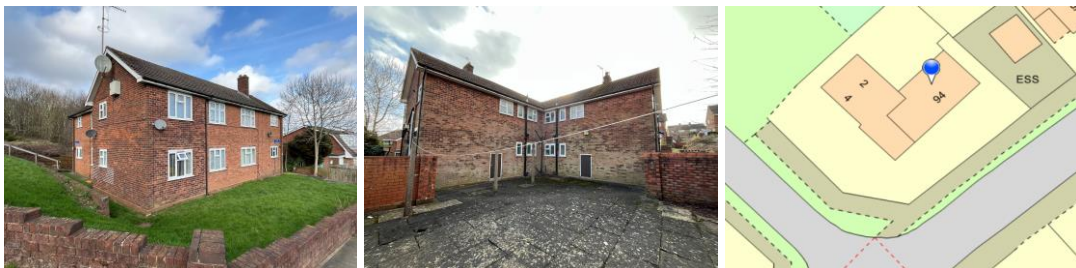
94-94A Tower Road front and rear

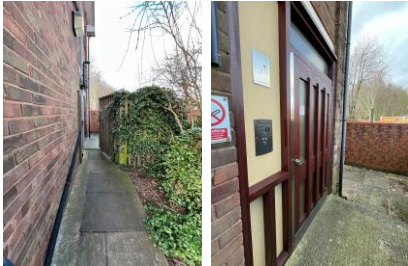
The main entrance to the building is through a timber gate on the side elevation which leads to the entrance to the block.

Block access is via a means of door access control; residents use a key fob to access the building.

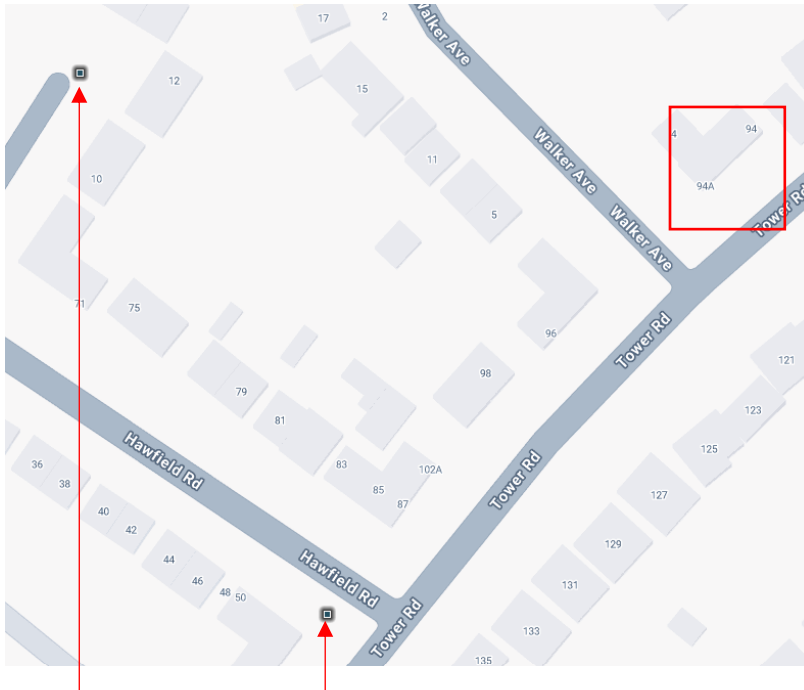
Location of Hydrants

Location of the nearest Hydrant is located on the corner of Tower Road and Hawfield Road. There is also an additional hydrant located at the end of Hawfield Close.

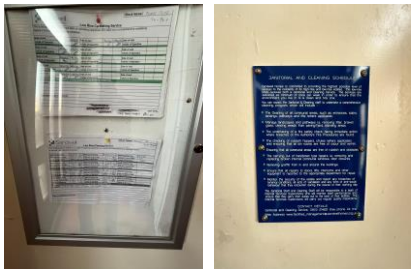
- 1) Sandwell Cleaning services and caretaking teams are employed at this block; there is a scheduled plan in place for cleaning teams to attend site.

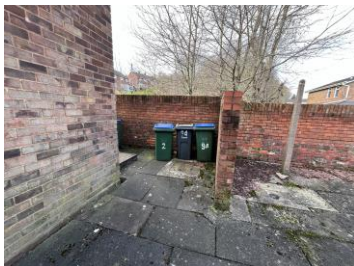
- 2) Refuse bins are located at rear of the building, away from the envelope of the block.

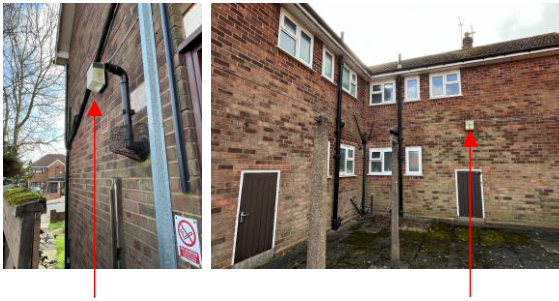
- 1) There is no current evidence of arson.
- 2) The perimeter of the premises is well illuminated with the installation of external lighting.

Front and rear external lighting
