Fire Risk Assessment

96-96A Tower Road

Tower Road, Tividale, Oldbury, B69 1LD

Date Completed: 5th February 2026

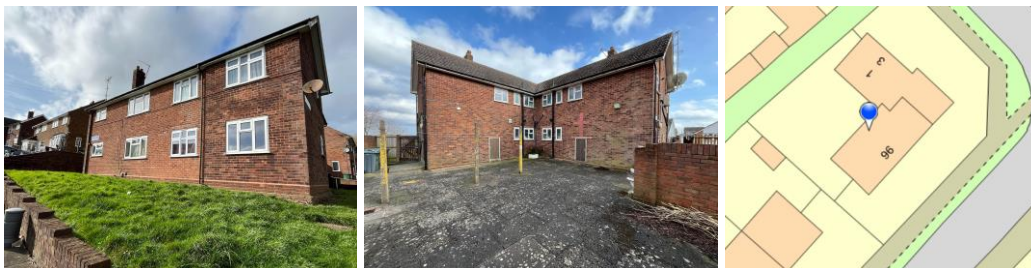
96-96A Tower Road front and rear

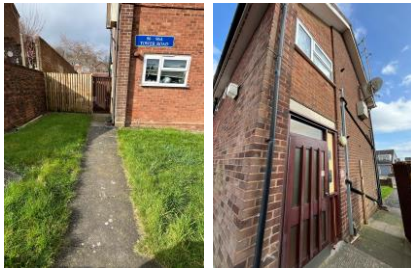
The main entrance to the building is through a timber gate on the side elevation which leads to the entrance to the block.

Block access is via a means of door access control; residents use a key fob to access the building.

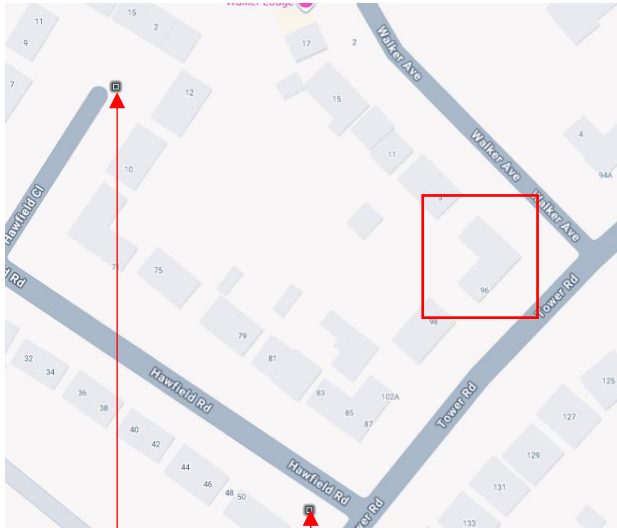
Location of Hydrants

Location of the nearest Hydrant is located on the corner of Tower Road and Hawfield Road. There is also an additional hydrant located at the end of Hawfield Close.
