Fire Risk Assessment

Sampson Close 7-12

Sampson Close Tividale, B69 1NL

Date Completed: 1st April 2026

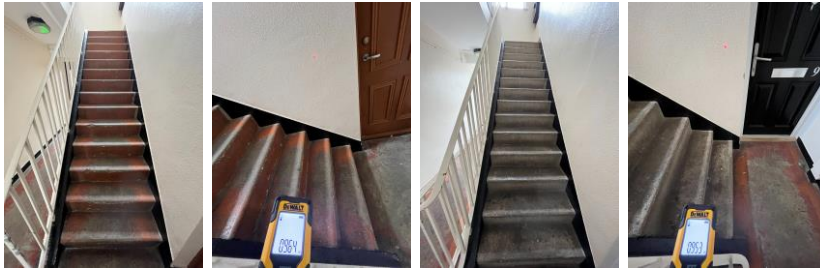
Ground to 1st & 2nd floor staircase.

- 4) 7-12 Sampson Close consists of a single staircase that provides sufficient means of escape, this is located as you enter each block. The width of the staircases has been measured from handrail to the wall at a measurement of 964mm and 953mm These stairs are kept clear to maintain safe means of escape.
-

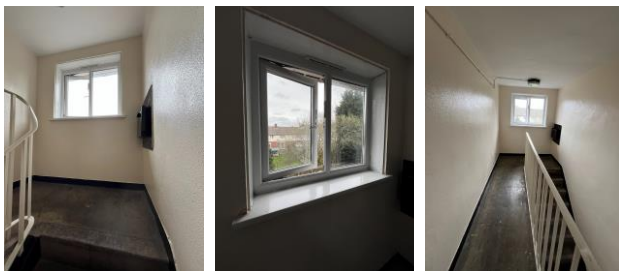
1st and 2nd floor landing

- 5) UPVC windows units have been installed on the staircase landing and within the corridors to the flats, these windows can be opened without the use of a key to allow sufficient airflow into the corridor and stairwell. There is no automatic smoke ventilation system installed in this premises.

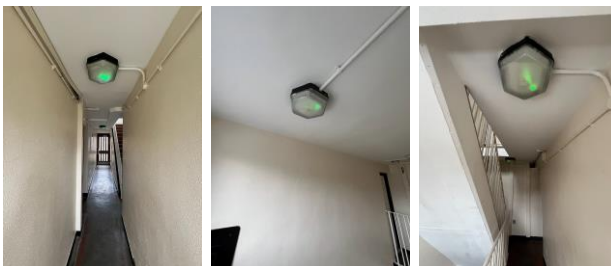
- 6) Emergency lighting is installed throughout the building, these are installed near final exit doors, communal staircase, landing and the corridors for flat entrances.

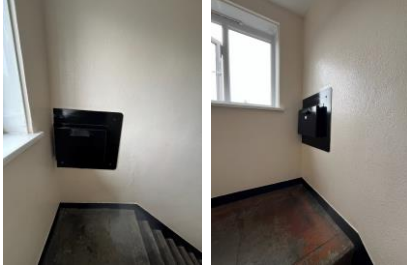
- 7) On both 1st floor and 2nd floor landings, there are bin chute hoppers within the means of escape, they do not present any obstruction in the event of safe evacuation.

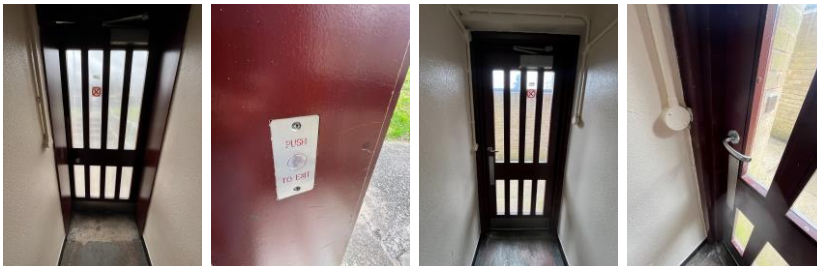
Front final & Rear final exits.

- 10) There is a clear and safe exit out of the building via the two-ground floor exits. The front final exit door is accessed using a push button, this will fail safe in an emergency, the rear final exit door accessed by a levered handle.

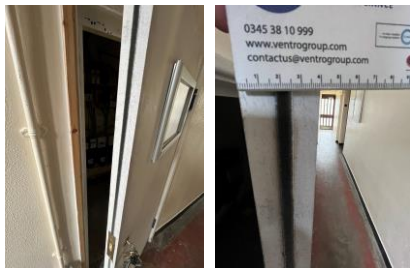
- 3) Electrical Service cupboard on the ground floor which accommodates the residents' electrical meters and other electrical apparatus is secured by a FD30s and accessed using a 138 key.

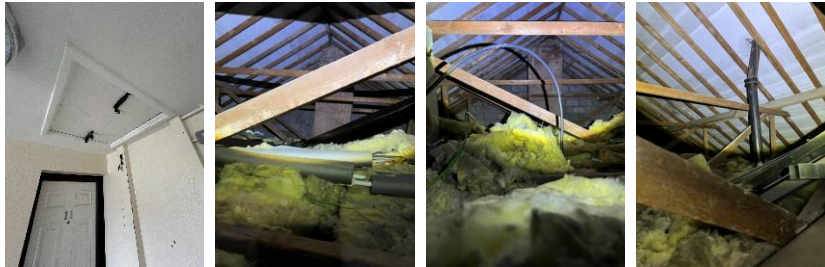
- 4) Access to the roof is by means of roof hatch which is on the 2nd floor landing. Compartmentation inspected within the roof space; there is no evidence of any breach in the compartmentation. Noted that there is an extraction fume venting out the roof. Rockwool insulation is layered within the Joice.

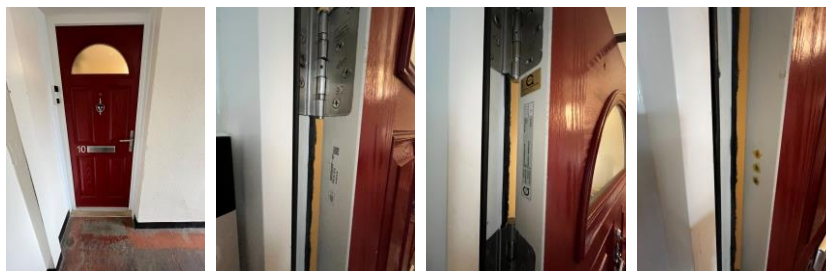
- 5) All individual flats are installed with composite FD30s rated doors. Flat 10 was checked for the function of the self-door closing device and smoke seals. The self-closing device was tested from a range of opening angles to determine its function, no issues found.

Confirmation of Certified Composite FD30s at flat 10

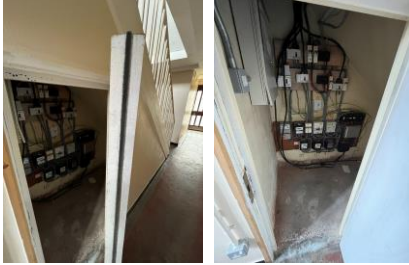
- 7) Electrical service cupboard on the ground floor which is located within the communal corridor near the rear final exit, this is secured behind a FD30s fire door. Cupboard is free from any combustibles.

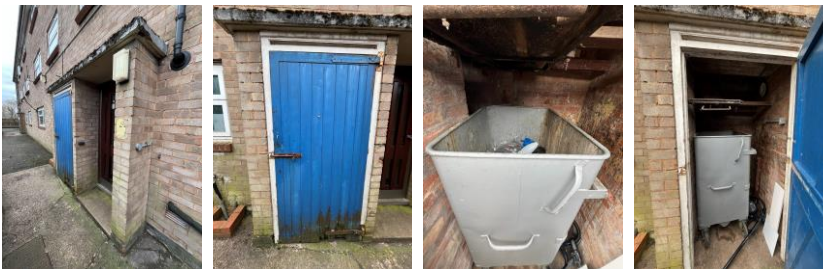
- 2) Refuse bin is stored in a secured bin room that is located next to the rear entrance of the building. This is kept secure by a means of a sliding bolt. Bins Are regularly emptied by site services.

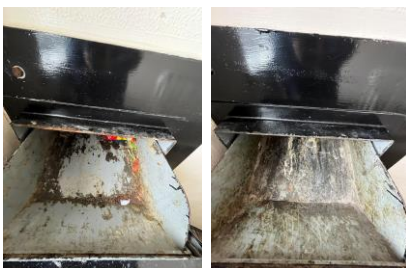
- 3) Both 1st and 2nd floor internal refuse chutes are clear of any rubbish.
