Fire Risk Assessment

Sampson Close 13 -18

Sampson Close Tividale, B69 1NL

Date Completed: 3rd April 2026

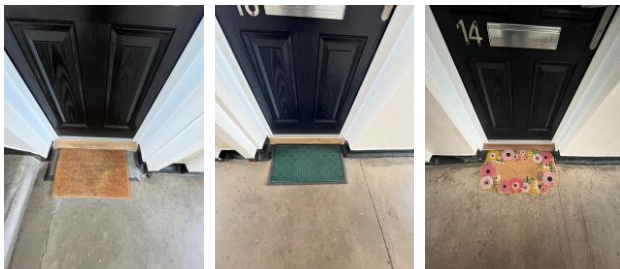
- 1) Each flat is equipped with, as a minimum LD3 fire detection to facilitate means of escape and provide sufficient response time.
- 2) Flat entrances have door mats placed within communal corridors, the fire rating is not known, however the condition and the size of these mats are acceptable.

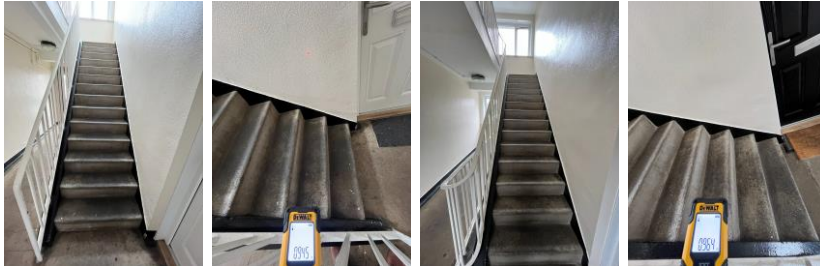
Ground to 1st & 2nd floor staircase.

5) 13-18 Sampson Close consists of a single staircase that provides sufficient means of escape, this is located as you enter each block. The width of the staircases has been measured from handrail to the wall at a measurement of 945mm and 964mm. These stairs are kept clear to maintain safe means of escape.

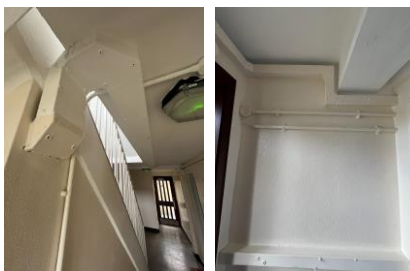
- 11) Electrical trunking located along the ground floor communal corridor is damage, resulting in the lid becoming dislodged and leaving the internal cabling exposed. It is recommended that the damaged trunking be replaced or repaired, and that the lid be securely refitted to ensure all cabling is fully enclosed and adequately protected.**
-

Question/ Ref No	Required Action	Supporting photograph	Priority	Timescale and Person Responsible	Date Completed
7/11	Ground floor communal corridor, electrical trunking damaged exposing cables, Replace and make secure.

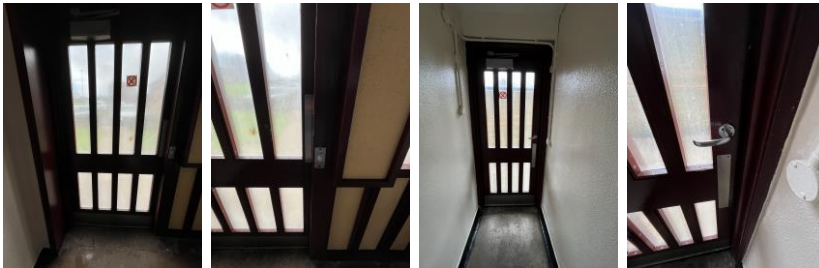
Front final & Rear final exits.

13) There is a clear and safe exit out of the building via the two-ground floor exits. The front final exit door is accessed using a push button, this will fail safe in an emergency, the rear final exit door accessed by a levered handled.

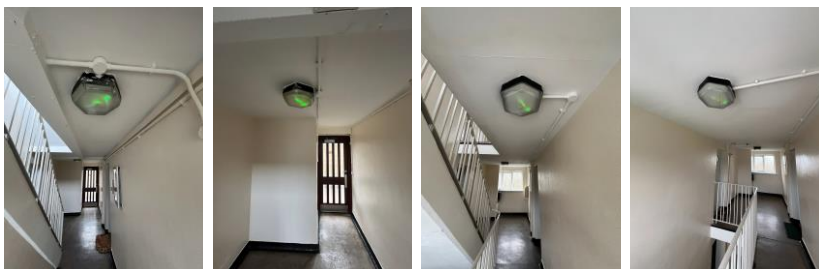
Communal corridors on ground, 1st and 2nd floors

- 4) Emergency lighting is installed throughout the building; units are installed in communal areas e.g. stairways & corridors. Emergency light test switch is installed within the electrical cupboard on the ground floor,

5) Emergency light on the 1st floor landing is not functioning, *email sent to the electrical team on the 31/03/2026. Repair has been scheduled.*

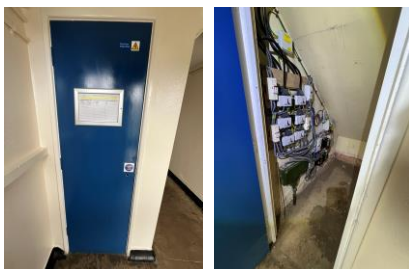
- 3) Electrical Service cupboard on the ground floor which accommodates the residents' electrical meters and other electrical apparatus is secured by a FD30 and accessed using a 138 key.

- 4) **Electrical cupboard does not have the required combined smoke and intumescent seals installed.**

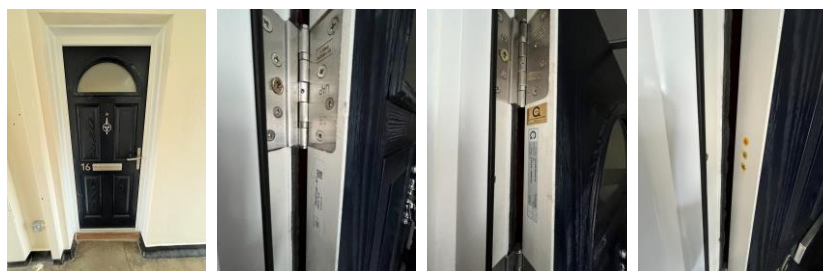
Confirmation of Certified Composite FD30s at flat 16

- 5) All individual flats are installed with composite FD30s rated doors. Flat 16 was checked for the function of the self-door closing device and smoke seals. The self-closing device was tested from a range of opening angles to determine its function, no issues found.

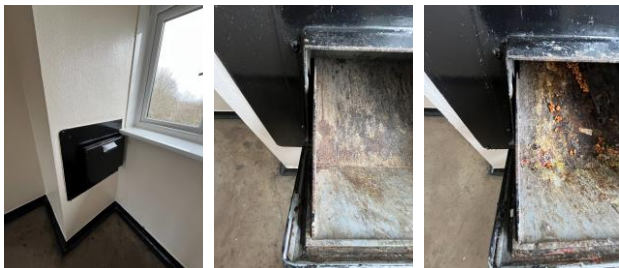
6) Intumescent seals have been installed within the chute hoppers on the 1st and 2nd landing

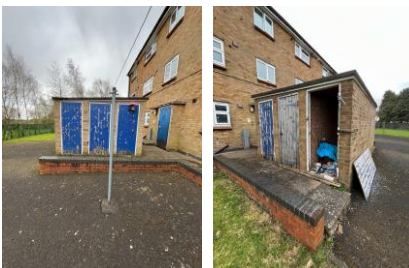
- 6) Resident external storage cupboard to the rear has a door removed, leaving stored combustibles easily accessible to arson.
Email sent to repairs on 13/04/2026.
