Fire Risk Assessment

Sampson Close 19-24

Sampson Close Tividale, B69 1NL

Date Completed: 3rd April 2026

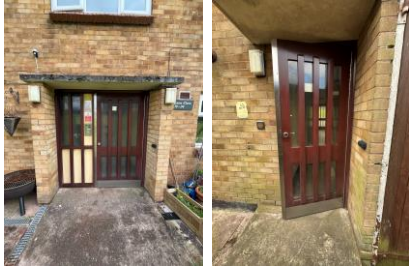
Front and rear entrances to block

Main entrance to the building is through a timber door, with both the front and rear doors accessed via fob reader, trades and visitors use an intercom system. For emergency access there is a firefighter manual override switch located above the door intercom panel.

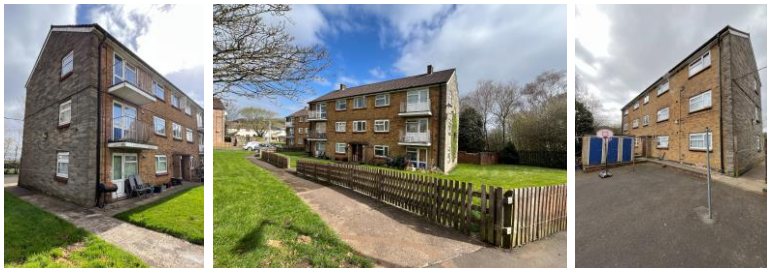
Timber perimeter and courtyard at the rear.

Externally the building has a timber fenced perimeter, there is access to the rear from the side of the building which leads to the courtyard, this courtyard also supports the resident storage cupboards.

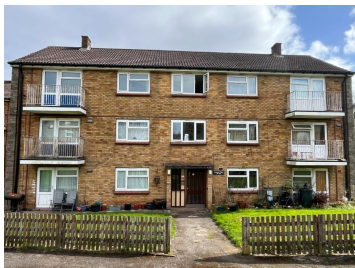
Front Elevation

- 1) The exterior of the building is predominately traditional brick construction with a pitched roof design with UPVC fascia boards to the roof line and interlocked concrete roof tiles above. Front entrance is through timber doors with glazing in the inserts of the door alongside spandrel panelling to the side door panel.

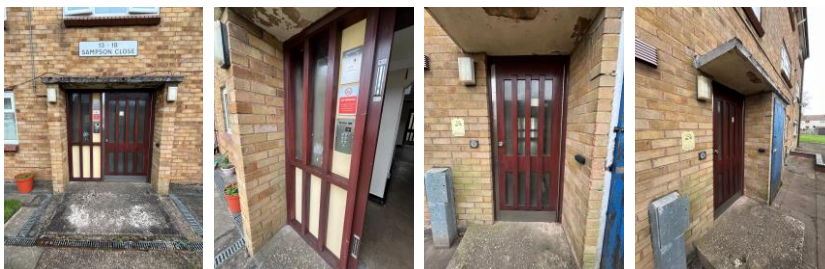
- 2) The front and rear entrance are positioned beneath a concrete canopy, Adjacent to the rear exit is the refuse bin store, which is enclosed by a timber door.

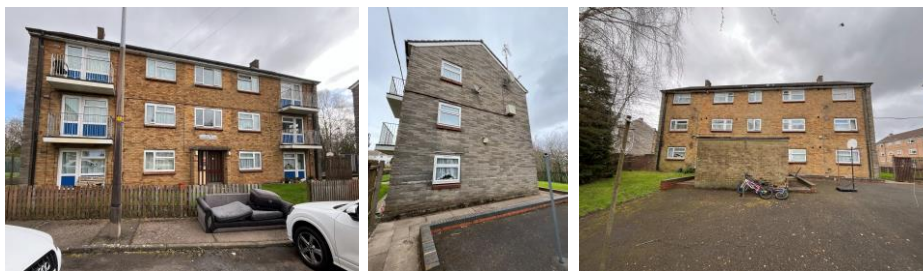
- 3) UPVC double glazed window units have been installed for each flat and communal areas within the block.

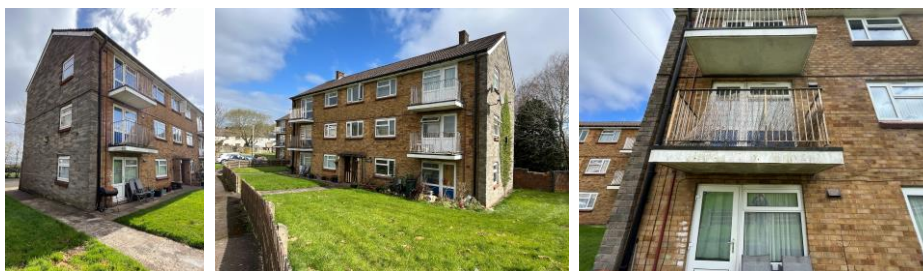
- 4) Front elevation of the building has vertical aligned cantilever balconies; these are only for flats on the 1st and 2nd floor. Balconies are consisting of a reinforced concrete floor slab with steel railings around.

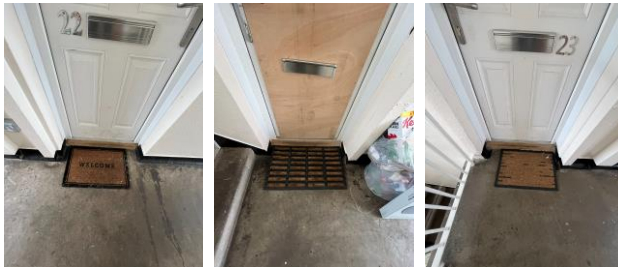
- 1) Each flat is equipped with, as a minimum LD3 fire detection to facilitate means of escape and provide sufficient response time.
- 2) Flat entrances have door mats placed within communal corridors, the fire rating is not known, however the condition and the size of these mats are acceptable.

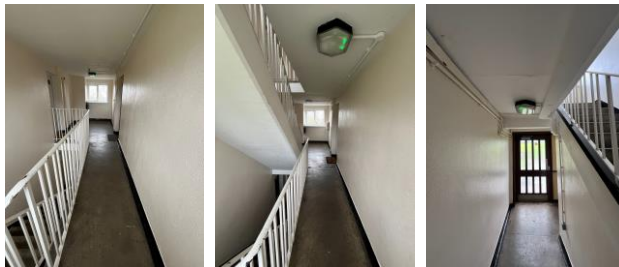
- 3) All corridors, landing and staircase are of adequate width and are kept clear to promote & maintain safe exit in an event of fire.

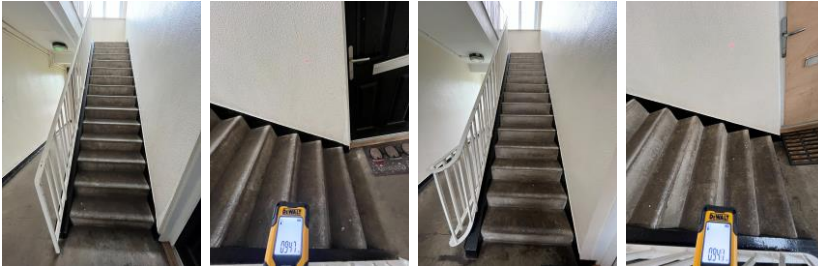
Ground to 1st & 2nd floor staircase.

5) 19-24 Sampson Close consists of a single staircase that provides sufficient means of escape, this is located as you enter each block. The width of the staircases has been measured from handrail to the wall at a measurement of 947mm and 941mm. These stairs are kept clear to maintain safe means of escape.

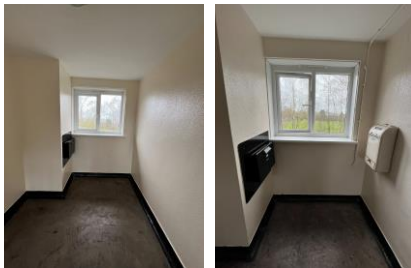
1st and 2nd floor landing

6) UPVC windows units have been installed on the staircase landing and within the corridors to the flats, these windows can be opened without the use of a key to allow sufficient airflow into the corridor and stairwell. There is no automatic smoke ventilation system installed in this premises.

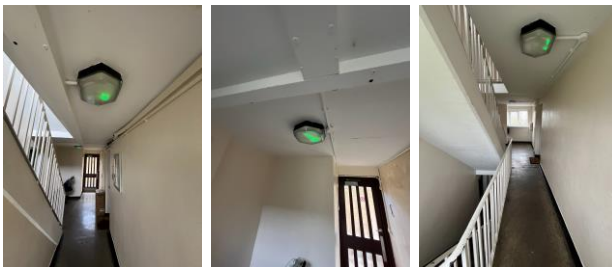
7) Emergency lighting is installed throughout the building, these are installed near final exit doors, communal staircase, landing and the corridors for flat entrances.

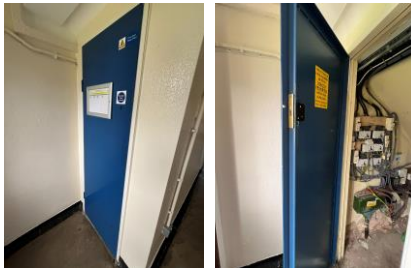
- 9) The electrical meters and distribution board for block are housed in the electrical cupboard which is in the communal corridor as you enter the block.

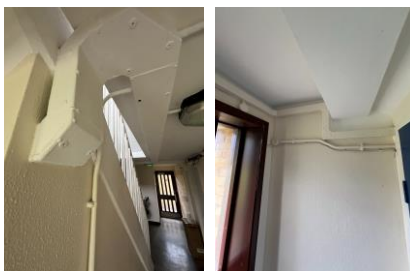
- 10) All electrical cabling installed within the communal corridors and escape routes are channelled via metal electrical trunking and metal conduits.

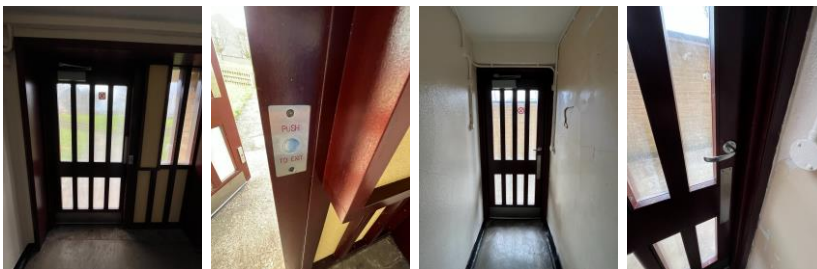
Front final & Rear final exits.

- 12) There is a clear and safe exit out of the building via the two-ground floor exits. The front final exit door is accessed using a push button, this will fail safe in an emergency, the rear final exit door accessed by a levered handled.

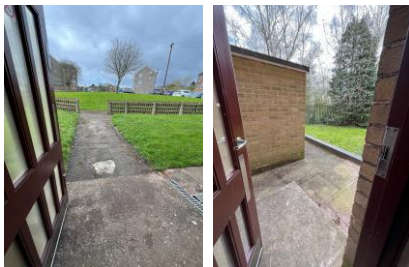
Front and rear final exit routes

- 14) The route out the block to ultimate safety is clear from both final exit doors.

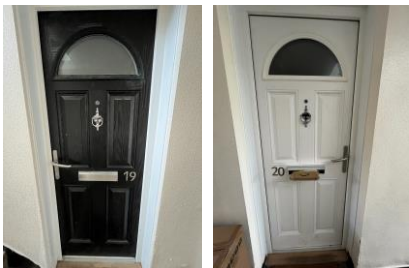
Ground floor flats 19,20

- 6) All individual flats are installed with composite FD30s rated doors. Reasonable attempts were made to access flats to check for the function of self-closing devices and the condition of smoke and intumescent seals; this was not possible due to residents not being present at the flats or not answering.

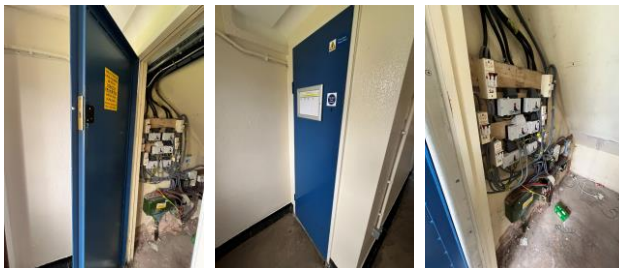
- 7) Electrical service cupboard on the ground floor which is located within the communal corridor near the rear final exit, this is secured behind a steel door with smoke seals. Cupboard is free from any combustibles.

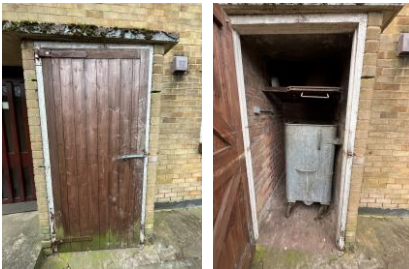
- 2) Refuse bin is stored in a secured bin room that is located next to the rear entrance of the building. This is kept secure by a means of a sliding bolt. Bins Are regularly emptied by site services.

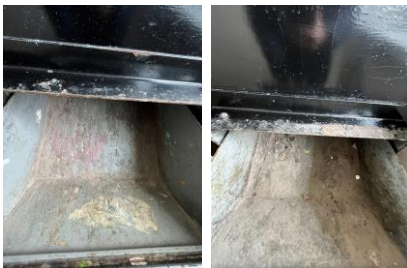
- 3) Both 1st and 2nd floor internal refuse chutes are clear of any rubbish.

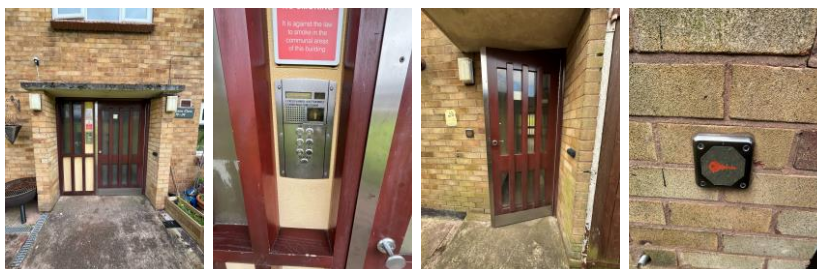
Front and rear entrance doors with access system.

- 1) Regular checks are undertaken by Caretakers / Cleaning Team(s) 365 days per year which helps reduce the risk of arson.
- 2) Both blocks have restricted access, this is via a key lock, each resident has their own fob to gain access. There is an intercom system that can allow visitors and contractors in.

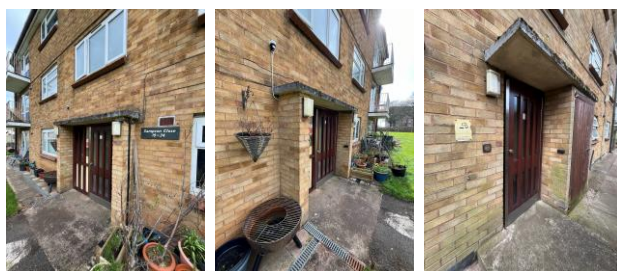
- 3) There is no current evidence of arson.
- 4) The perimeter of the premises is well illuminated. The front and rear both have external lighting units installed.

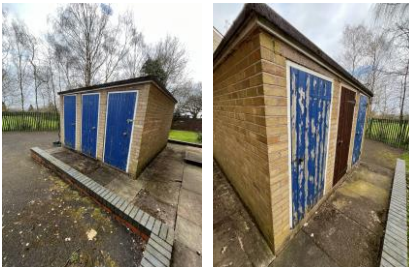
- 1) Residents instructed not to bring L.P.G cylinders into block.
- 2) The tenancy conditions, Section 7 – Condition 5.6 stipulates “If you live in a flat or maisonette, you, people living with you and any visitors to your property must not keep or use paraffin oil, petrol, bottled gas appliances or any other explosive, FLAMMABLE or dangerous material in the property. This restriction also applies to any storage facility situated in or attached to the block, which has been provided for your use.”
- 3) No Flammable liquids stored on site by Caretakers / cleaners.
- 4) There are no flammable liquids or gas cylinders stored on site.
- 5) Residents have external storage units to the rear of the building; these are kept secure by residents themselves.
