# Fire Risk Assessment

**2-4 Tower Rise,  
Tividale,  
B69 1NP**

**Date Completed: 02/04/2026**

**Officer: S. Henley Fire Risk Assessor**

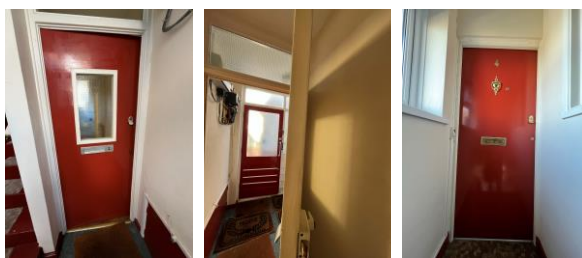
- 4) None of the corridors that form part of the means of escape are dead ends.
- 5) Two flats are located within the block, and both entrance doors are of timber construction (notional fire doors). Flat 2 incorporates a Georgian wired window within the centre of the door and a Georgian wired window light above the door. Flat 4 is a full timber door.

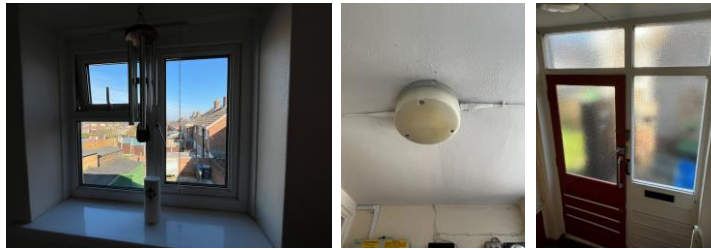
- 1) The premises is not fitted with emergency lighting
- 2) There is standard lighting within the communal area also a landing window and final exit door to assist in lighting the communal areas from outside
