# Fire Risk Assessment

**Walker Avenue,  
Tividale,  
B69 1NP**

**Date Completed: 13/04/2026**

**Current Risk Rating = Tolerable**

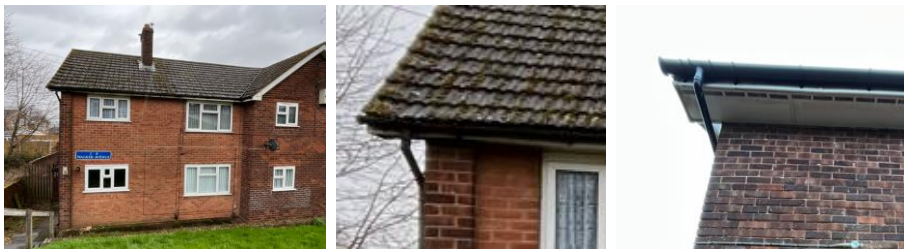
- 1) The external surface of the building is predominantly brick structure with uPVC facia and asbestos cement undercloaking soffits. The roof is pitched and fitted with concrete interlocking roof tiles on the roof.

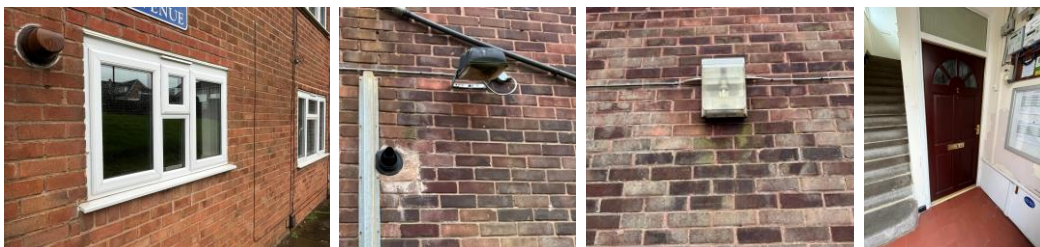
- 2) uPVC double-glazed units have been installed in each flat and one at the top of the communal stairway. A security/safety light is fitted to the side of the entrance door and one at the rear of the property. The entrance door is timber construction with glazed panels.

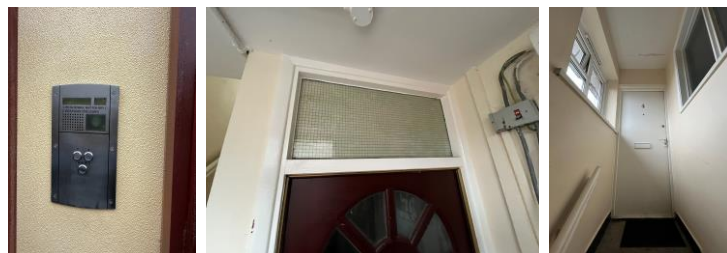
- 4) None of the corridors that form part of the means of escape are dead ends.
- 5) Two flats are situated within the block, each accessed through a timber entrance door. Flat 2 is fitted with a non-fire-rated door and Georgian wired glass above the door, while Flat 4 has a notional upgraded FD30 fire door. Both doors will be included in the FRA action plan for replacement or further upgrading, along with compliant door furniture, to ensure they meet current fire safety standards.

Walker Avenue 2-4 (E)	BL50640WA17	2 Walker Avenue;Tivdale;Oldbury;West Midlands;	Timber non fire door	Glazed
Walker Avenue 2-4 (E)	BL50640WA17	4 Walker Avenue;Tivdale;Oldbury;West Midlands;	Timber Door FD30s	Not Glazed
Walker Avenue 2-4 (E)	BL50640WA17	Walker Avenue 2-4;Walker Avenue;Tivdale;Oldbury;West Mid	Intentionally Blank

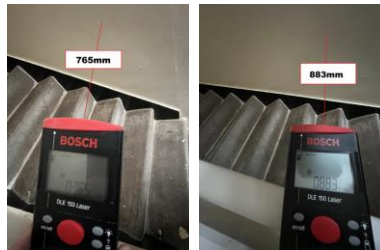
- 9) Within this block the first floor is accessed via a single staircase that provides a means of escape for flat 4 and has a width of a minimum of 765mm between the handrails, and 883mm wall to wall.

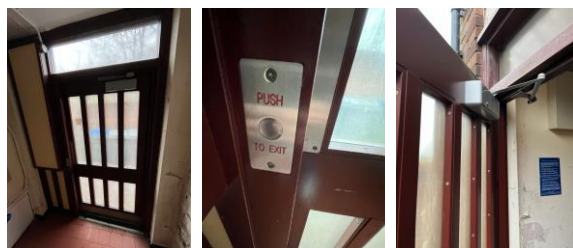
17) The final exit doors are fitted with a push button to egress the building and are also fitted with automatic closing devices that are checked on a regular basis by caretaking teams as part of their checks. Defective closing devices are replaced either by the Caretaking Team(s) or the in-house repairs team(s). The final exit doors have door entry systems installed. These systems are designed to fail safe i.e. door unlocked in the event of a power failure. This prevents residents being locked in or out of the building.

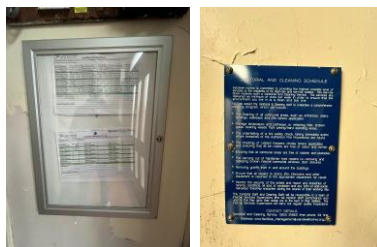
18) Communal areas are kept free of flammable items. The communal areas are checked on a regular basis by Caretaking / Cleaning teams 365 days per year and all items of rubbish are immediately removed. There is also an out of hour's service that allows combustible items of furniture / rubbish to be removed.

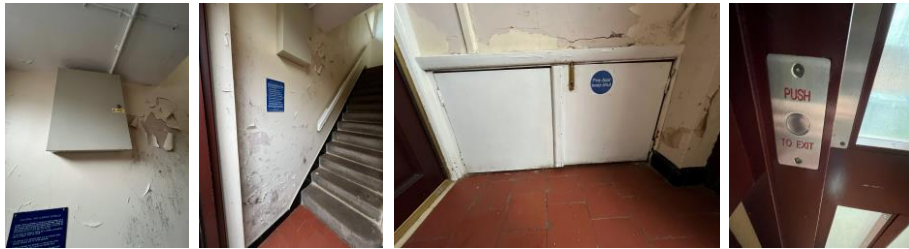
- 1) The premise is not fitted with emergency lighting.
- 2) No emergency lighting is provided to communal landings and stairs. Adequate lighting comes from standard lighting also from borrowed lighting from the door and window areas.

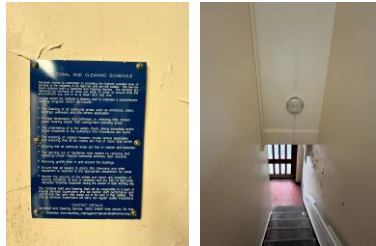
- 1) There is a regular Cleaning Service to the premises.

- 2) The refuse bins for 2-4 Walker Avenue are stored close to the block entrance/exit. These are emptied with the regular waste collections. Email sent to the caretaker and housing manager (16/03/2026) to relocate the bins away from the building.

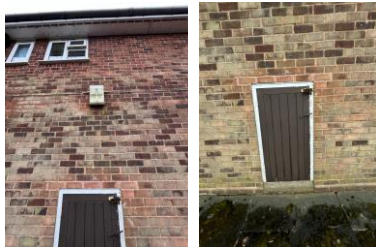
- 1) Regular checks are undertaken by Caretakers / Cleaning Team(s) 365 days per year which helps reduce the risk of arson.
- 2) Access to the premises is by means of a key, fob that only residents or using a fire fighters drop key.
- 3) Perimeter is covered by external lighting

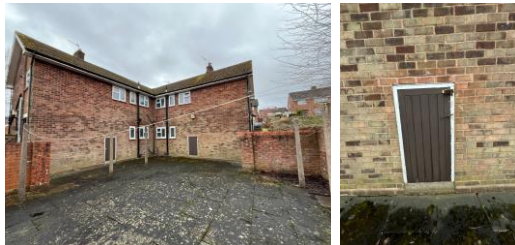
- 1) Residents instructed not to bring L.P.G cylinders into block.
- 2) The tenancy conditions, Section 7 – Condition 5.6 stipulates “If you live in a flat or maisonette, you, people living with you and any visitors to your property must not keep or use paraffin oil, petrol, bottled gas appliances or any other explosive, FLAMMABLE or dangerous material in the property. This restriction also applies to any storage facility situated in or attached to the block, which has been provided for your use.”
- 3) Residents should not store flammable liquids or gas cylinders on site.
- 4) No Flammable liquids stored on site by Caretakers / Cleaners.
- 5) There is one storage cupboard in the rear courtyard, which is built within the building and is locked by a tenant only key.
