# Fire Risk Assessment

**Blue Rock Place,  
31-39,  
Tividale,  
Oldbury,  
B69 1PD.**

**Date Completed: 08/05/2026**

**Current Risk Rating = Tolerable**

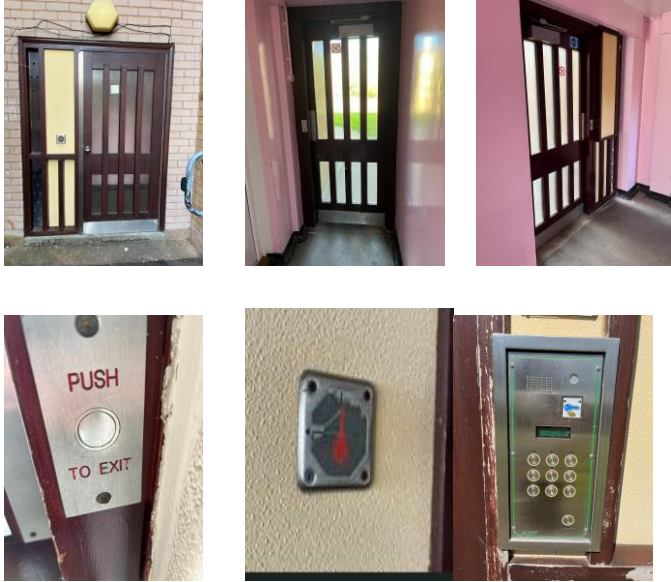
The main entrance is on the front elevation with a further 2 exits located on the rear elevation, a door entry system using a fob reader is installed. The escape routes lead to an ultimate place of safety. The front final exit door has a firefighter override switch operated by drop-latch key. The door entry system is designed to fail safe and unlock in the event of a power failure.
