Fire Risk Assessment

**Falcon Place,
13-18,
Tividale,
Oldbury,
B69 1PB.**

Date Completed: 01/05/2026

Current Risk Rating = Tolerable

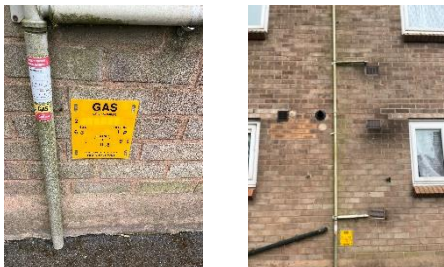
The gas supply to the block is supplied externally.

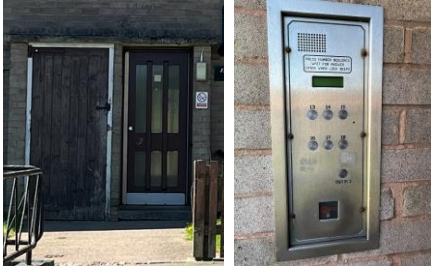
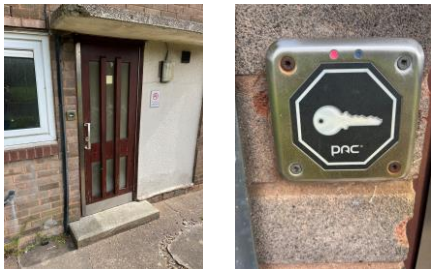
- 4) Access is gained to all flats from the ground floor using the main access door leading to the staircase area, further egress is available via the rear access door. All doors are solid timber with glass vision panels and have a Fob access system and a self-closer attached.

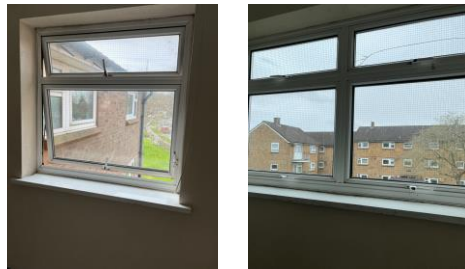
- 12) It was noted that some of the windows in the communal area have damage to them and do not close properly in to the frame, so an email has been sent to repairs on the 19/05/2026
- 13) Refuse chute located within the communal landing areas on 1st and 2nd floor.

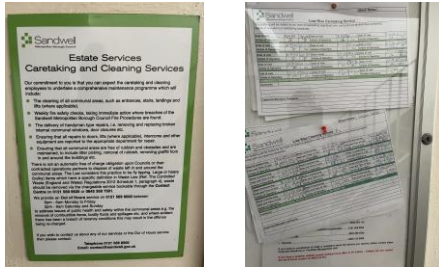
5. Regular checks by Caretakers minimise risk of waste accumulation.
