# Fire Risk Assessment

**14-18**

**Bishops Close,  
Smethwick,  
B66 2RD**

**Date Completed: 26/05/2026**

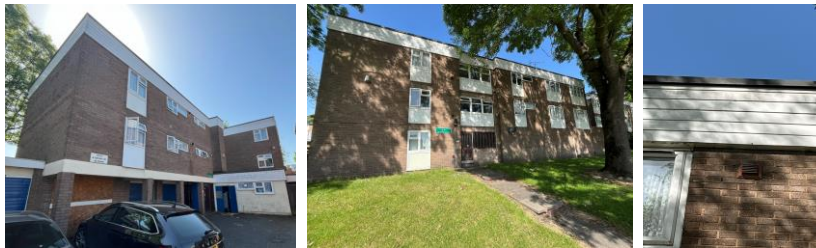
- 1) The external surface of the building is predominantly brick structure. The building has a flat bitumen-felt roof with uPVC fascia boards fitted around the roofline

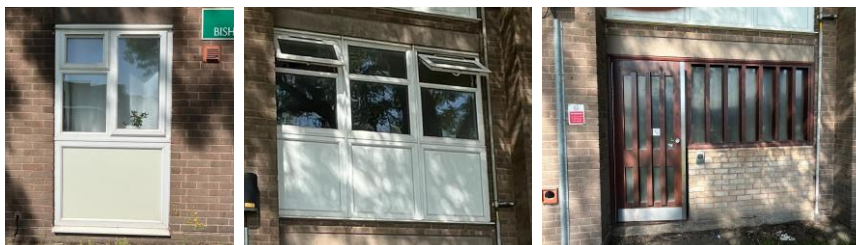
- 2) uPVC double-glazed units have been installed in each flat and within the communal stairway, most of the large units have spandrel panels fitted on the lower sections of the units. The entrance doors are a timber construction with glazed panels.

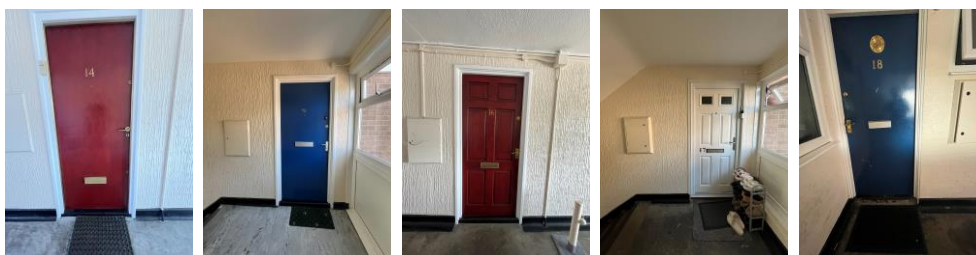
- 1) Each property is fitted with a minimum of an LD3 detection system within the flat. See Section 8
- 2) All corridors are of adequate width (at least 1050mm) and will be maintained clear to that width as a minimum
- 3) None of the corridors that form part of the means of escape are dead ends.
- 4) Majority of the flats within the block are fitted with timber notional doors, with one flat having a composite FD30s door fitted.

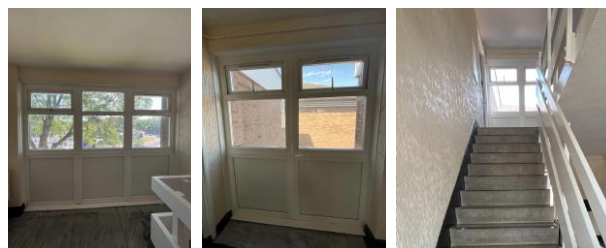
- 9) Automatic smoke ventilation is not employed. Windows fitted on the stairwell are fitted with manual openers; the windows will assist in additional lighting and any ventilation required.

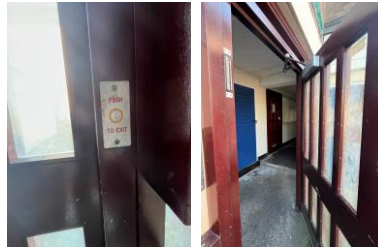
10) The final exit doors are operated using either a handle or push button to egress the building and are also fitted with automatic closing devices that are checked on a regular basis by caretaking teams as part of their checks. Defective closing devices are replaced either by the Caretaking Team(s) or the in-house repairs team(s). The final exit doors have door entry systems installed. These systems are designed to fail safe i.e. door unlocked in the event of a power failure. This prevents residents being locked in or out of the building.

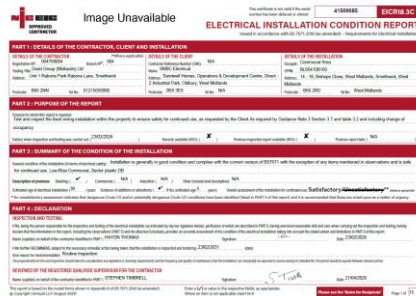
- 1) Smoking is prohibited on entrance and within any communal parts of the building in line with Smoke Free England legislation.
- 2) Hot working is not normally carried out. If essential maintenance requires the use of hot work processes, then corporate policies and procedures are to be followed.
- 3) Portable electrical equipment used as part of the Caretaking / Cleaning regime is subject to annual PAT Testing. This information is held by the Estate Services Manager.
- 4) The fixed electrical installation shall be tested every 5 years. The date of the last EICR was 23/02/2026.

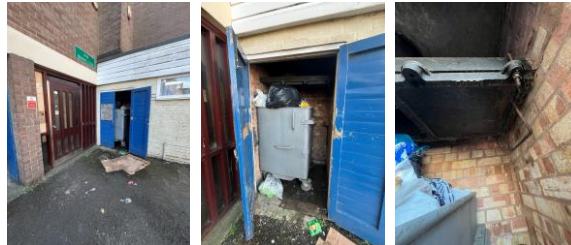
- 2) The refuse bins for Bishops Close 14-18 are stored at the side of the premises within a designated storage cupboard. This area also functions as the bin-chute room, with hopper doors located on the 1st and 2nd floors for residents to dispose of refuse. The bins are emptied as part of the routine waste collection service.

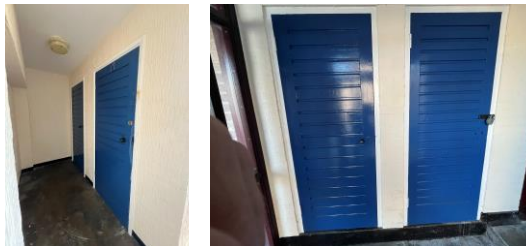
- 1) Residents instructed not to bring L.P.G cylinders into block.
- 2) The tenancy conditions, Section 7 – Condition 5.6 stipulates “If you live in a flat or maisonette, you, people living with you and any visitors to your property must not keep or use paraffin oil, petrol, bottled gas appliances or any other explosive, FLAMMABLE or dangerous material in the property. This restriction also applies to any storage facility situated in or attached to the block, which has been provided for your use.”
- 3) Residents should not store flammable liquids or gas cylinders on site.
- 4) No Flammable liquids stored on site by Caretakers / Cleaners.
- 5) There is a storage cupboard for each flat upon the ground floor and is locked by a tenant only key.
