# Fire Risk Assessment

**1-20**

**Crystal House,  
Smethwick,  
B66 3JT**

**Date Completed: 10/06/2026**

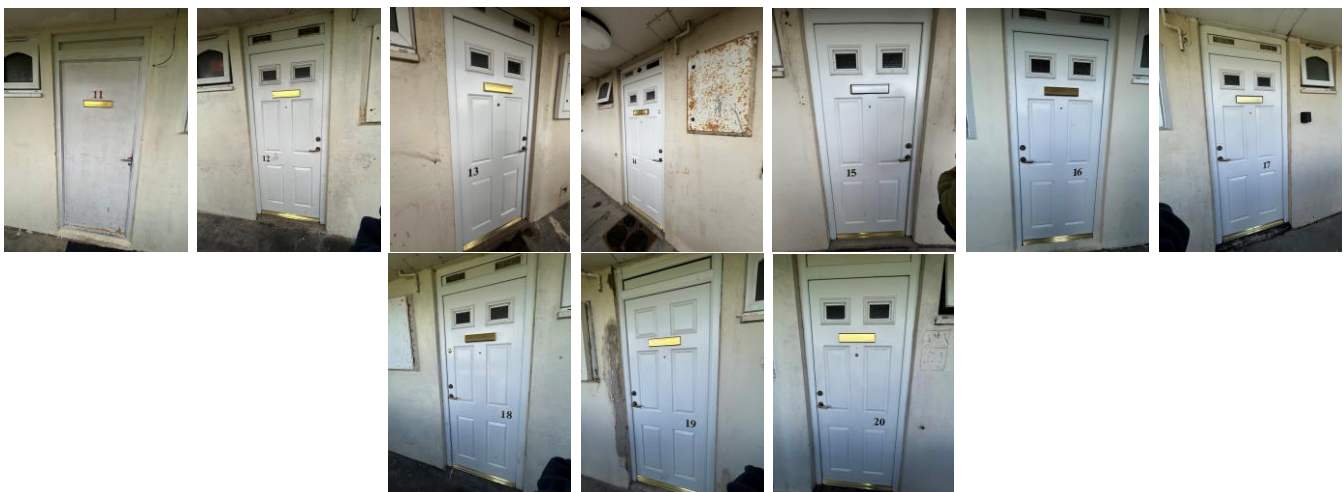
- 1) Each property is fitted with a minimum of an LD3 detection system within the flat. [See Section 8](#)
- 2) Each property was fitted with a composite FD30-rated flat entrance door, apart from Flat 11 which had a notional FD30 timber door. However, as these doors opened directly onto an open-deck arrangement, with immediate access to open air and more than one direction of travel, they were not required to be fire-rated under the applicable guidance. For this reason, the doors were not inspected in detail during the Fire Risk Assessment.

Images below show the doors opening directly onto the open-deck area

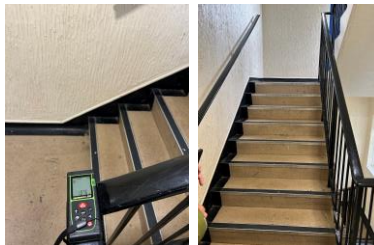
- 4) Within the block each floor is accessed via a two staircase's that provides a means of escape and has a width of a minimum of 1m between the handrails, this includes the minimum width of the landings

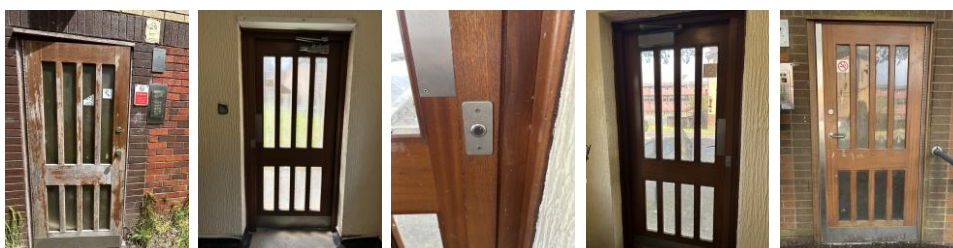
- 6) The escape route for upper-floor residents was available in two directions via the open-deck access, which was naturally well-ventilated and fitted with emergency lighting along the route. The protected staircases leading from the open deck were kept clear, provided with ventilation, and equipped with emergency lighting, with a final exit door located at ground level.

The final exit doors are fitted with automatic closing devices and open using push button. These are checked regularly by the caretaking teams, and any defective closing devices are replaced by either the Caretaking Team or the in-house Repairs Team. The systems are designed to fail safe, ensuring doors remain unlocked in the event of a power failure to prevent residents from being locked in or out.

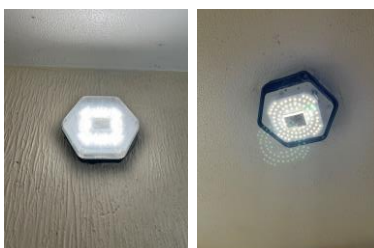
- 9) Emergency lighting is provided to communal landings and stairs, also landing windows and standard lighting units supply light within the communal areas. [\(Refer to section 9\)](#)

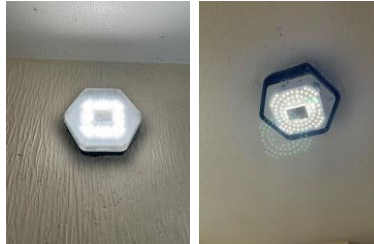
- 1) These premises have been fitted with emergency lighting within the communal areas.

- a) On the second-floor staircase on the left elevation, the casing for the emergency light has become detached and requires reinstallation. Electrical team emailed on 16/06/26.

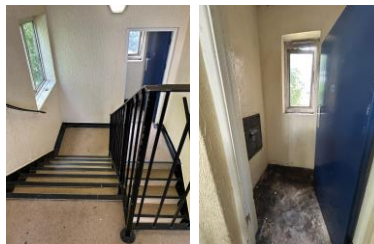
- 2) As well as emergency lighting fitted there is also standard lighting and windows to assist in lighting the communal areas

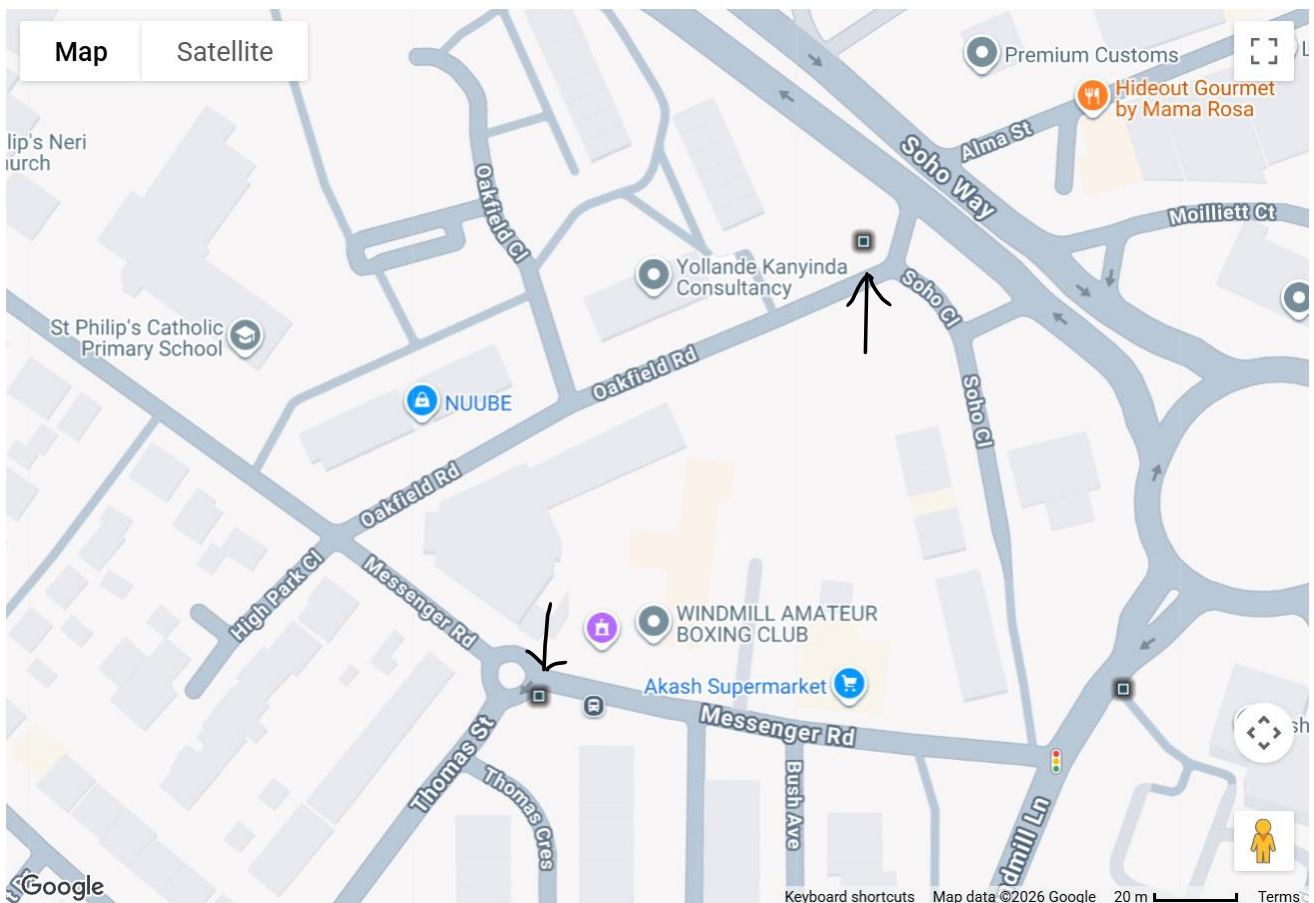
- 1) There is no firefighting equipment on this premises.
- 2) Nearest fire hydrant is indicated within the attached plan.  
Information from <https://dataservices.riscauthority.co.uk/map/index>

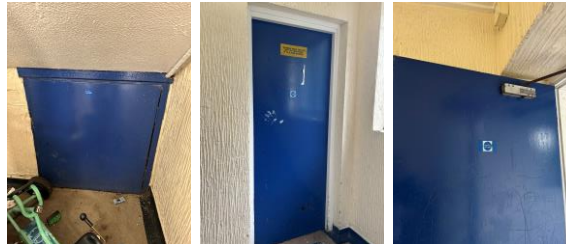
- 1) 'Fire door keep shut' signs are displayed on the doors off the stairway.

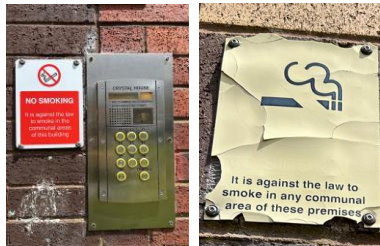
- 2) Smoking is prohibited within any communal parts of the building in line with Smoke Free England legislation.

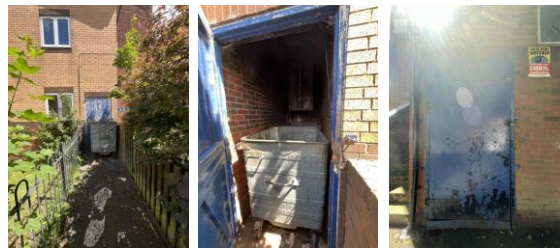
- 1) There is a regular Cleaning Service to the premises.
- 2) Rubbish within the block is disposed of via a bin chute system, with chutes primarily located internally and additional chutes positioned on either side of the block adjacent to the bin chute rooms. The bin chute rooms are secured by timber doors fitted with padlocks. Each room contains two Eurobins, which are rotated and maintained by the caretaking staff. Access was only obtained to the bin storage room on the Messenger Road elevation; therefore, it has not been possible to comment on the level of compartmentation within the corresponding bin storage room on the Oakfield Close elevation.
