# Fire Risk Assessment

## Bridge House1-12

**Oakfield Close, Smethwick  
B66 3JZ.**

**Date Completed:** 9<sup>th</sup> June 2026

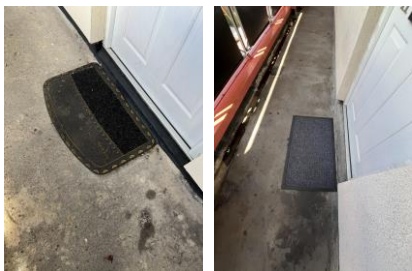
- 1) Each flat is equipped with, as a minimum LD3 fire detection to facilitate means of escape and provide sufficient response time.
- 2) Floor mats outside flats entrances are of acceptable size and condition.

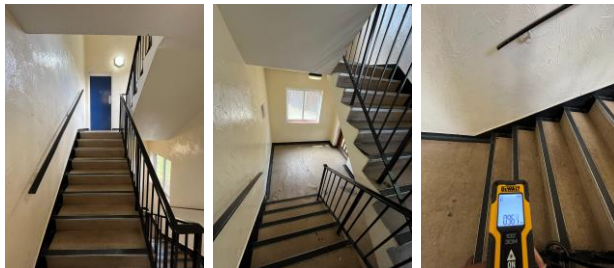
Ground to 1<sup>st</sup> floor staircase.

- 5) 1-12 Bridge House consists of 2 staircases that provides sufficient means of escape, these are located as you enter the block from either entrance. The width of the staircases has been measured from handrail to handrail at a measurement of 969mm These stairs and landings are kept clear to maintain safe means of escape.

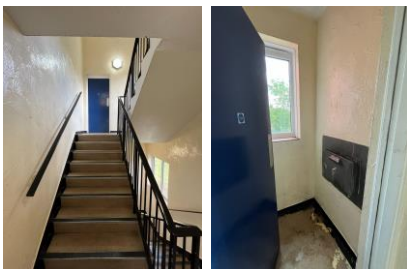
- 8) Bin chute rooms are located on the staircase landings at both ends of the block. Situated within the escape routes, these rooms are secured behind timber FD30S fire doors and present no risk to a safe evacuation.

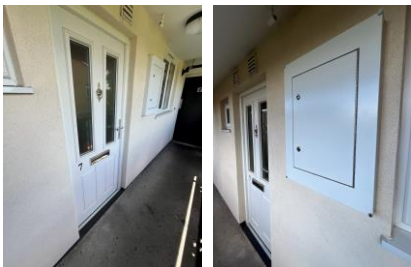
- 9) Electrical meters for residents are located next to flat entrance doors, for flats 7-12 these are in the means of escape on the open deck access but are installed behind a safe and secure metal electrical enclosure.

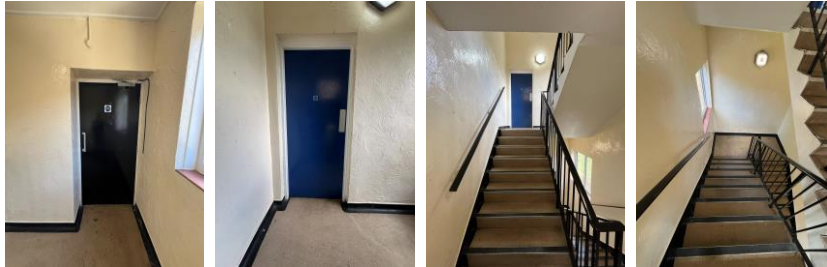
- 6) Both stairwells maintain sufficient compartmentation via FD30S fire doors equipped with self-closing devices, which control access from the landings to the open-deck walkways

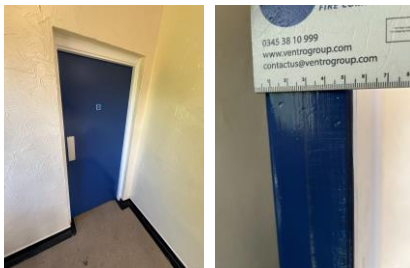
- 9) Both refuse chute rooms are installed with timber FD30s fire doors, with self closing devices. The self closing devices were inspected and checked for auto closure, no issues found.

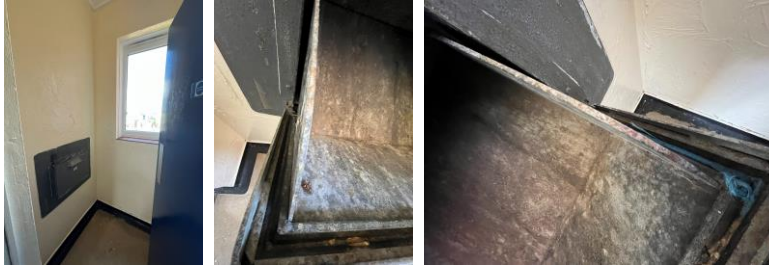
- 11) Intumescent seals have been installed within the chute hoppers located in both refuse chute rooms within the communal stairwell at either end of the block

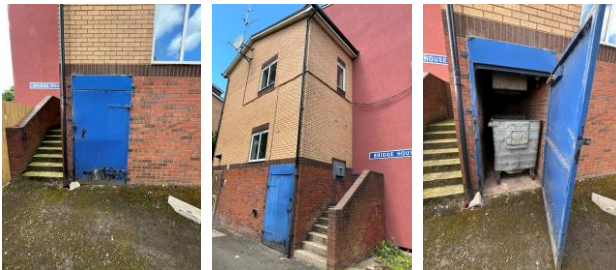
- 1) There is a regular Cleaning Service to the premises.
- 2) Refuse bin are stored in secured bin rooms that are located at the side of the building. This is kept secure by a means of a sliding bolt and padlock. Bins Are regularly emptied by site services.

- 3) **External refuse bin store room door has a damaged securing handle, this leaves the door open and unsecure.**

| 15/3 | Secure external refuse bin storage door with securing handle, | | P2 | 1-3 Months<br>Repairs | |

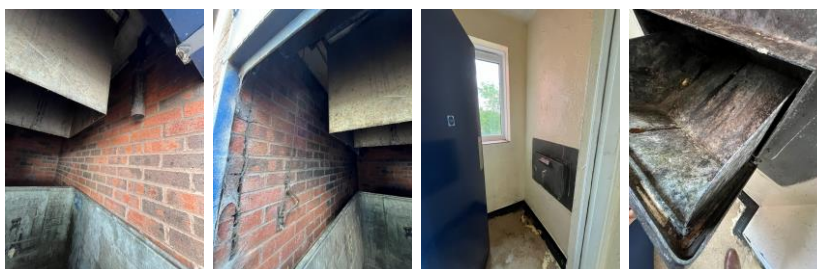
- 4) Refuse storage cupboard has a fusible link bin closure plate to mitigate any potential fire risk, both 1<sup>st</sup> floor internal refuse chutes are clear of any rubbish.
