**FIRNTEC**  
BUILDING COMPLIANCE

# EXTERNAL WALL SURVEY

## ALLEN HOUSE

West Road  
Hamstead  
B43 5PS

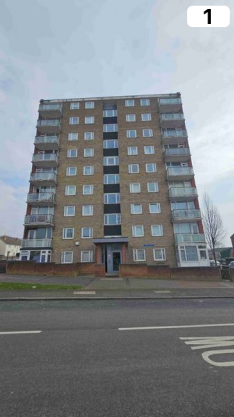
| Photo | Name | No. of Storeys | Features |
|---|---|---|---|
| A photograph of the west elevation of Allen House, a 9-story brick building with a central entrance and multiple windows. A small white box with the number '1' is in the top right corner. | West Elevation | 9 Storeys | <ul style="list-style-type: none"><li>• Escape Route Exit</li><li>• Private Balconies Stacked</li></ul> |
