**FIRNTEC**  
BUILDING COMPLIANCE

# FIRE RISK APPRAISAL EXTERNAL WALLS

## ALLEN HOUSE

West Road  
Hamstead  
B43 5PS

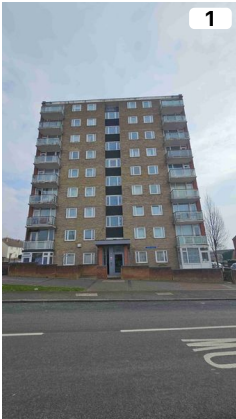
| Photo | Name | No. of Storeys | Features |
|---|---|---|---|
| A photograph of the west elevation of a nine-story brick apartment building. The building has a symmetrical facade with a central entrance and multiple windows. A small white box with the number '1' is in the top right corner of the photo. | West Elevation | 9 Storeys | <ul style="list-style-type: none"><li>• Escape Route Exit</li><li>• Private Balconies Stacked</li></ul> |

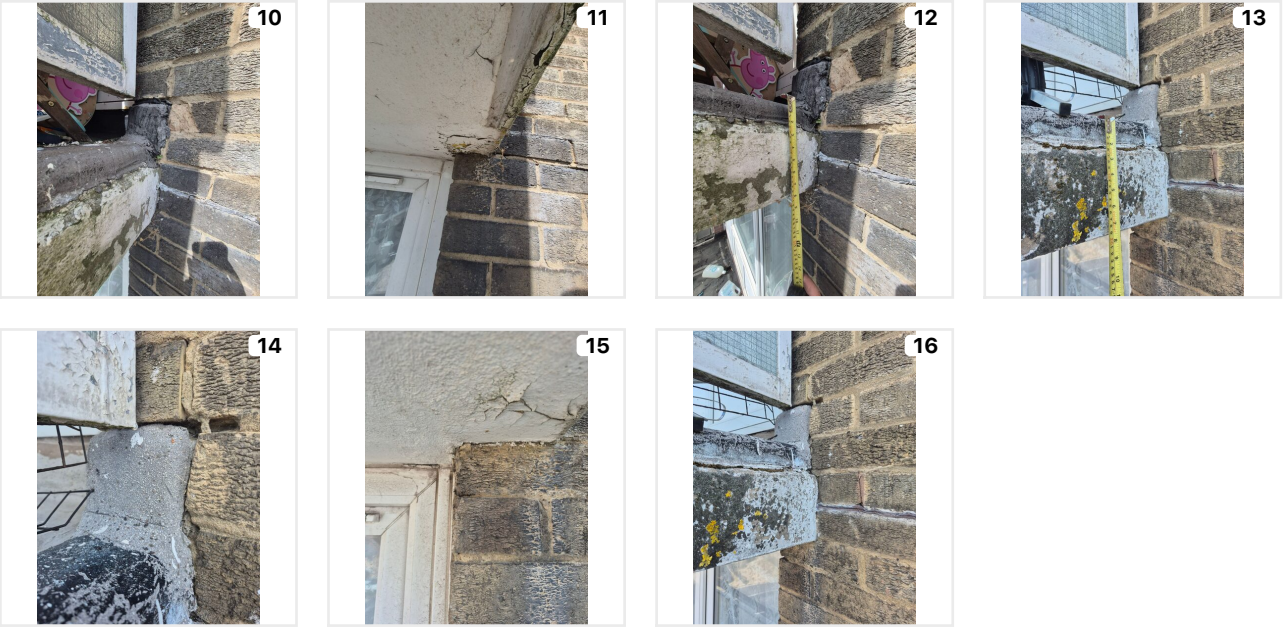
# Inspection: Z1MLVW

Elevation • Location  
East Elevation • Compartment Floor Junction
