Survey Date 02/05/2025

# EXTERNAL WALL SURVEY

## FARLEY STREET

West Brom  
DY4 7LA

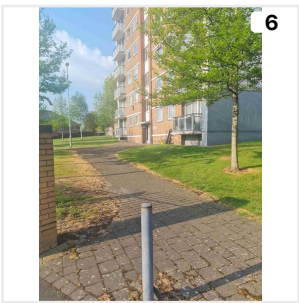
Unable to access, mewt cannot drive on grass and wheels will be on grass. Unable to use ladder due to ledge

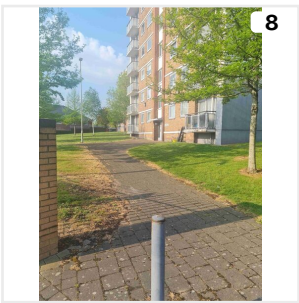
# Inspection: W82XJC

Unable to access, mewt cannot drive on grass and wheels will be on grass. Unable to use ladder due to ledge

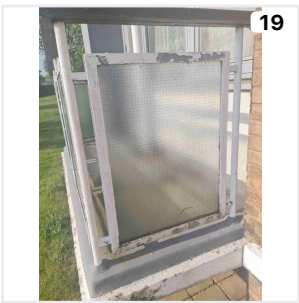
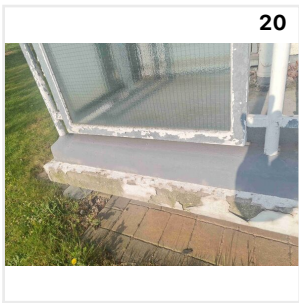
Location dropped due to machine access
