# FIRE RISK APPRAISAL EXTERNAL WALLS

## HOLLY COURT

Holly Court  
Acacia Avenue  
West Bromwich  
West Midlands  
WS5 4HB

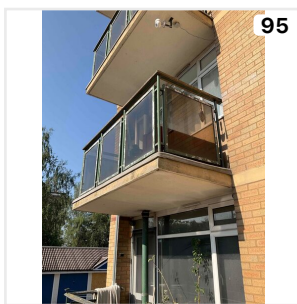
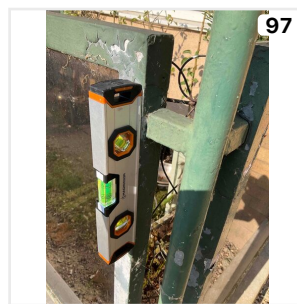
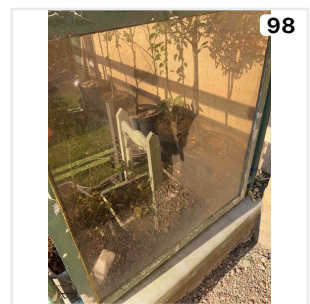
## Photos

The soffit will also act to disrupt the mechanism for vertical fire spread between the balconies. The adjacent wall system is a non-combustible double leaf masonry system filled with mineral wool and as such will not be negatively impacted by a fire occurring on a balcony.

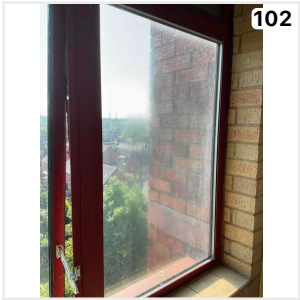
## Photos

Windows to stairwell
