**FIRNTEC**  
BUILDING COMPLIANCE

# EXTERNAL WALL SURVEY

## 1-32 HORTON STREET

1-32 Horton Street  
Tipton  
DY4 7JW

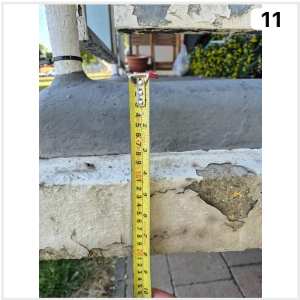
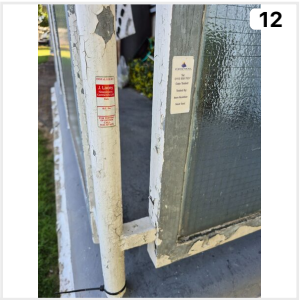
Elevation • Location  
South Elevation • Compartment Floor Junction

**Substrate**  
The render is applied directly to a solid masonry wall—specifically blockwork inner leaf with brick outer leaf and cavity insulation.  
No evidence of any carrier board, EPS insulation, or framing behind the render was observed.

**2. Render Type and Build-Up**  
The render is a cementitious or acrylic-based system, likely composed of the following layers:  
Base coat: A thick, grey cementitious layer providing mechanical adhesion.  
Mesh-reinforced scratch coat: Not exposed, but presumed typical for crack resistance.  
Finish coat: A coarse-textured acrylic or polymer-modified topcoat, cream/grey in colour.

**3. Fire Performance**  
The render system appears to be direct-to-substrate with no combustible backing.  
Combined with mineral wool cavity insulation and masonry substrate, this system is non-combustible (Euroclass A1–A2-s1,d0).  
No combustible detailing, intumescent trims, or polymeric expansion joints were observed.
