Document Version 1  
Survey Date 15/09/2025  
Suggested Review Date 15/09/2030

# FIRE RISK APPRAISAL EXTERNAL WALLS

## LAWRENCE COURT

Kingsway  
Brandhall  
B68 0HB

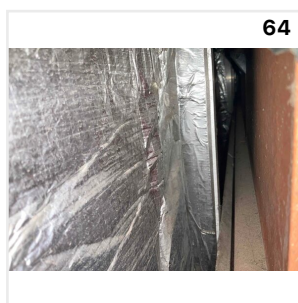
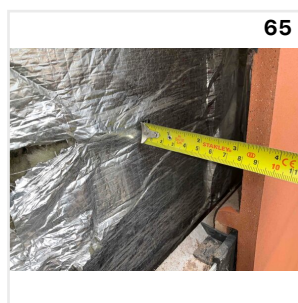
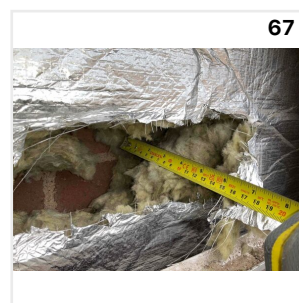
| 1 Cavity Barrier | Material | Photo Ref. |
|---|---|---|
| Cavity not closed between the compartment wall and the outer tiles | | |
