Survey Date 01/05/2025

# EXTERNAL WALL SURVEY

## BEECH HOUSE

Meadow Avenue  
West Brom  
B71 3EJ

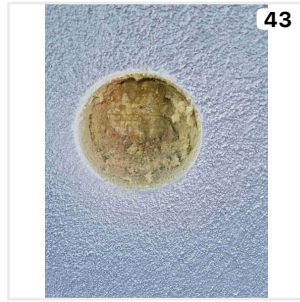
# Inspection: 5IHYD6

Elevation • Location  
Wall Inspection • Compartment Floor Junction

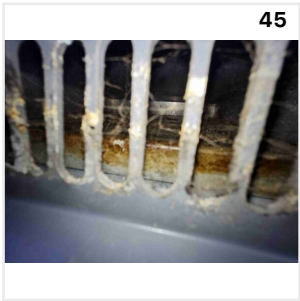
# Inspection: IGGQCL

Elevation • Location  
Wall Inspection • Ventilation Outlet

Rainscreen

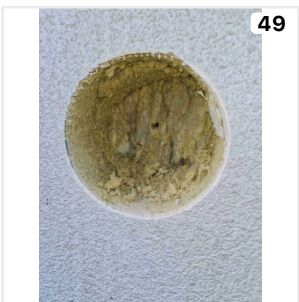
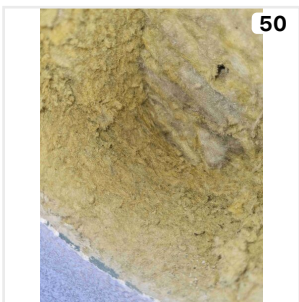
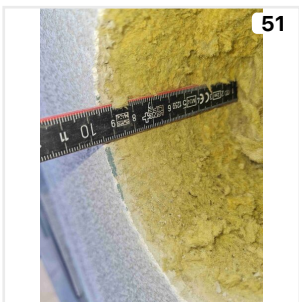
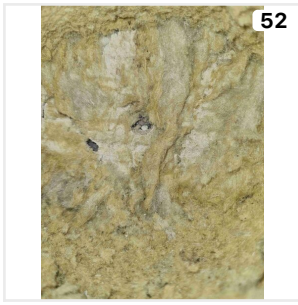
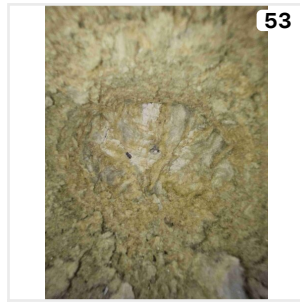
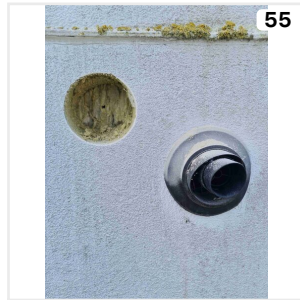
# Inspection: TRQA6K

Elevation • Location  
Wall Inspection • Ventilation Outlet

| 3 Elements | Thickness/Depth | Material | Photo Ref. |
|---|---|---|---|
| Inner Leaf | | Concrete wall | 52, 53 |

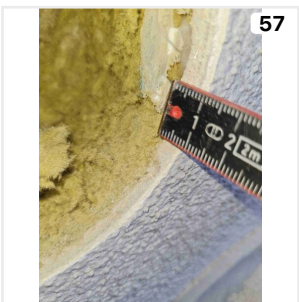
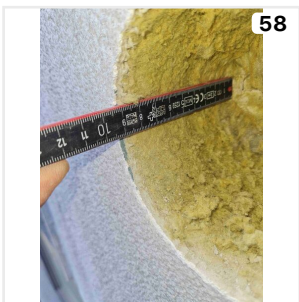
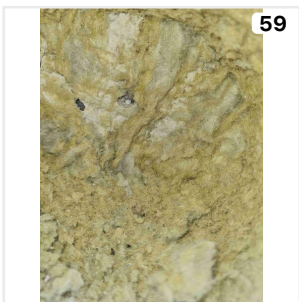
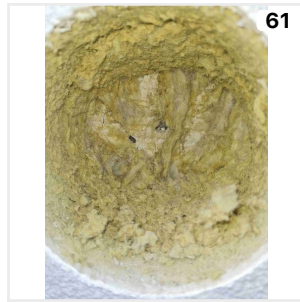
# Inspection: JZ5U7G

Elevation • Location  
Wall Inspection • Compartment Floor Junction

| 3 Elements | Thickness/Depth | Material | Photo Ref. |
|---|---|---|---|
| Inner Leaf | | Concrete wall | 60, 61 |
