Document Version 4  
Survey Date 14/01/2025  
Suggested Review Date 14/01/2030

# EXTERNAL WALL SURVEY

## SHEAPCOATE HOUSE

Sheapecoate House  
Beconview Road  
West Brom  
B71 3PP

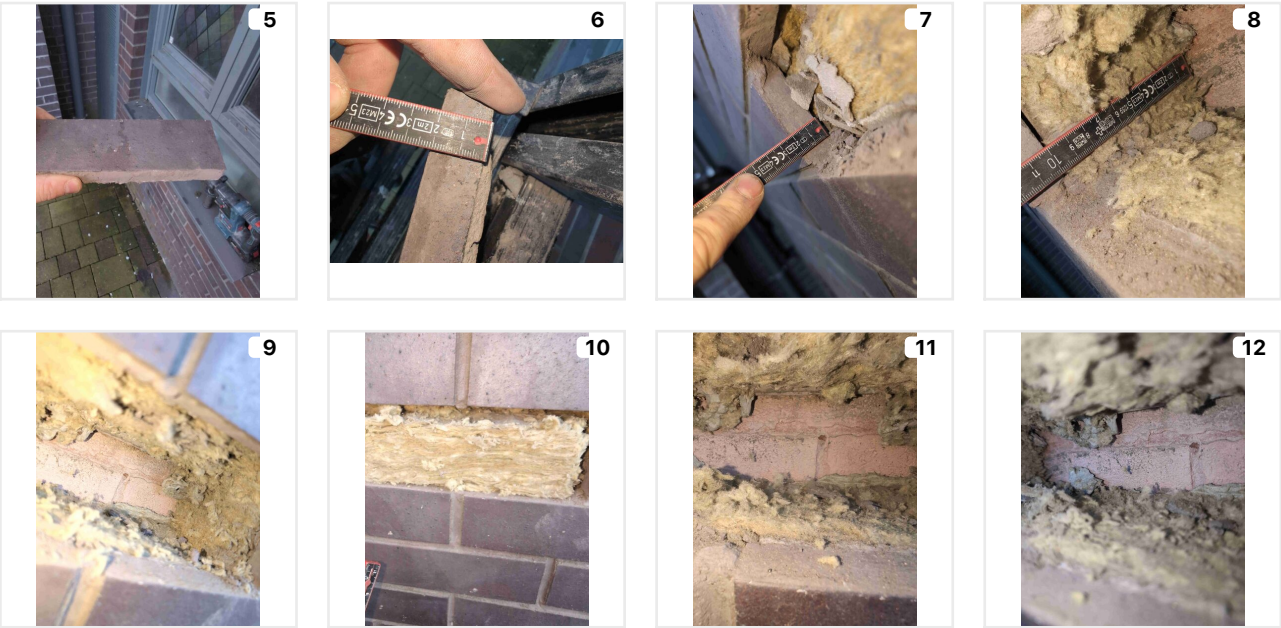
# Build-up Photos

# Inspection: BTETLI

Elevation • Location  
North Elevation • Compartment Floor Junction

| 3 Elements | Thickness/Depth | Material | Photo Ref. | Rating (BS EN13501) |
|---|---|---|---|---|
| Surface Finish | 20mm | Brick Slip / Brick Tile | 5, 6, 7 | A1 - Non-Combustible |
| Inner Leaf | | Brickwork | 11, 12 | A1 - Non-Combustible |

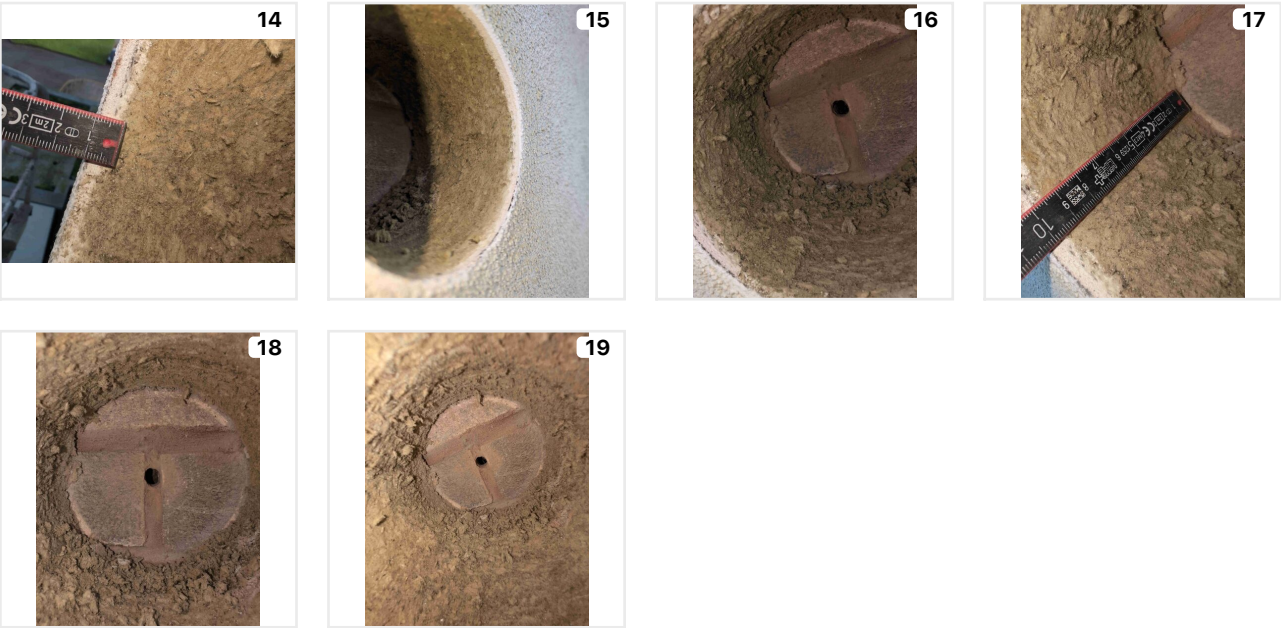
# Build-up Photos

**Inspection: XTQ1ZV**  
North Elevation  
Compartment Floor Junction

- Surface Finish (Sto render)
- Insulation (Mineral Wool Insulation)
- Inner Leaf (Brickwork)

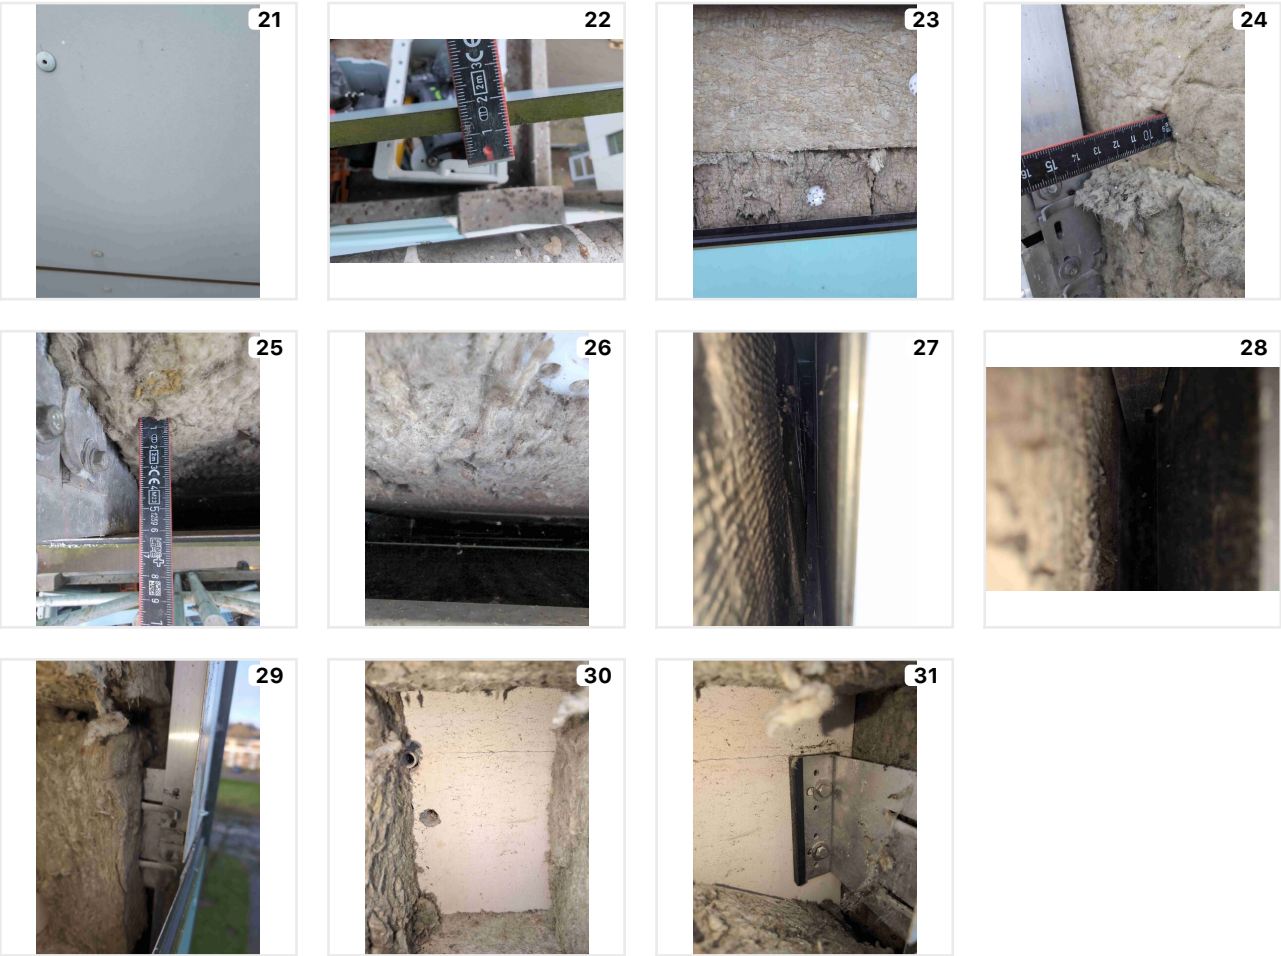
# Build-up Photos

**Inspection: CY1L2R**  
North Elevation  
Compartment Floor Junction

- Surface Finish (Suspected High Pressure Laminate (HPL) Panel)
- Insulation (Mineral Wool Insulation)
- Cavity
- Inner Leaf (Reinforced concrete)

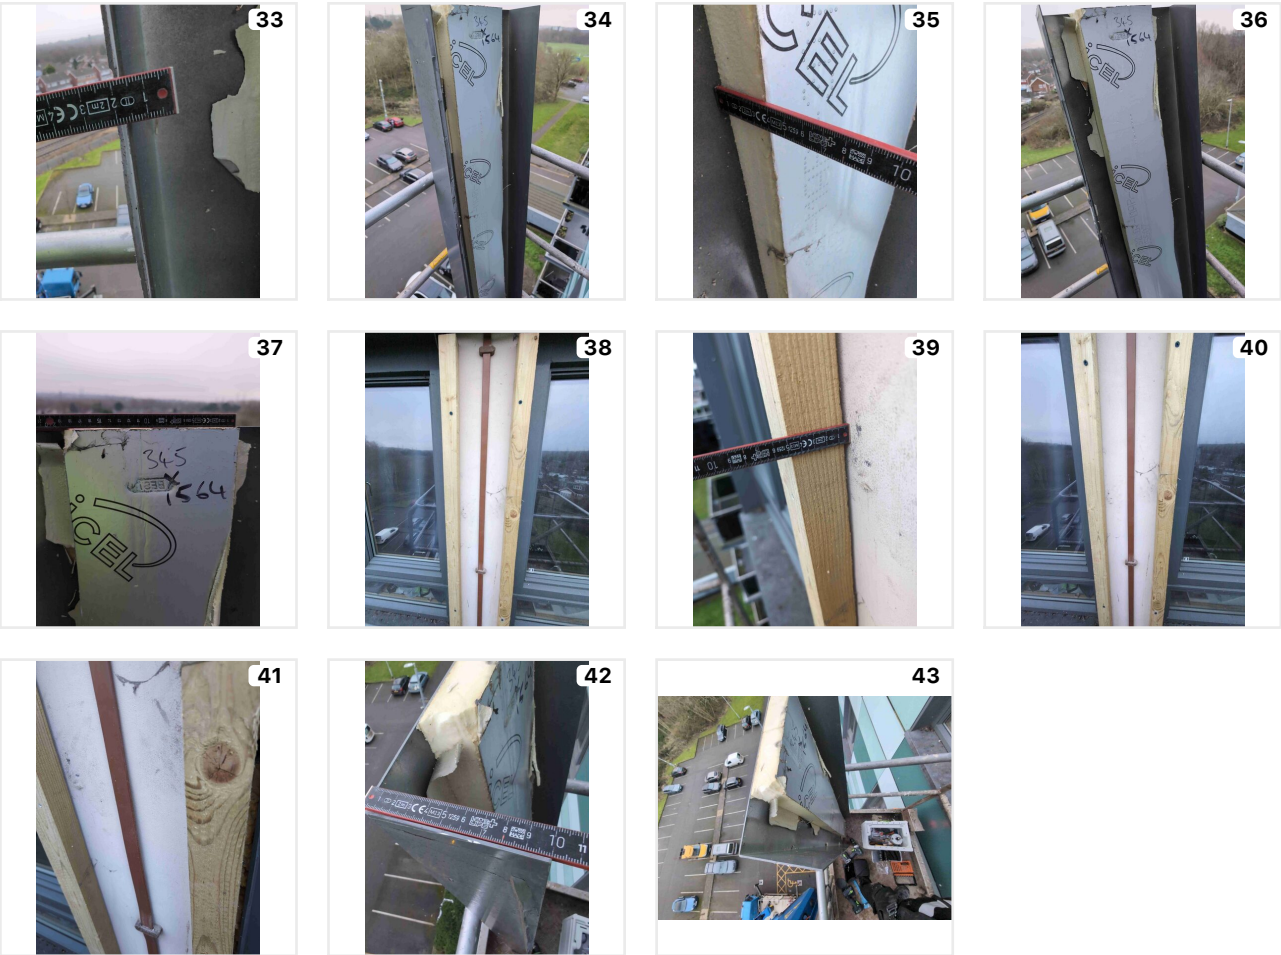
## Build-up Photos

**Inspection: 3ZA4CZ**  
East Elevation  
Vertical Compartment Junction

- Surface Finish (Aluminium Panel)
- Insulation (PIR Insulation)
- Cavity Support Frame (Timber Batten)
- Inner Leaf (Reinforced concrete)
- Cavity

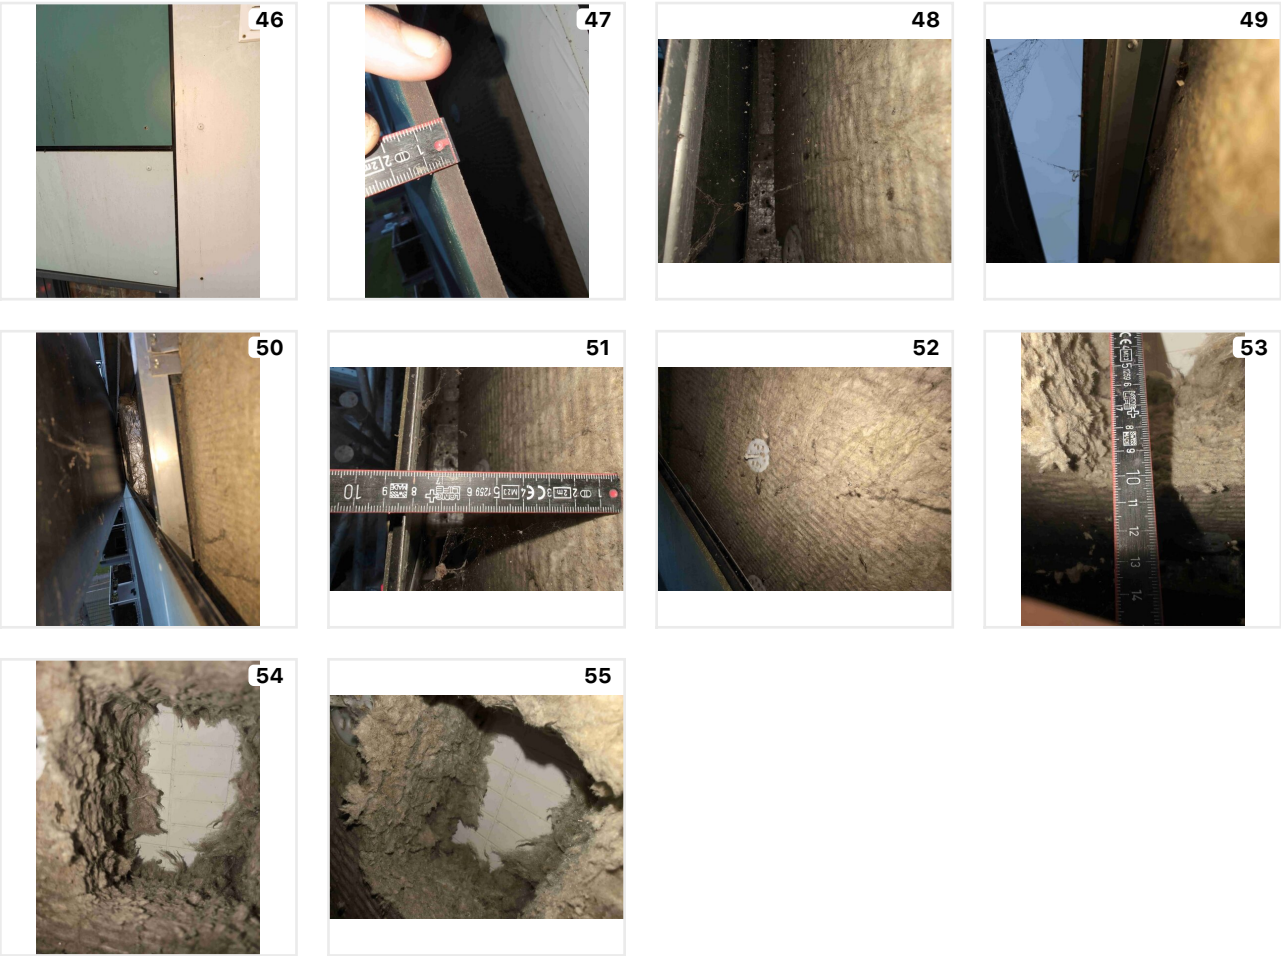
# Build-up Photos

**Inspection: IHG4W8**  
East Elevation  
Compartment Floor & Vertical Junction

- Surface Finish (Suspected High Pressure Laminate (HPL) Panel)
- Cavity
- Insulation (Mineral Wool Insulation)
- Inner Leaf (Reinforced concrete)

# Inspection: IHG4W8

Elevation • Location  
East Elevation • Compartment Floor & Vertical Junction

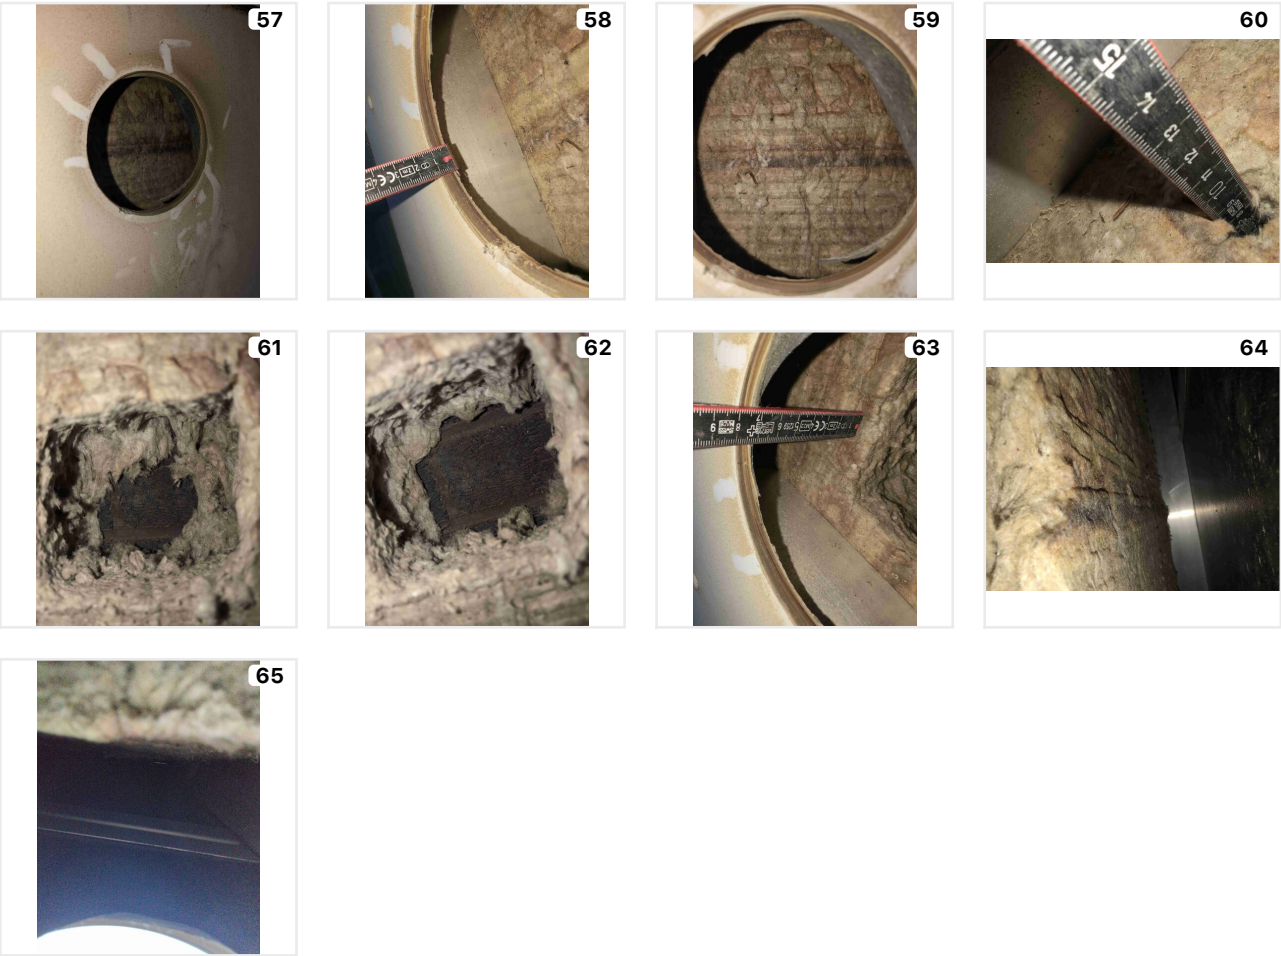
# Build-up Photos

**Inspection: RPBT51**  
East Elevation  
Compartment Floor Junction

- Surface Finish (Suspected High Pressure Laminate (HPL) Panel)
- Insulation (Mineral Wool Insulation)
- Inner Leaf (Blockwork)
- Cavity
