VISUAL STRUCTURAL APPRAISAL

Addenbrooke Court

Southbank Road  
Oldbury  
B64 6LJ

29<sup>th</sup> November 2024

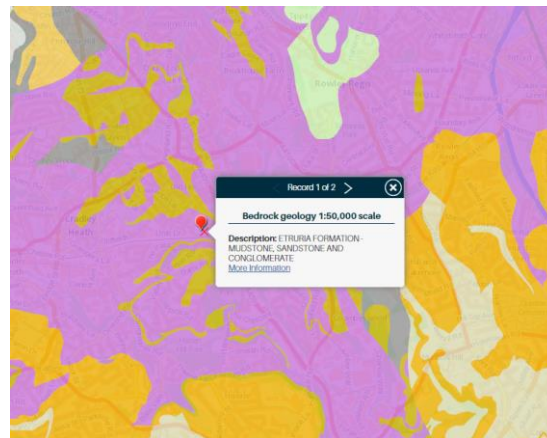
Figure 2. Bedrock Geology

The bedrock is the 'Etruria Formation – mudstone and sandstone. Superficial deposits sit on the older deposits referred to as bedrock.

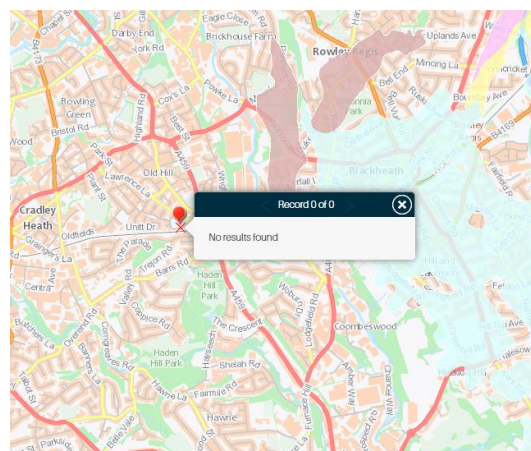
Figure 3. Superficial Geology

For the site, no superficial deposits were found.

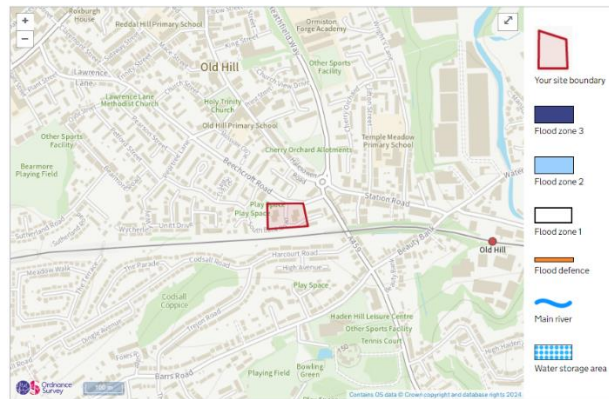
Figure 4. Flood Risk from Environmental Agency

There are 3 flood zones as defined by the EA; Flood Zone 1, 2 and 3. The flood zones are based on the likelihood of an area subject to flooding, with Flood Zone 1 areas least likely to flood and Flood Zone 3 areas more likely to flood. The property is in Flood Zone 1 i.e. less than 0.1% chance of flooding from river or sea in any year.

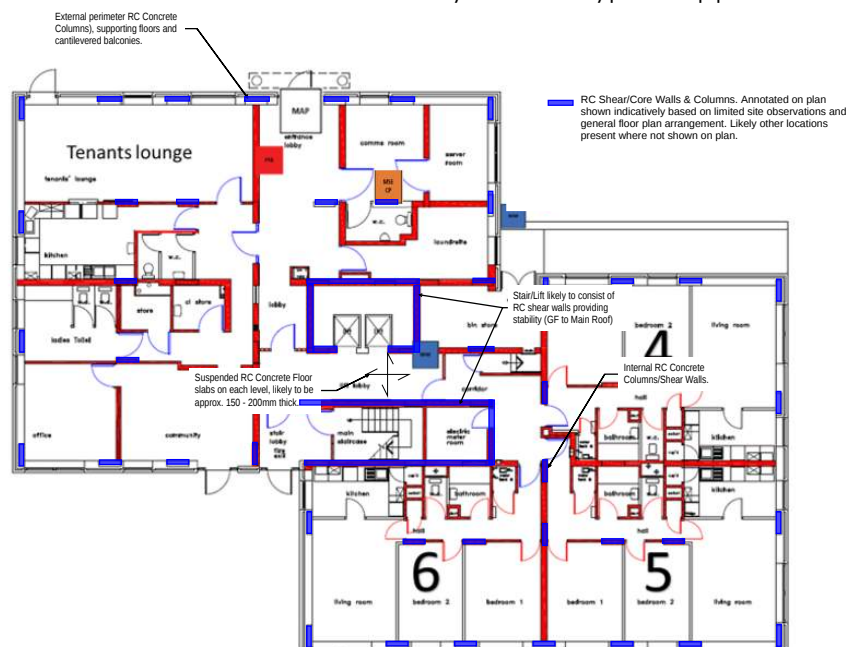
Figure 6: Diagram of typical floor plan

Figures 6 indicates the assumed structural layout for a typical upper floor level.

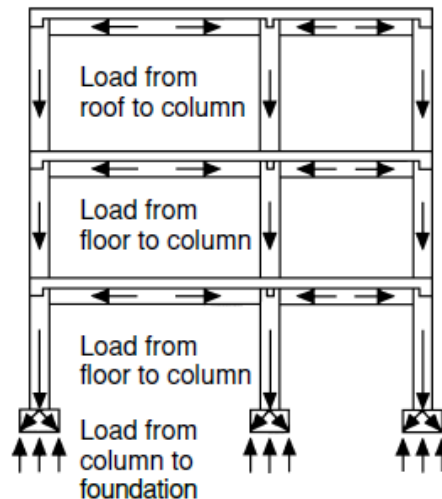
Figure 7 describes the vertical load path for the buildings

Figure 7 describes the load path for a RC framed building such as this. The loads distribute from the RC floor plates to the supporting load bearing RC walls/columns. The walls/columns are supported off the foundations which disperse the loads into the ground. The current foundation system is unknown but is presumed to be a reinforced concrete piled system.

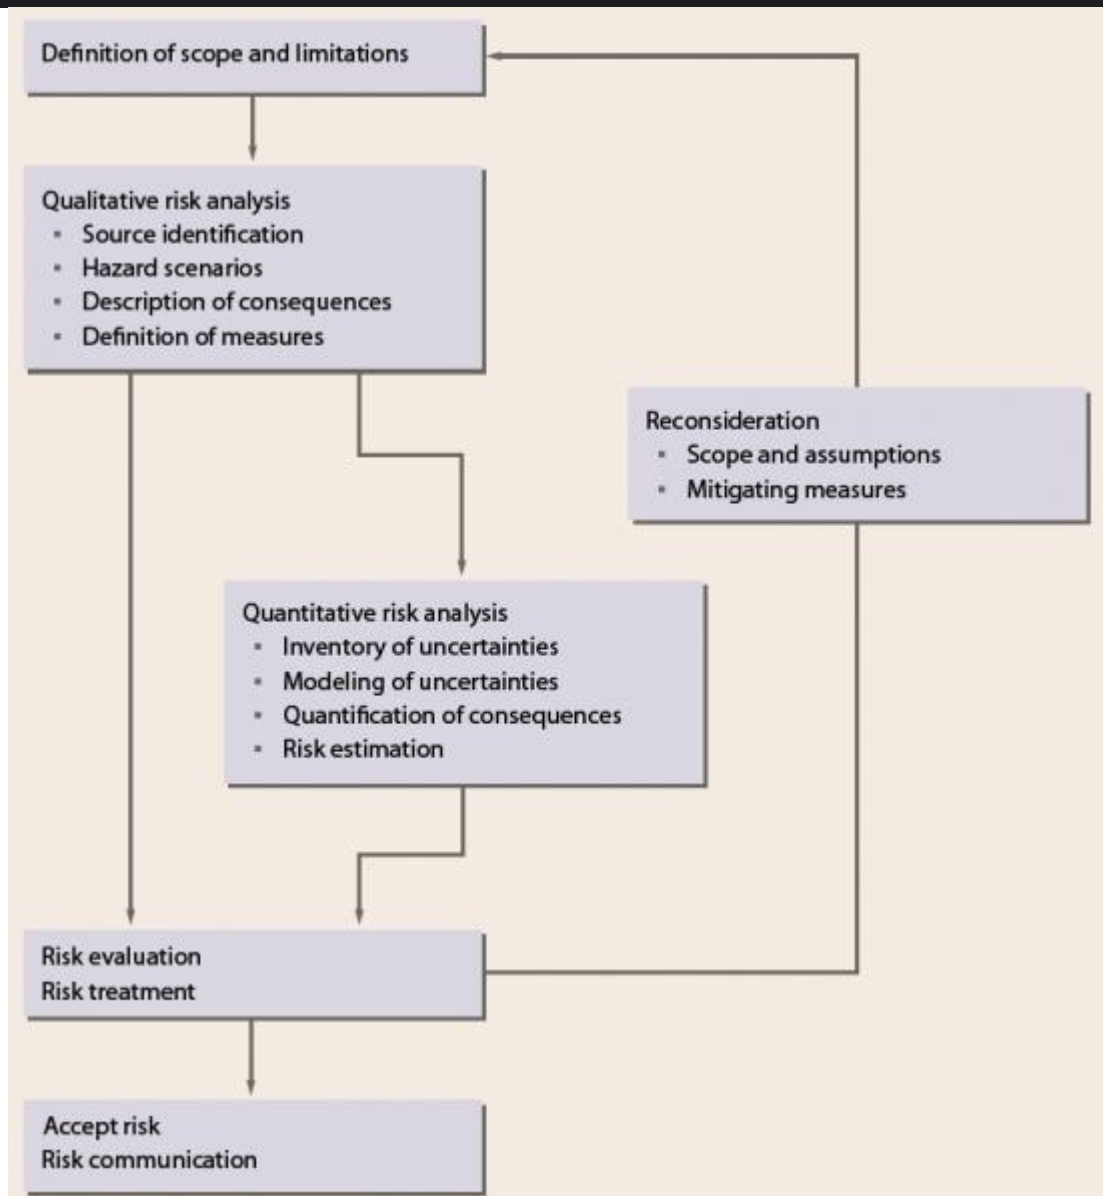
Figure 8: Systematic Risk Assessment Procedure as per BS EN 1991-1-7

In addition as the building is classified as a Class 3 building, a systematic risk assessment to determine whether there are any hazard scenarios that have an unacceptable level of risk and if so to identify steps to mitigate those risks. BS EN 1991-1-7 presents a flow diagram of the overall risk analysis procedure, shown in figure 8.

As the building is classified as a Class 3 building, a systematic risk assessment to determine whether there are any hazard scenarios that have an unacceptable level of risk and if so to identify steps to mitigate those risks. Refer to Figure 8 for the risk analysis procedure.
