VISUAL STRUCTURAL APPRAISAL

1-90 Ashcroft

Windmill Lane  
West Bromwich  
B66 3JP

29<sup>th</sup> November 2024

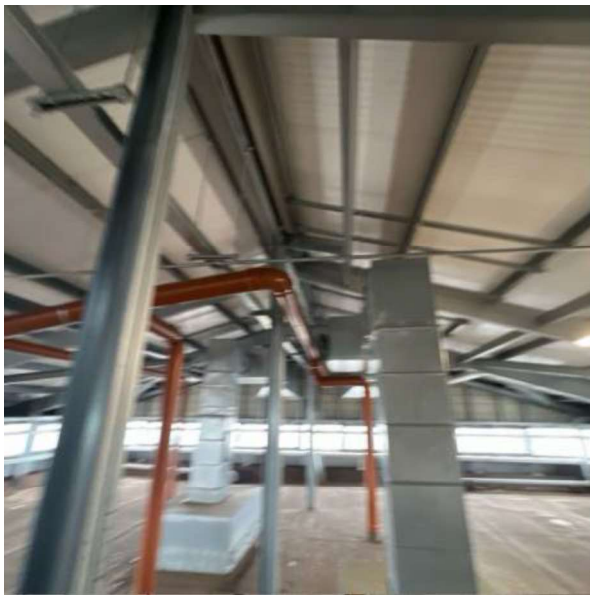
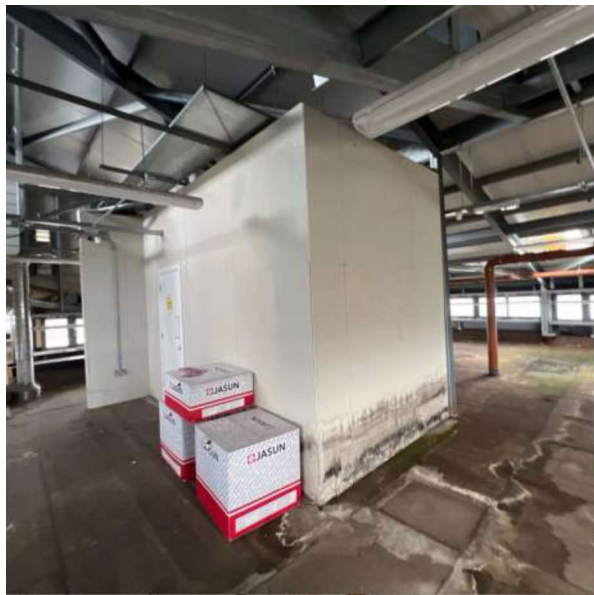
## Main Roof

Comments: Roof structure is formed of a concrete slab with a Lightweight frame (appears to be cold rolled) with a pitched roof fixed on to main roof structure. Frame columns fixed to perimeter of roof.  
Some historical staining to roof coverings noted however no tell tale signs of leaks noted to pitched roof coverings.

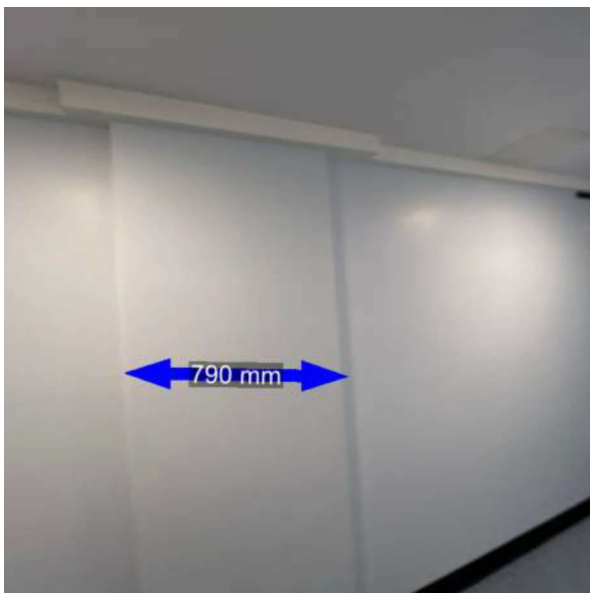
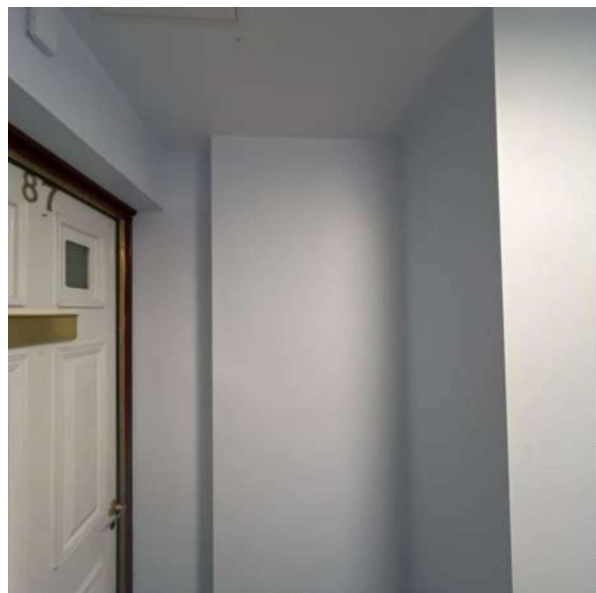
## 14th Floor Hallway

Comments: No jams or distortions noted to hallway doors to indicate any serviceability issues. Generally walls covered with finishes in hallway, likely to consist a mixture of concrete shear walls and embedded columns with internal partition walls. Riser cupboard shows infill masonry walls with a partially exposed concrete element likely an RC Column.

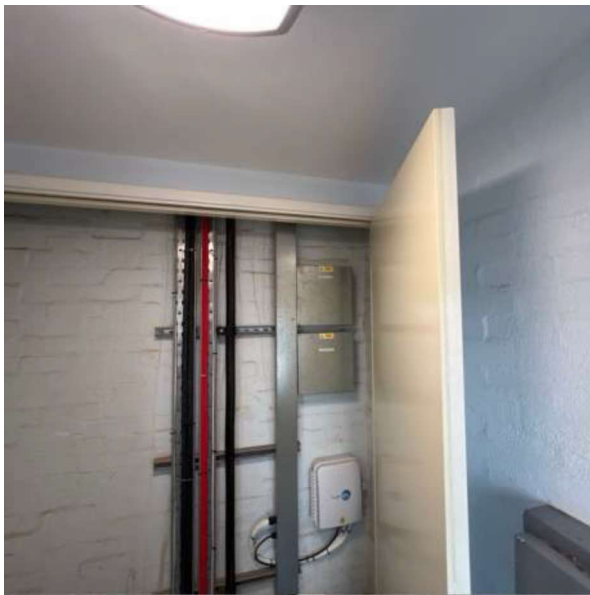
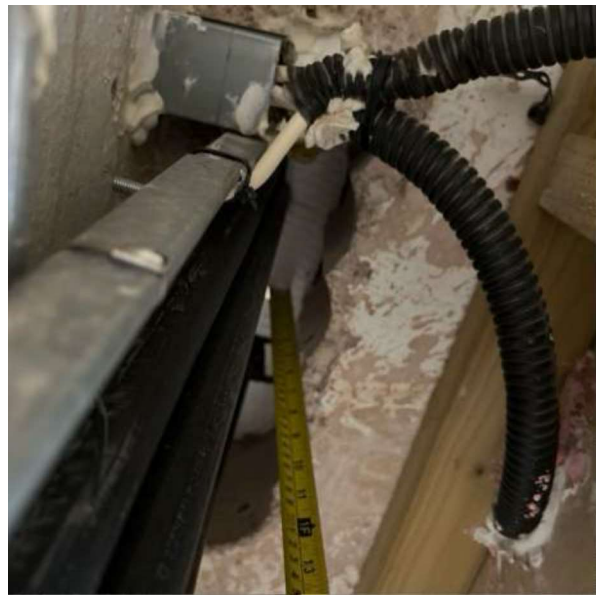
Comments: No jams or distortions noted to hallway doors to indicate any serviceability issues. Generally walls covered with finishes in hallway, likely to consist a mixture of concrete shear walls and embedded columns with internal partition walls. Riser cupboard shows infill masonry walls with a partially exposed concrete element likely an RC Column. Concrete floor slab measured through void in service cupboard noted to be approx. 160mm thick.

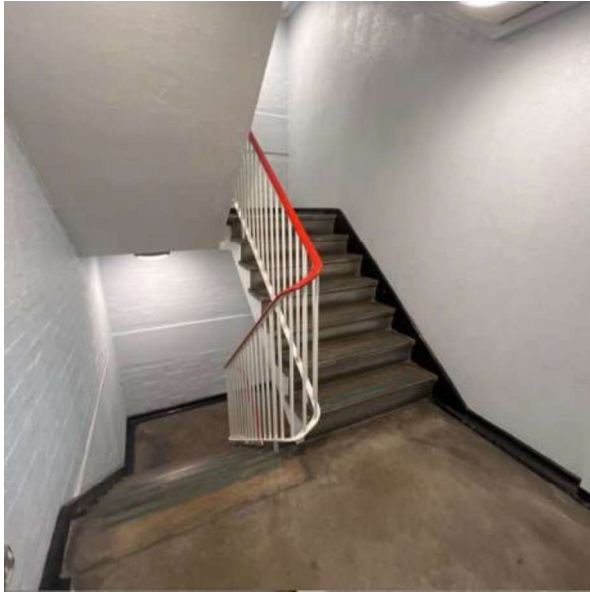
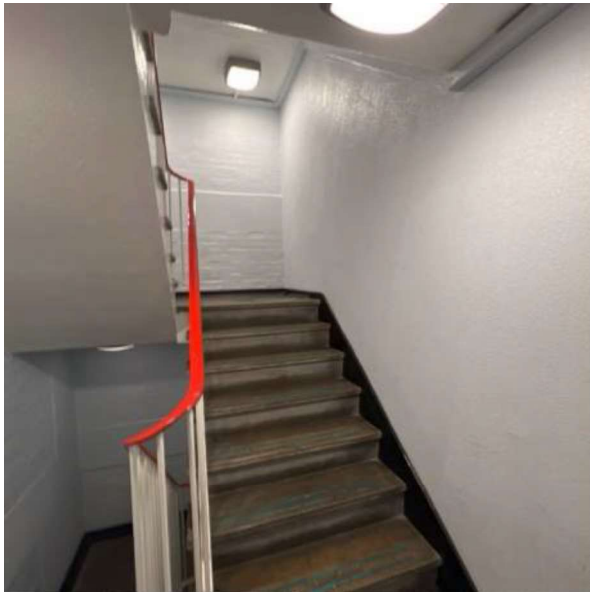
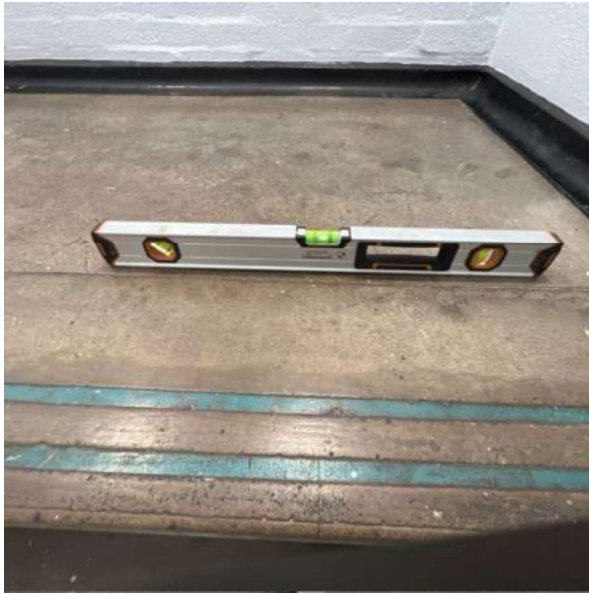
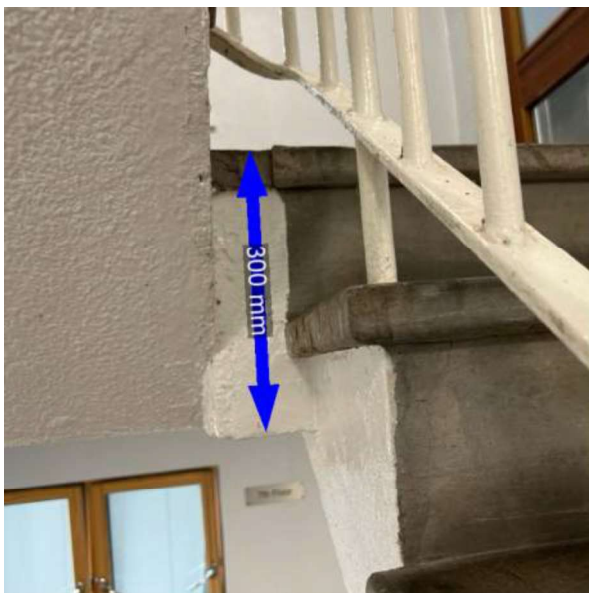
## 8th Floor Staircase

Insitu concrete stairs with steel hand railing fixed to stairs. Walls and floors appear to be fairly level.

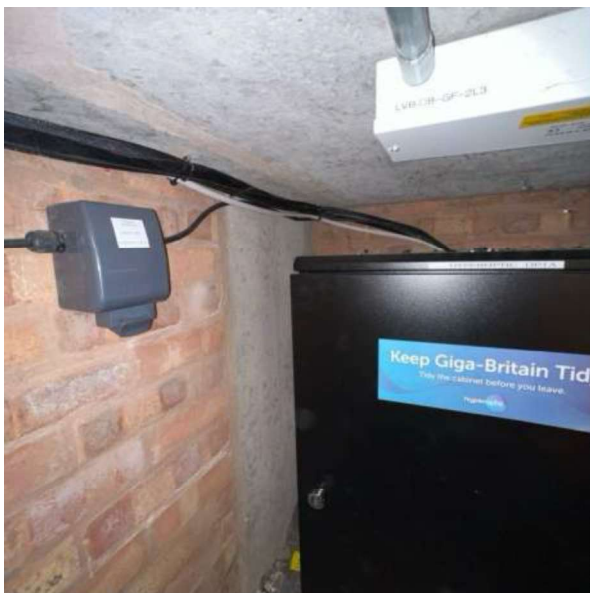
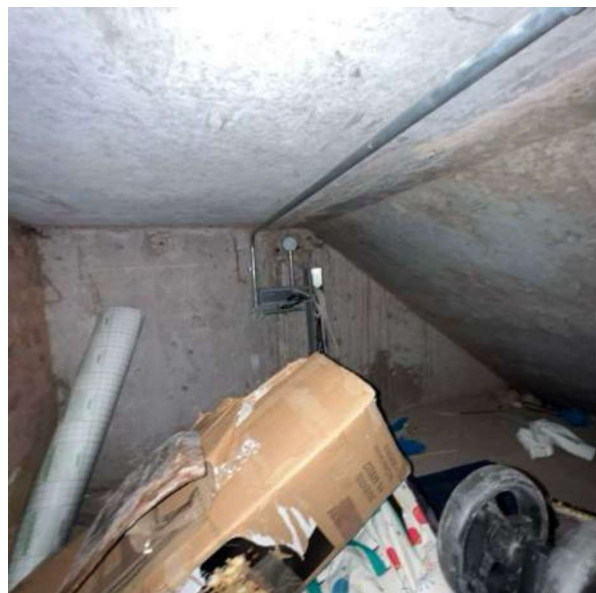
## Ground Floor Hallway

No jams or distortions noted to hallway doors to indicate any serviceability issues. Generally walls covered with finishes in hallway, likely to consist a mixture of concrete shear walls and embedded columns with internal partition walls. Riser cupboard shows infill masonry walls with a partially exposed concrete element likely an RC Column. Storage room under ground floor staircase shows embedded RC concrete beam and column in infill masonry walls. One side of stair wall noted to be an RC concrete wall likely forming a shear core wall of the structure.

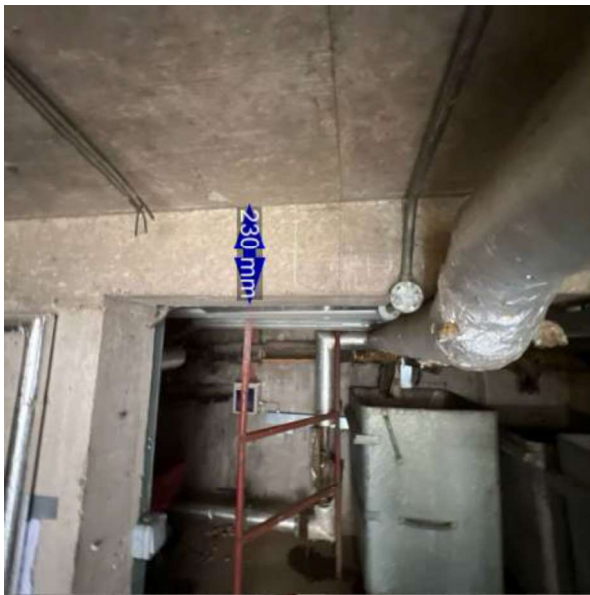
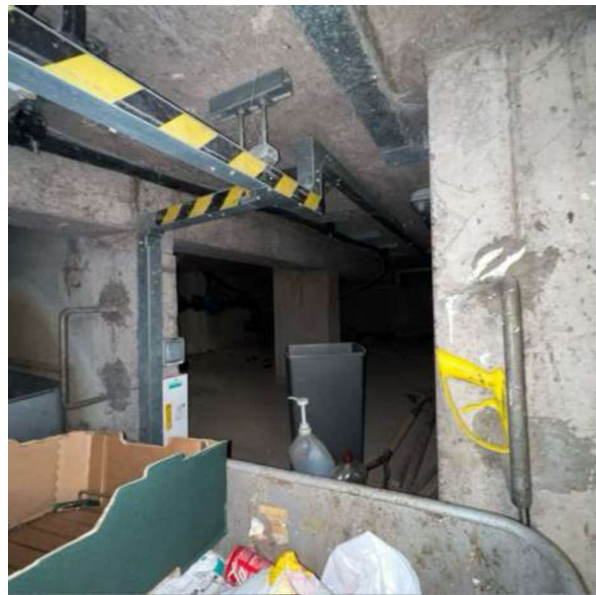
## Bin Store

Bin store located at basement level with a retaining wall leading up to bin store entrance. RC frame structure exposed forming of concrete beams, columns (230x600mm) and shear walls.

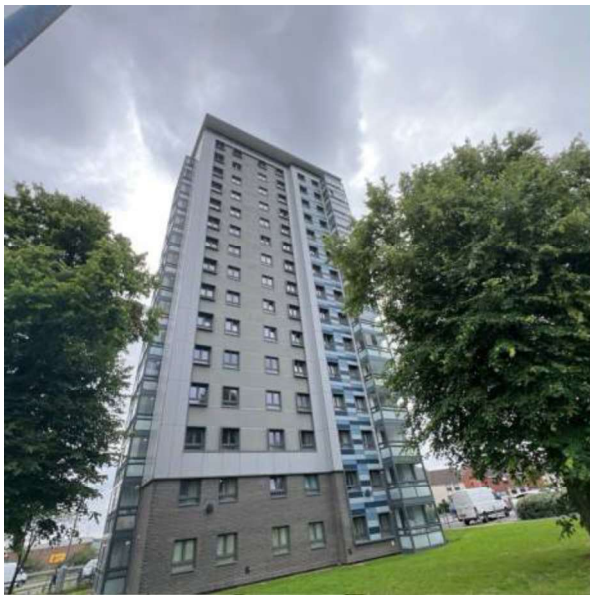
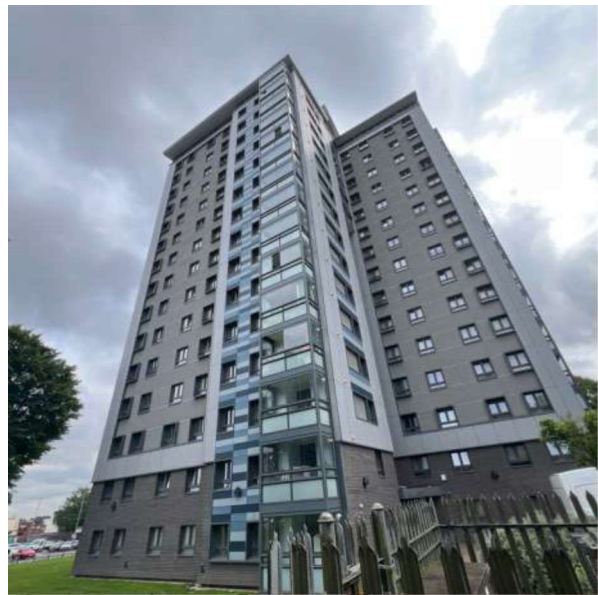
External ground and first floor levels consists of brick work to all elevations.  
Upper floors noted to have cladded facaded.
