**FIRNTEC**  
BUILDING COMPLIANCE

VISUAL STRUCTURAL APPRAISAL

1 -48 Astbury Cout

Kingsway  
Brandhall  
B68 0QG

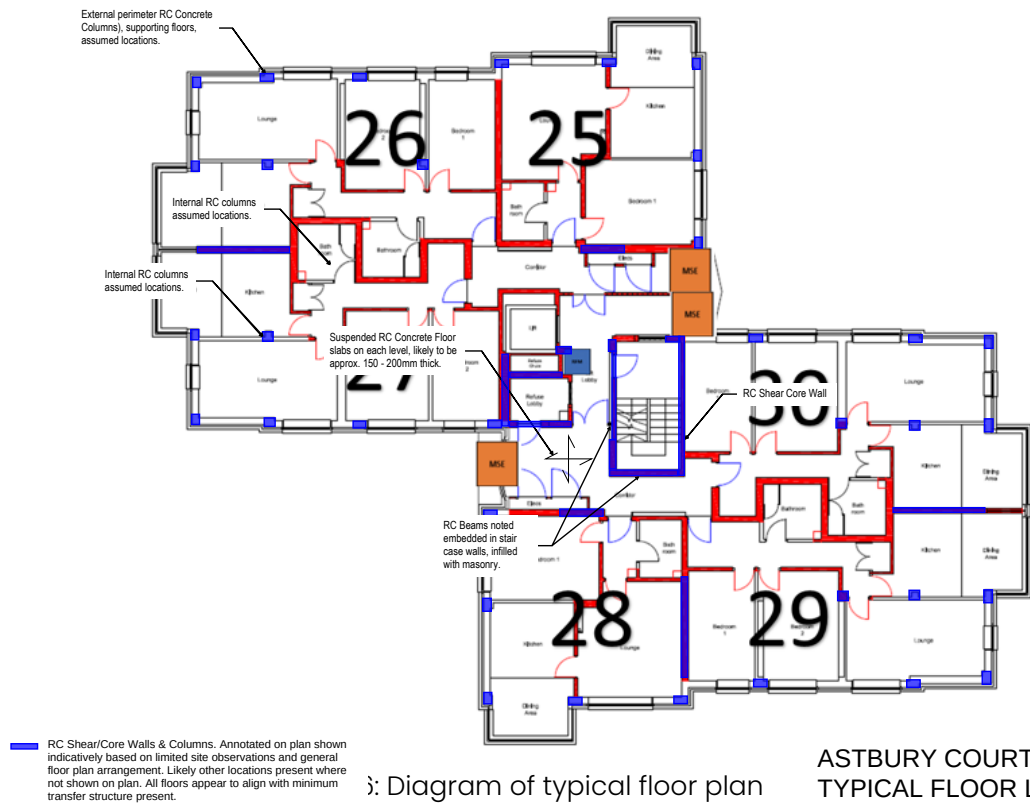
There were vertical concrete walls supporting the floor plates at every level. The elements visible matched the floor layout in Figure 6. The walls appear continuous from ground to roof with no transfer structure. The overall condition of the structure observed is good.

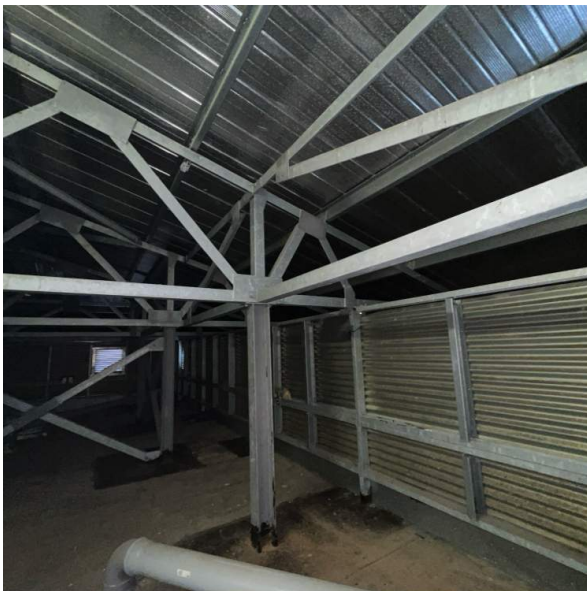
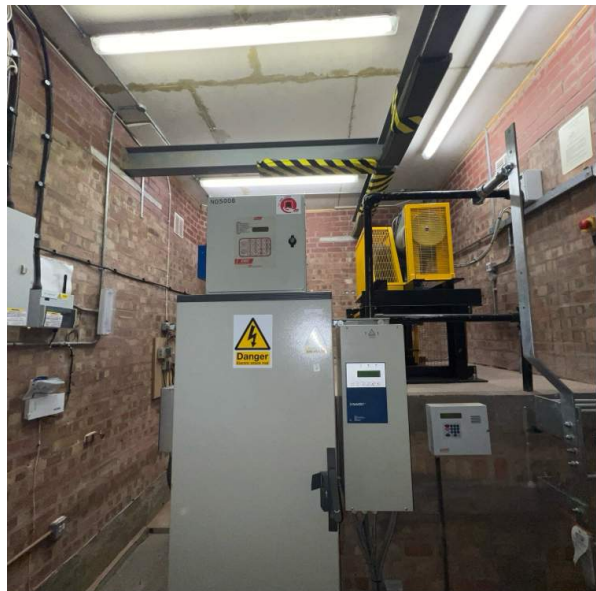
## Main Roof

Comments: A pitched roof constructed above existing original flat roof slab. Steel frame supporting purlins with aluminium standing / mineral wool core profiled panels.  
Masonry walls noted for motor room.

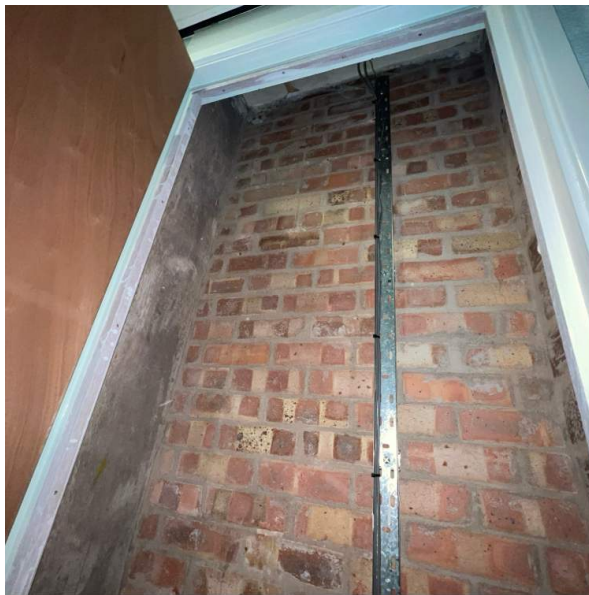
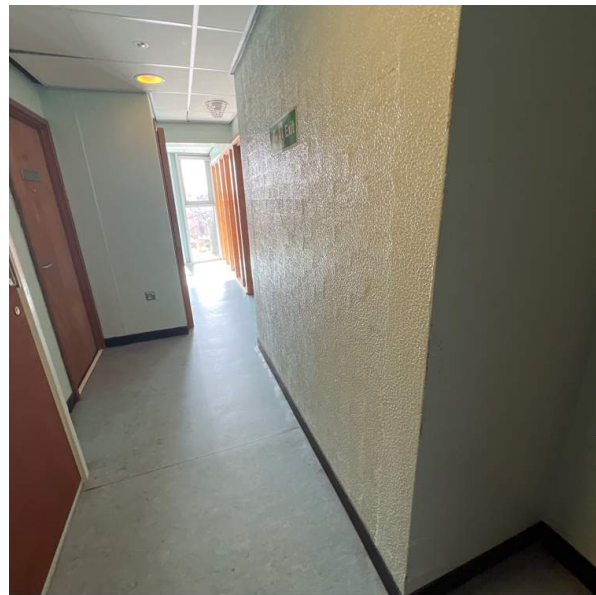
## 7th Floor Hallway

Comments: Hallway walls noted to comprise of a mixture of RC walls/columns and infill (non-load bearing) masonry walls. Concrete walls/columns noted via riser cupboards.

No jams or distortions noted to hallway doors to indicate any serviceability issues.

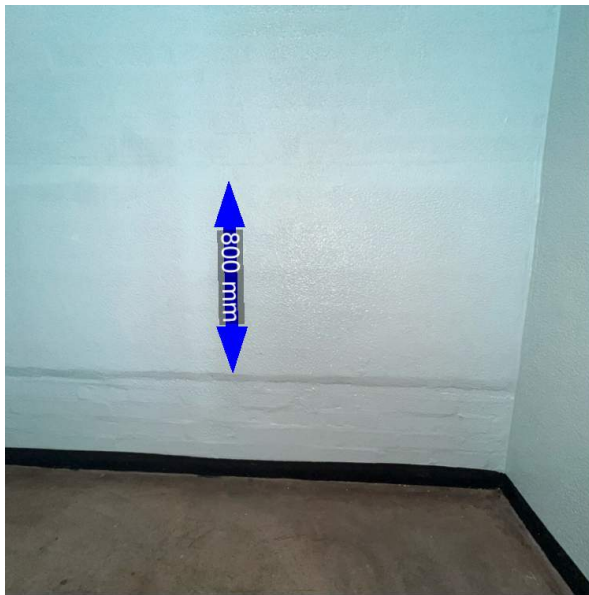
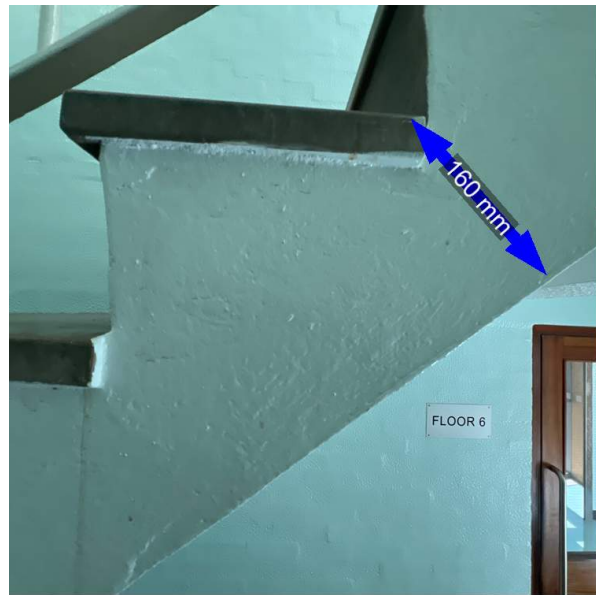
Comments: Insitu concrete stairs with steel hand railing fixed to stairs. Walls and floors appear to be fairly level.  
One side stair walls consist of a RC shear core wall. Other sides embedded with RC wall/column and beam with infill (non-load bearing) masonry.

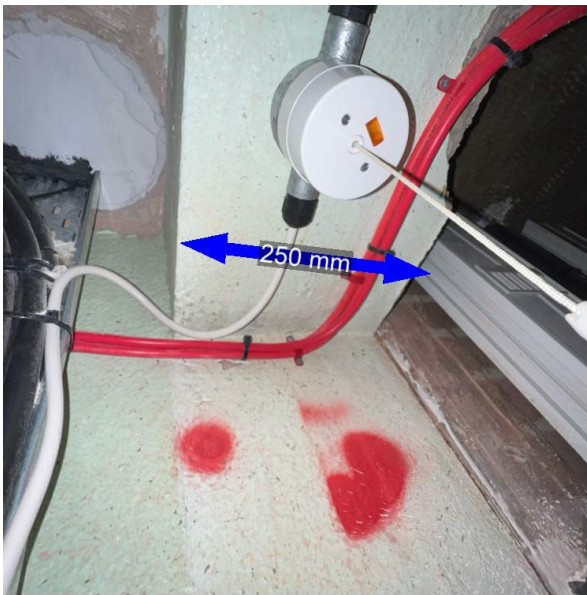
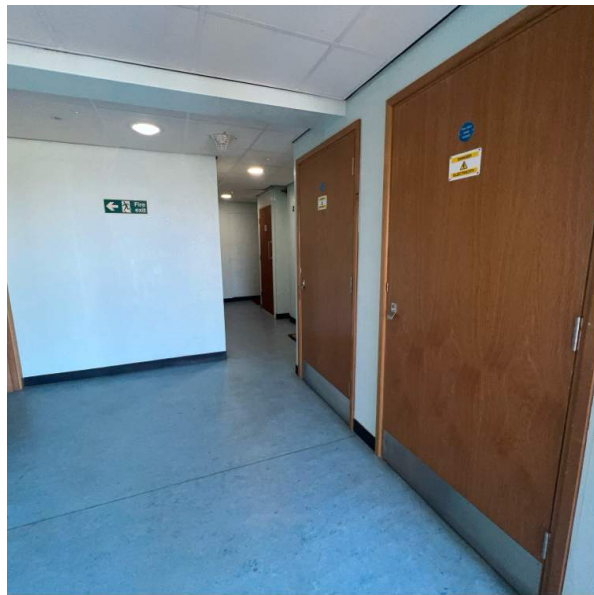
## 4th Floor Hallway

Comments: Hallway walls noted to comprise of a mixture of RC walls/columns and infill (non-load bearing) masonry walls. Concrete walls/columns noted via riser cupboards.

No jams or distortions noted to hallway doors to indicate any serviceability issues.

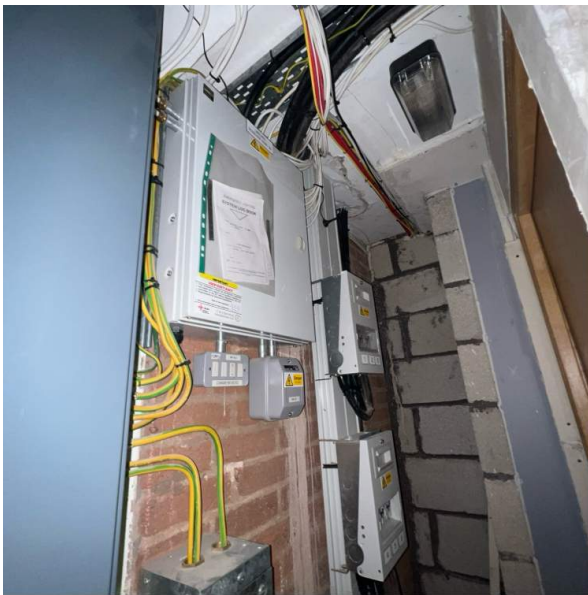
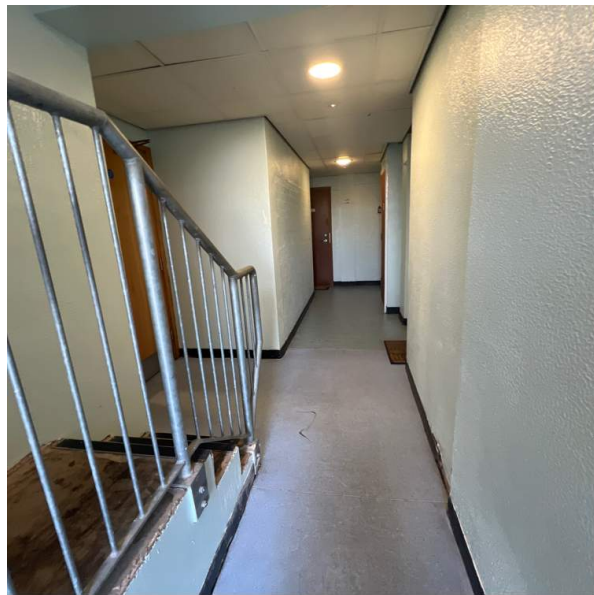
## Ground Floor Hallway

Comments: Hallway walls noted to comprise of a mixture of RC walls/columns and infill (non-load bearing) masonry walls. Concrete walls/columns noted via riser cupboards.

No jams or distortions noted to hallway doors to indicate any serviceability issues.

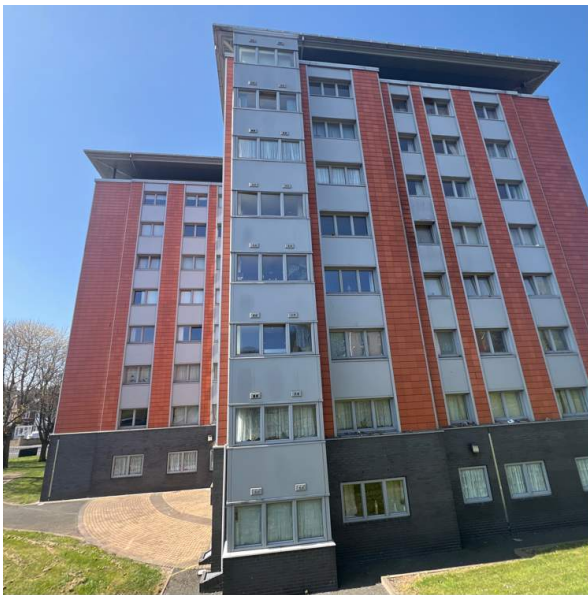
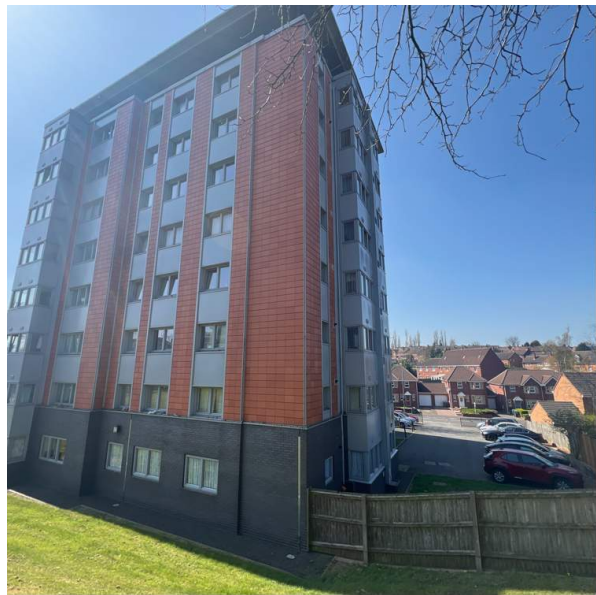
Ground floor level consists of brickwork. Remaining upper floors consist of cladded facade. Balconies have been encased in.
