VISUAL STRUCTURAL APPRAISAL

Beaconview House

Beaconview Road  
West Bromwich  
B71 3PL

31<sup>st</sup> January 2025

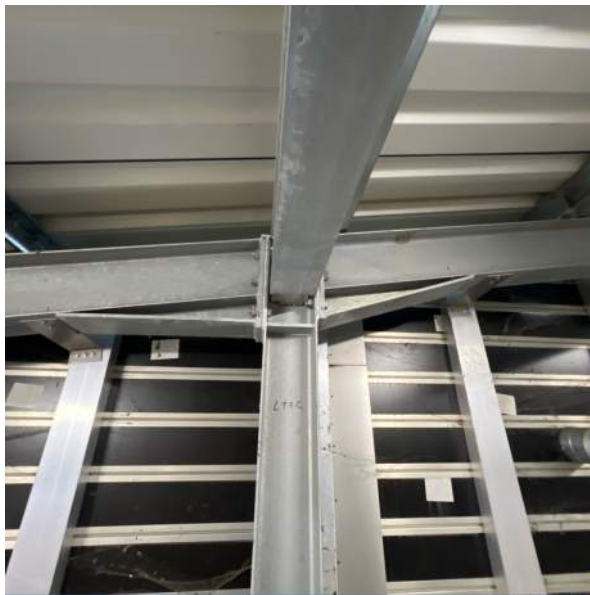
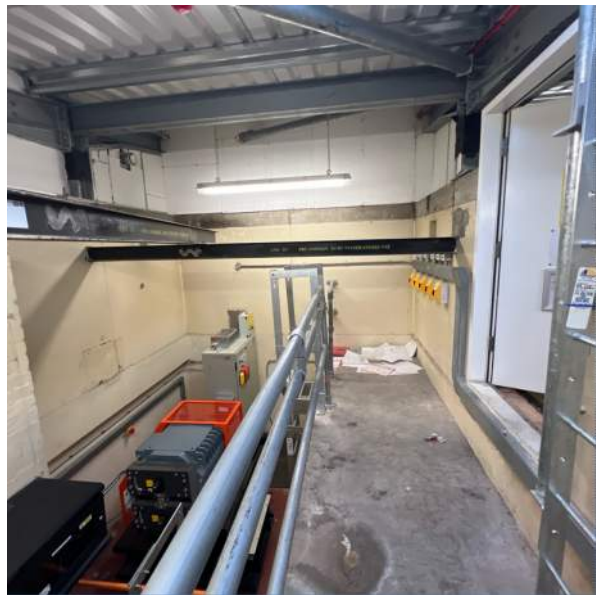
## Main Roof

Comments: A pitched roof constructed above existing original flat roof slab. Steel frame supporting purlins with aluminium standing / mineral wool core profiled panels.  
160mm thick RC core walls noted in motor room.

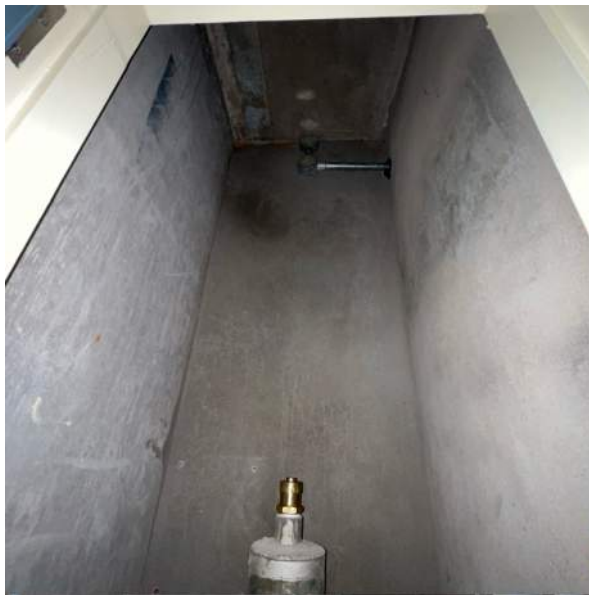
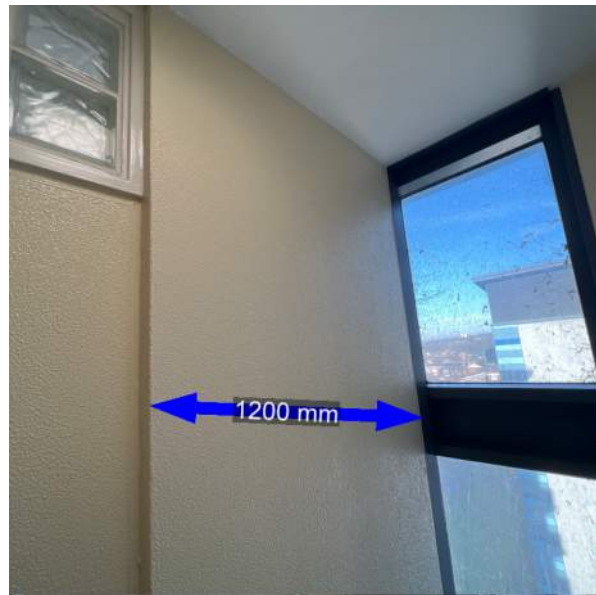
## 8th Floor Hallway

Comments: No jams or distortions noted to hallway doors to indicate any serviceability issues. Generally walls covered with finishes in hallway, likely to consist a mixture of concrete shear walls, embedded columns and masonry infill walls. Limited structure exposed. Concrete walls noted via riser cupboards.

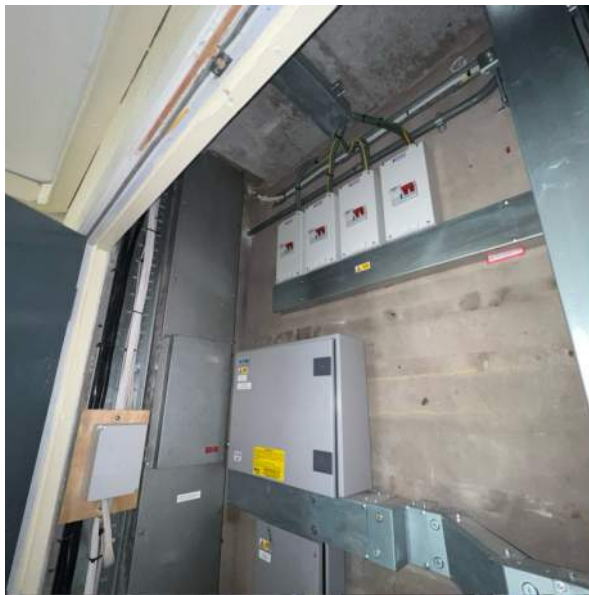
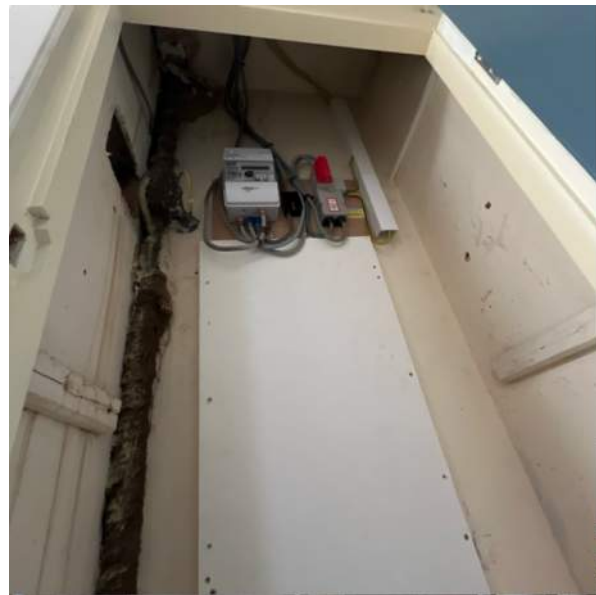
Comments: No jams or distortions noted to hallway doors to indicate any serviceability issues. Generally walls covered with finishes in hallway, likely to consist a mixture of concrete shear walls, embedded columns and masonry infill walls. Limited structure exposed. Concrete walls noted via riser cupboards.

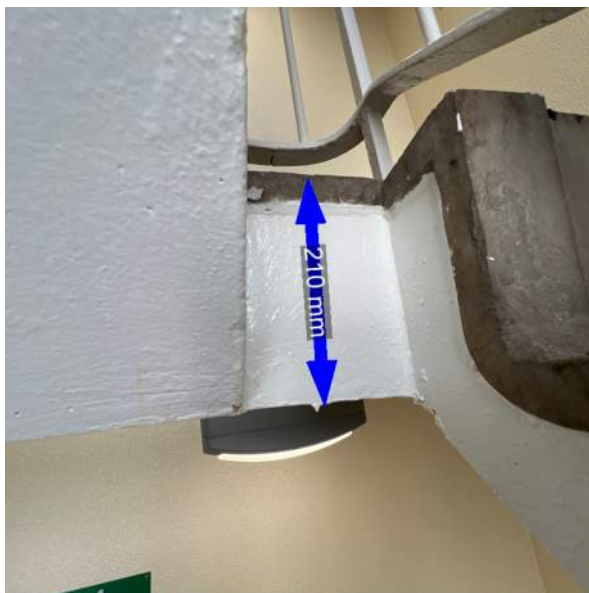
## 5th Floor Staircases

Comments: Insitu concrete stairs with steel hand railing fixed to stairs. Walls and floors appear to be fairly level.  
Stair walls covered with finishes however these would likely form the main concrete shear core walls. Partly infill/non-load bearing wall noted for one side of stair case wall.

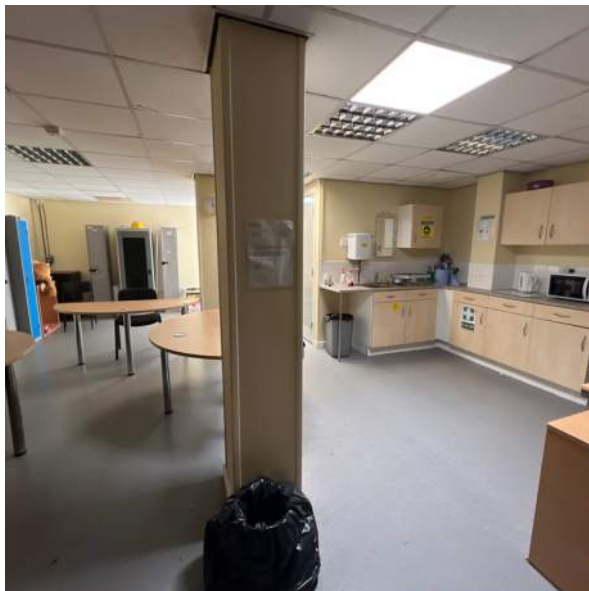
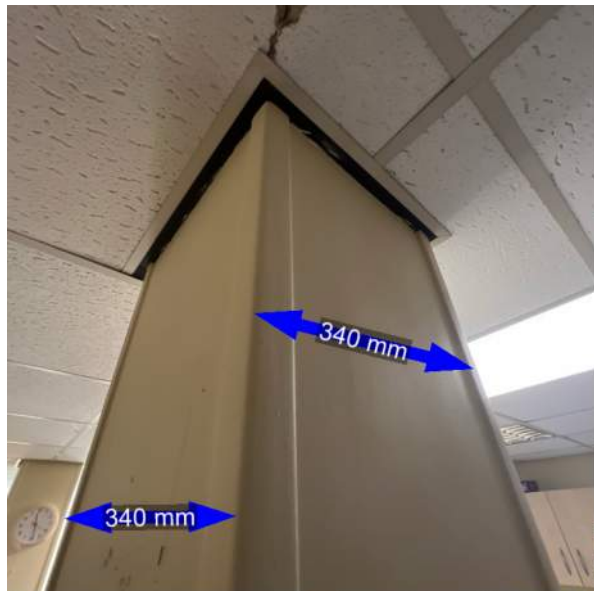
## Ground Floor Hallway

Comments: No jams or distortions noted to hallway doors to indicate any serviceability issues. Generally walls covered with finishes in hallway, likely to consist a mixture of concrete shear walls, embedded columns and block infill walls. Limited structure exposed. Partly visible concrete walls noted via electrical riser cupboards. RC Columns noted in security room.

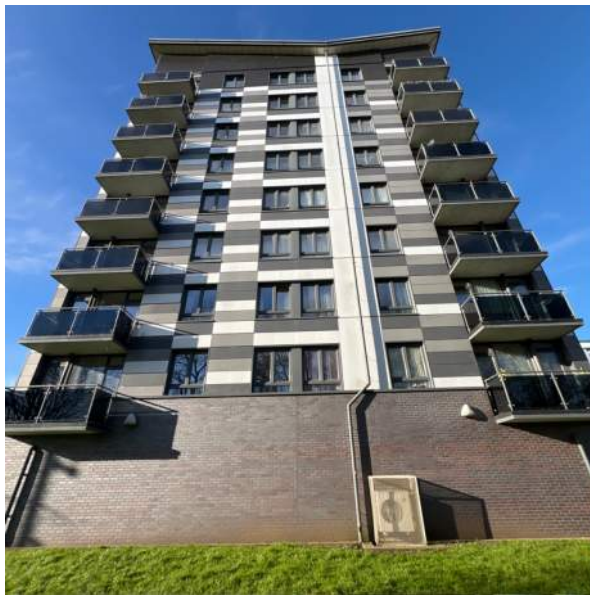
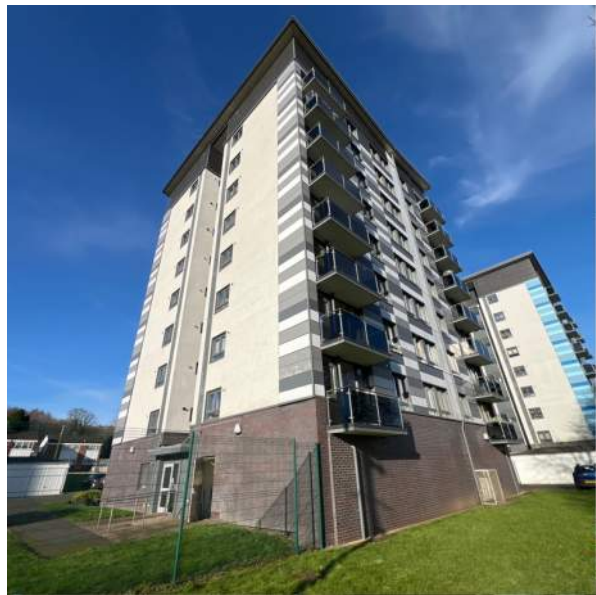
Ground floor level consists of brickwork. Remaining elevations consist of a mixture of rendered and cladded facade.
