**FIRNTEC**  
BUILDING COMPLIANCE

VISUAL STRUCTURAL APPRAISAL

380-450 Beaconview Road

29<sup>th</sup> April 2025

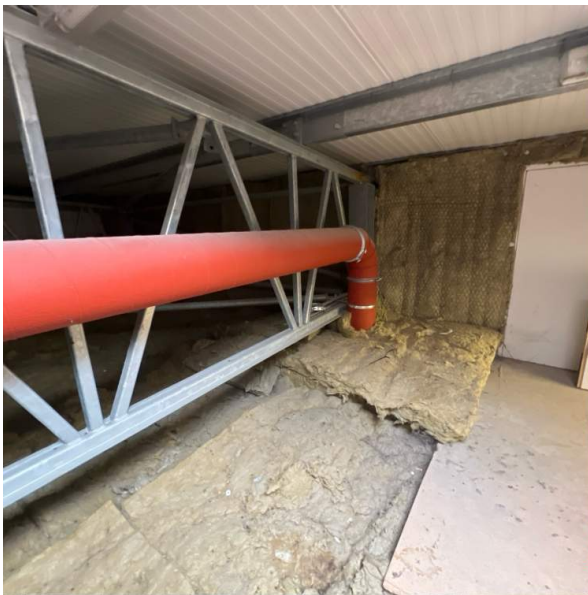
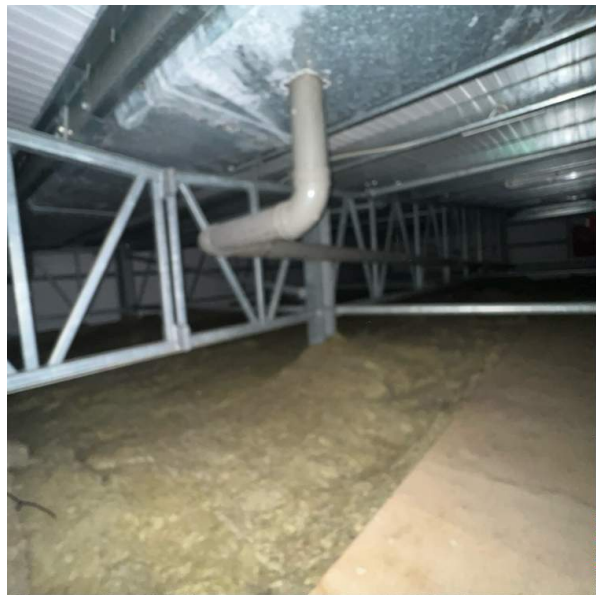
## Main Roof

Comments: A pitched roof constructed above existing original flat roof slab. Steel frame supporting purlins with aluminium standing / mineral wool core profiled panels.

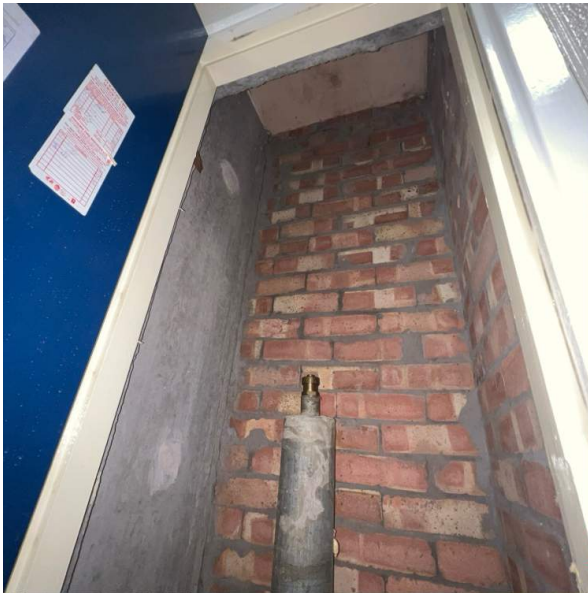
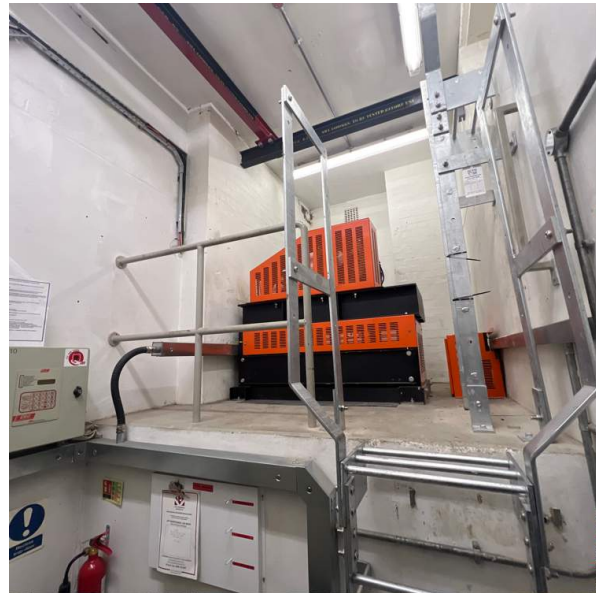
## 8th Floor Hallway

Comments: No jams or distortions noted to hallway doors to indicate any serviceability issues. Generally walls covered with finishes in hallway, likely to consist a mixture of concrete shear walls, embedded columns and masonry infill walls. Limited structure exposed. Concrete walls noted via riser cupboards, approx. 160mm thick.

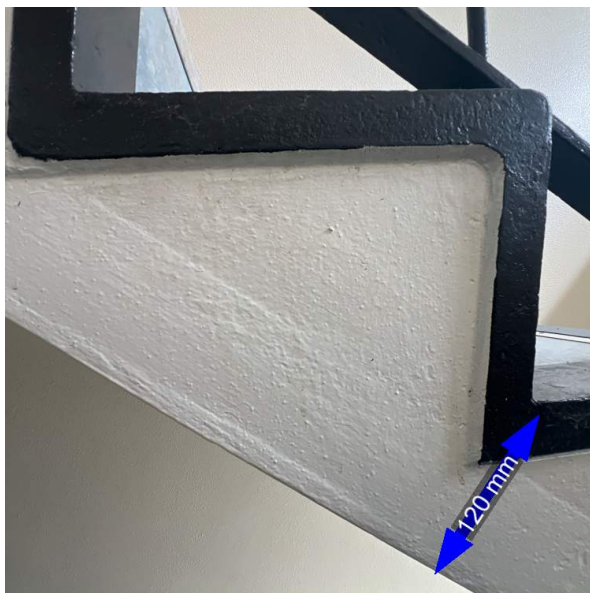
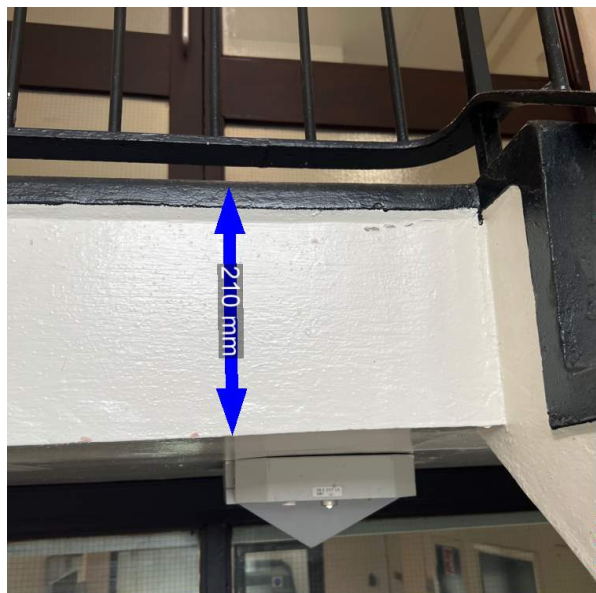
## 8th Floor Staircases

Comments: Insitu concrete stairs with steel hand railing fixed to stairs. Walls and floors appear to be fairly level.  
Stair walls covered with finishes however these would likely form the main concrete shear core walls.

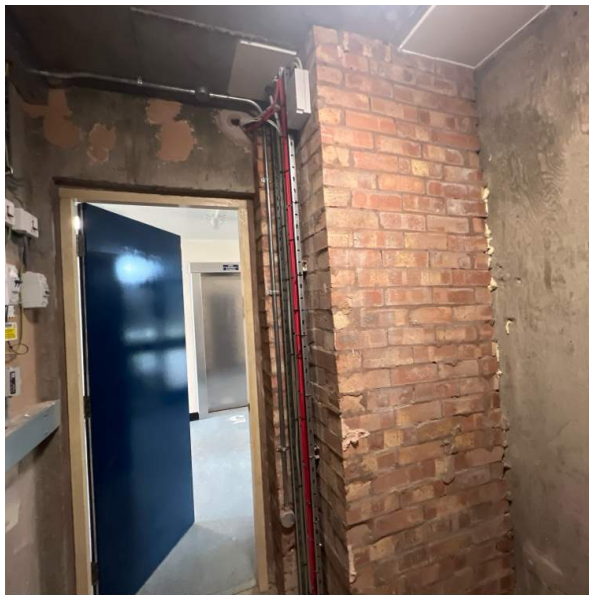
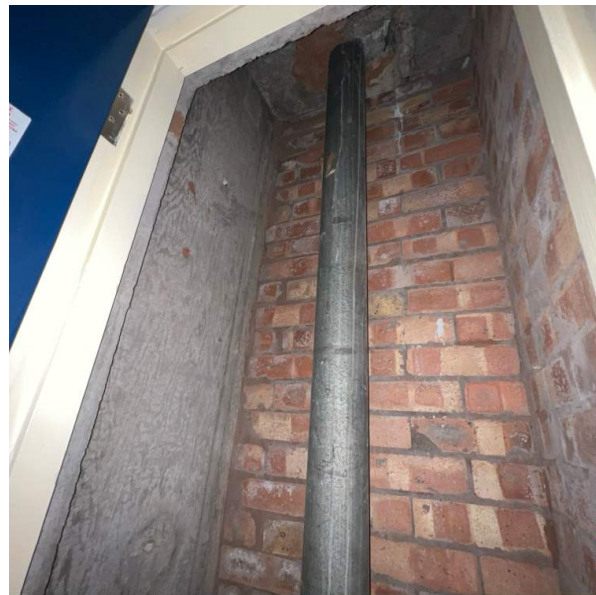
## 5th Floor Hallway

Comments: No jams or distortions noted to hallway doors to indicate any serviceability issues. Generally walls covered with finishes in hallway, likely to consist a mixture of concrete shear walls, embedded columns and masonry infill walls. Limited structure exposed. Concrete walls noted via riser cupboards approx. 160mm thick.

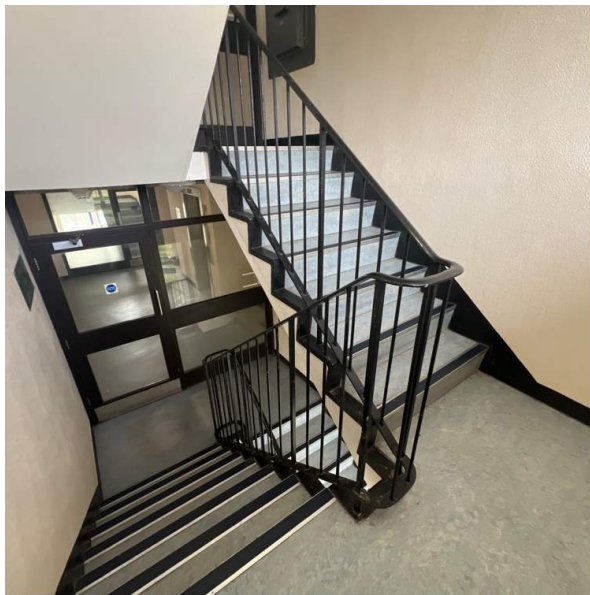
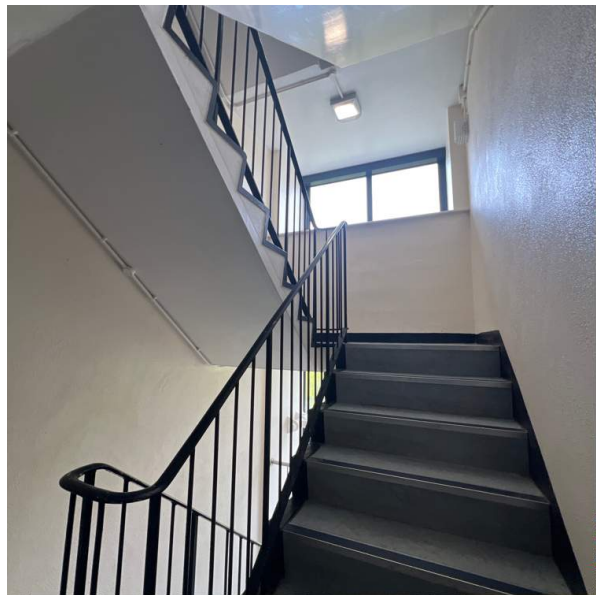
## 5th Floor Staircases

Comments: Insitu concrete stairs with steel hand railing fixed to stairs. Walls and floors appear to be fairly level.  
Stair walls covered with finishes however these would likely form the main concrete shear core walls.

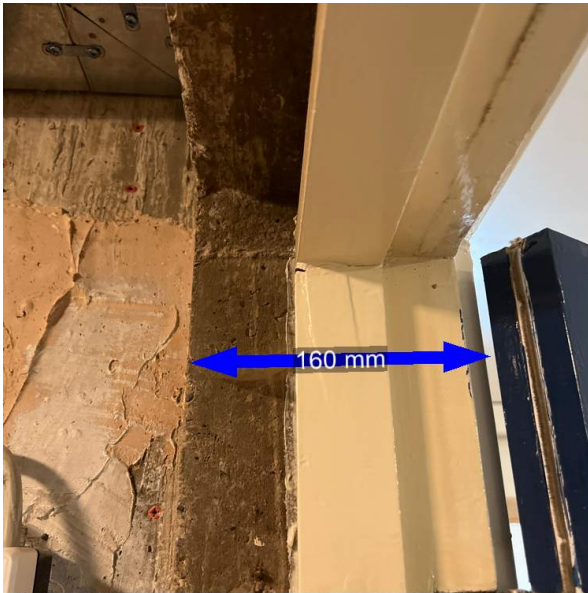
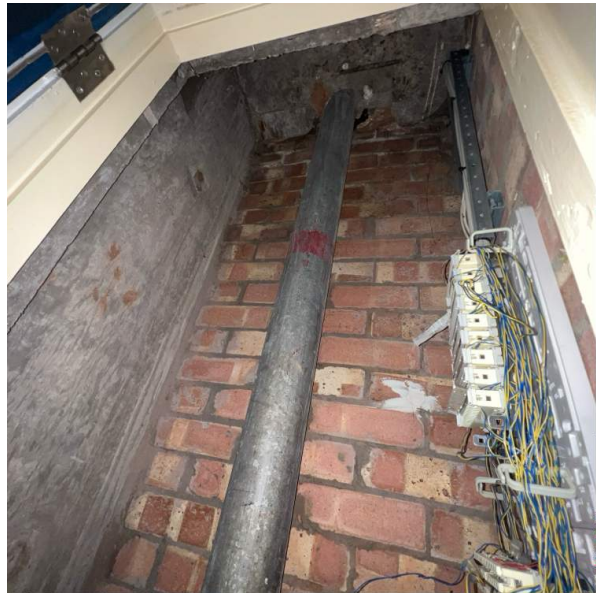
## Ground Floor Hallway

Comments: No jams or distortions noted to hallway doors to indicate any serviceability issues. Generally walls covered with finishes in hallway, likely to consist a mixture of concrete shear walls, embedded columns and block infill walls. Limited structure exposed. Partly visible concrete walls noted via electrical riser cupboards.

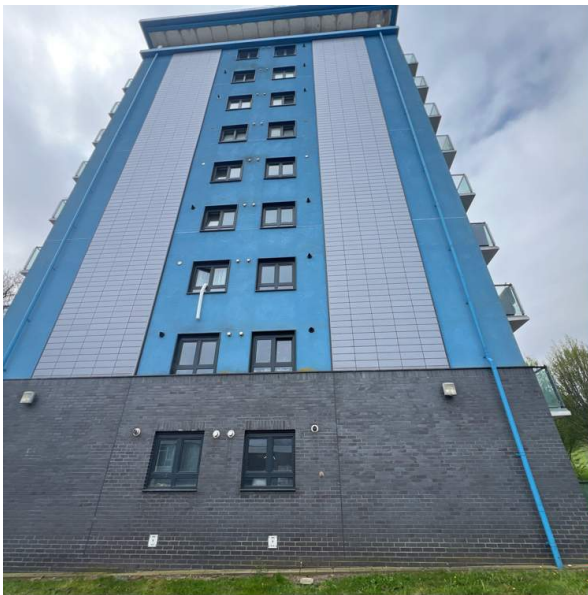
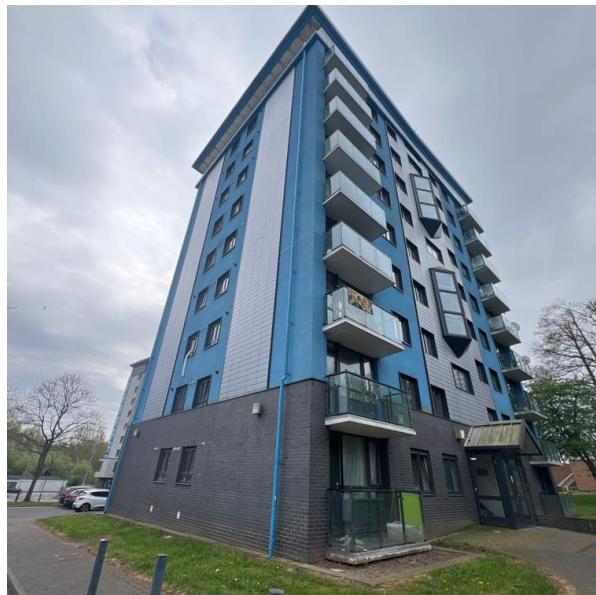
Ground floor level consists of brickwork. Remaining elevations consist of a mixture of rendered and cladded facade.
