**FIRNTEC**  
BUILDING COMPLIANCE

VISUAL STRUCTURAL APPRAISAL

1-90 Birchcroft

11<sup>th</sup> November 2024

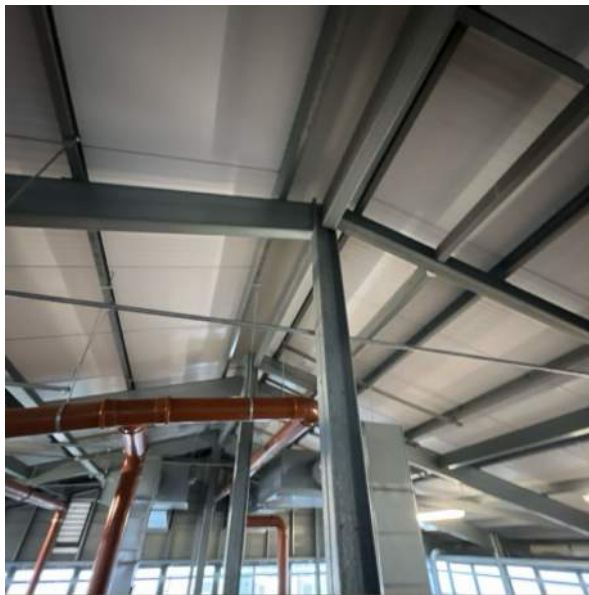
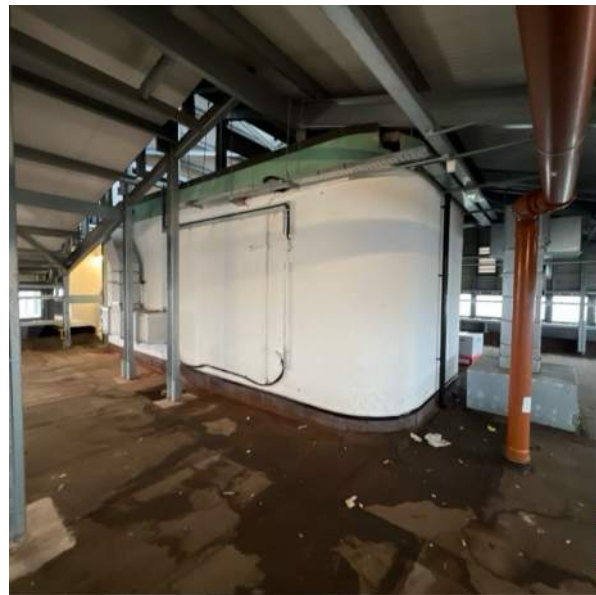
## Main Roof

Comments: Roof structure is formed of a concrete slab with a Lightweight SFS (appear to be cold rolled) frame with a pitched roof fixed on to main roof structure. Frame columns fixed to perimeter of roof.  
Some historical staining to roof coverings noted, potential leaks in pitched roof coverings.

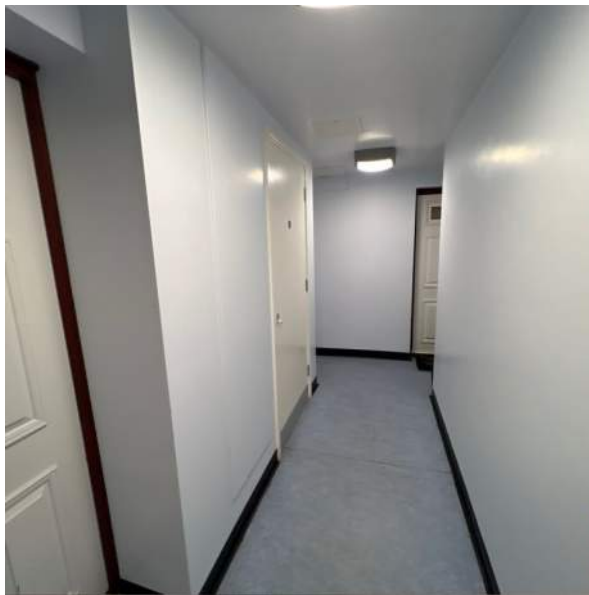
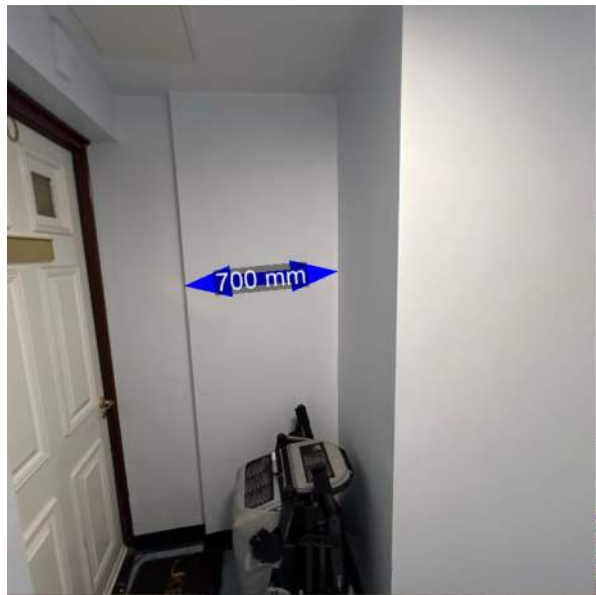
## 14th Floor Hallway

Comments: No jams or distortions noted to hallway doors to indicate any serviceability issues. Generally walls covered with finishes in hallway, likely to consist a mixture of concrete shear walls and embedded columns with internal partition walls. Riser cupboard shows infill masonry walls with partially exposed concrete elements which appears RC Columns.

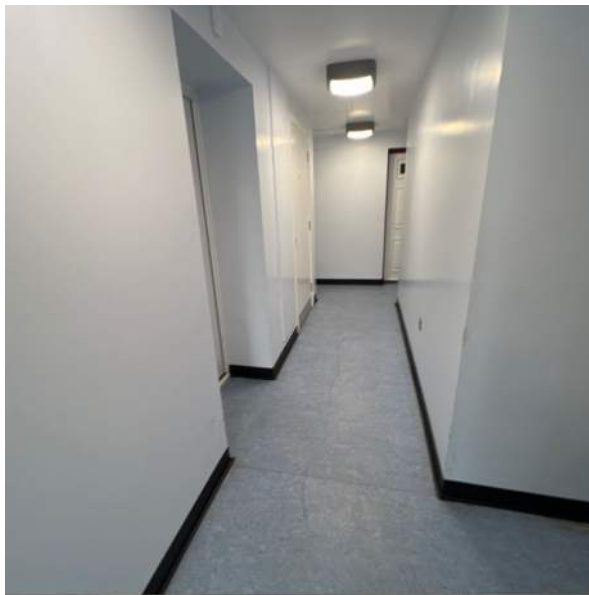
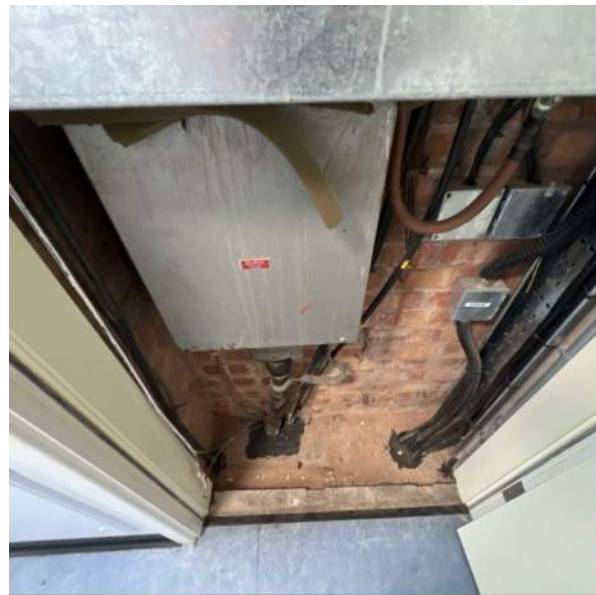
## 8th Floor Hallway

Comments: No jams or distortions noted to hallway doors to indicate any serviceability issues. Generally walls covered with finishes in hallway, likely to consist a mixture of concrete shear walls and embedded columns with internal partition walls. Riser cupboard shows infill masonry walls with partially exposed concrete elements appears to be RC Columns.

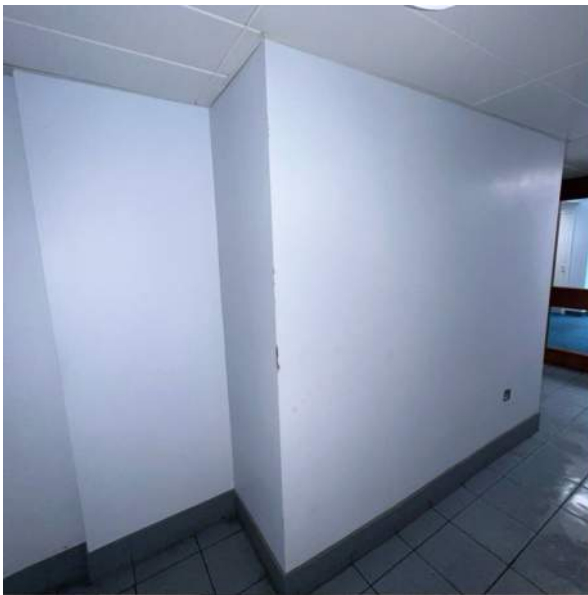
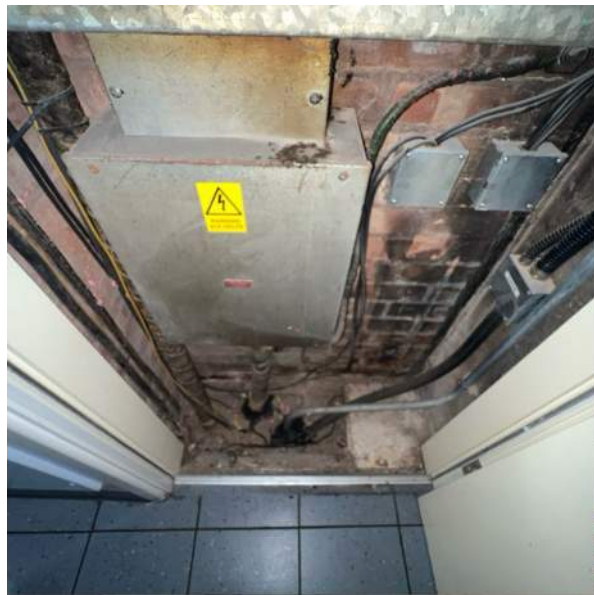
Comments: 24 Jul 2024 at 12:27 PM  
 No jams or distortions noted to hallway doors to indicate any serviceability issues.  
 Generally walls covered with finishes in hallway, likely to consist a mixture of concrete shear walls and embedded columns with internal partition walls.  
 Riser cupboard shows infill masonry walls with a partially exposed concrete element likely an RC Column.  
 Storage room under ground floor staircase shows embedded RC concrete beam and column in infill masonry walls. One side of stair wall noted to be an RC concrete wall likely forming a shear core wall of the structure.

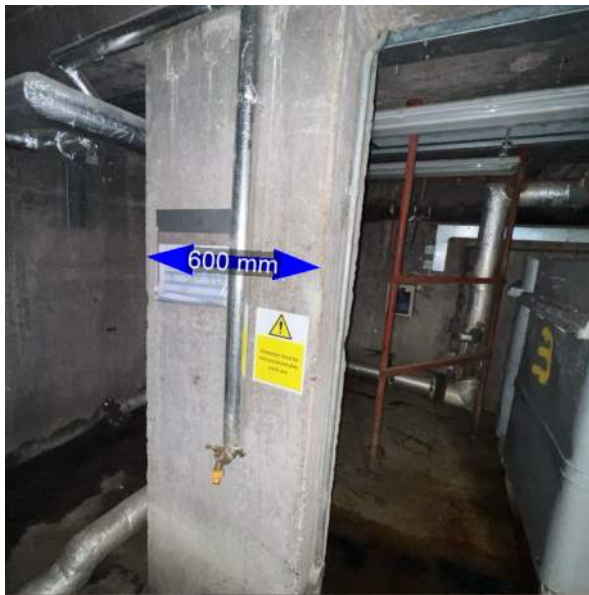
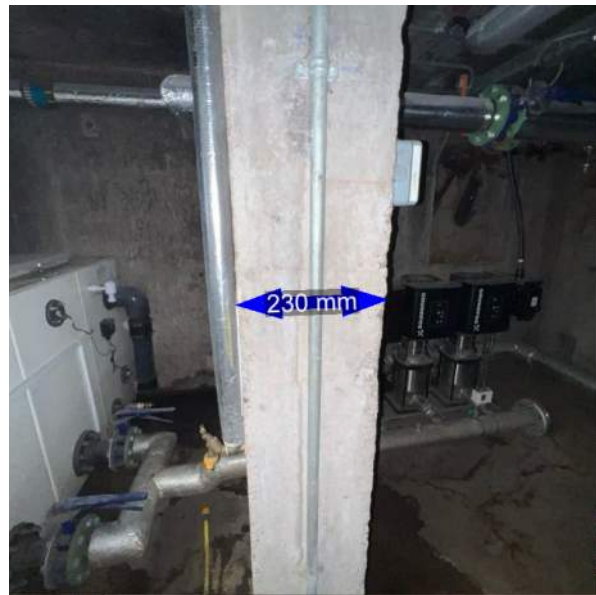
## Bin Store

Bin store located at basement level with a retaining wall leading up to bin store entrance. RC frame structure exposed forming of concrete beams, columns (230x600mm) and shear walls.  
Floor slab measured from bin store entrance noted to be approx. 180mm dp.

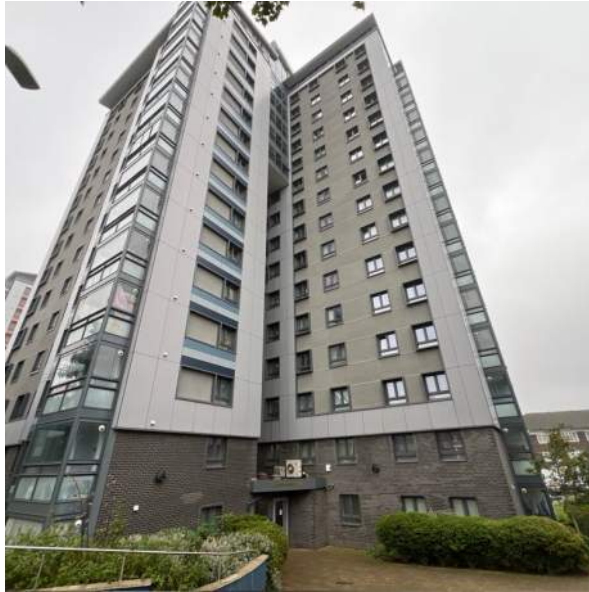
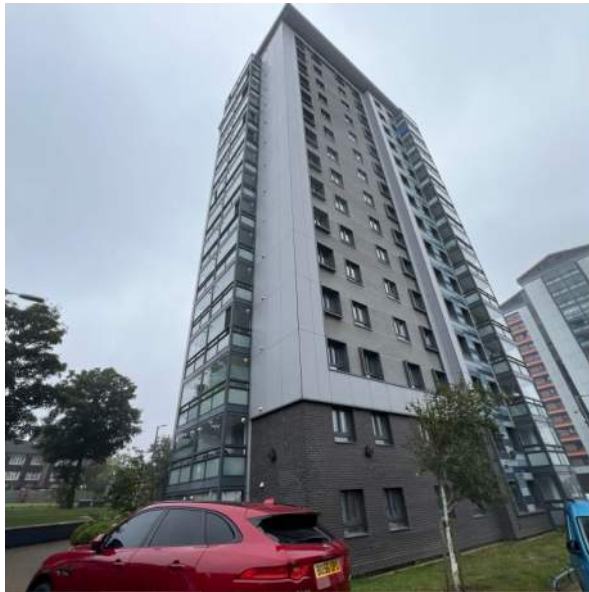
## Elevations

External ground and first level consists of brick work.  
Remaining floors noted to have a cladded facade to exterior.

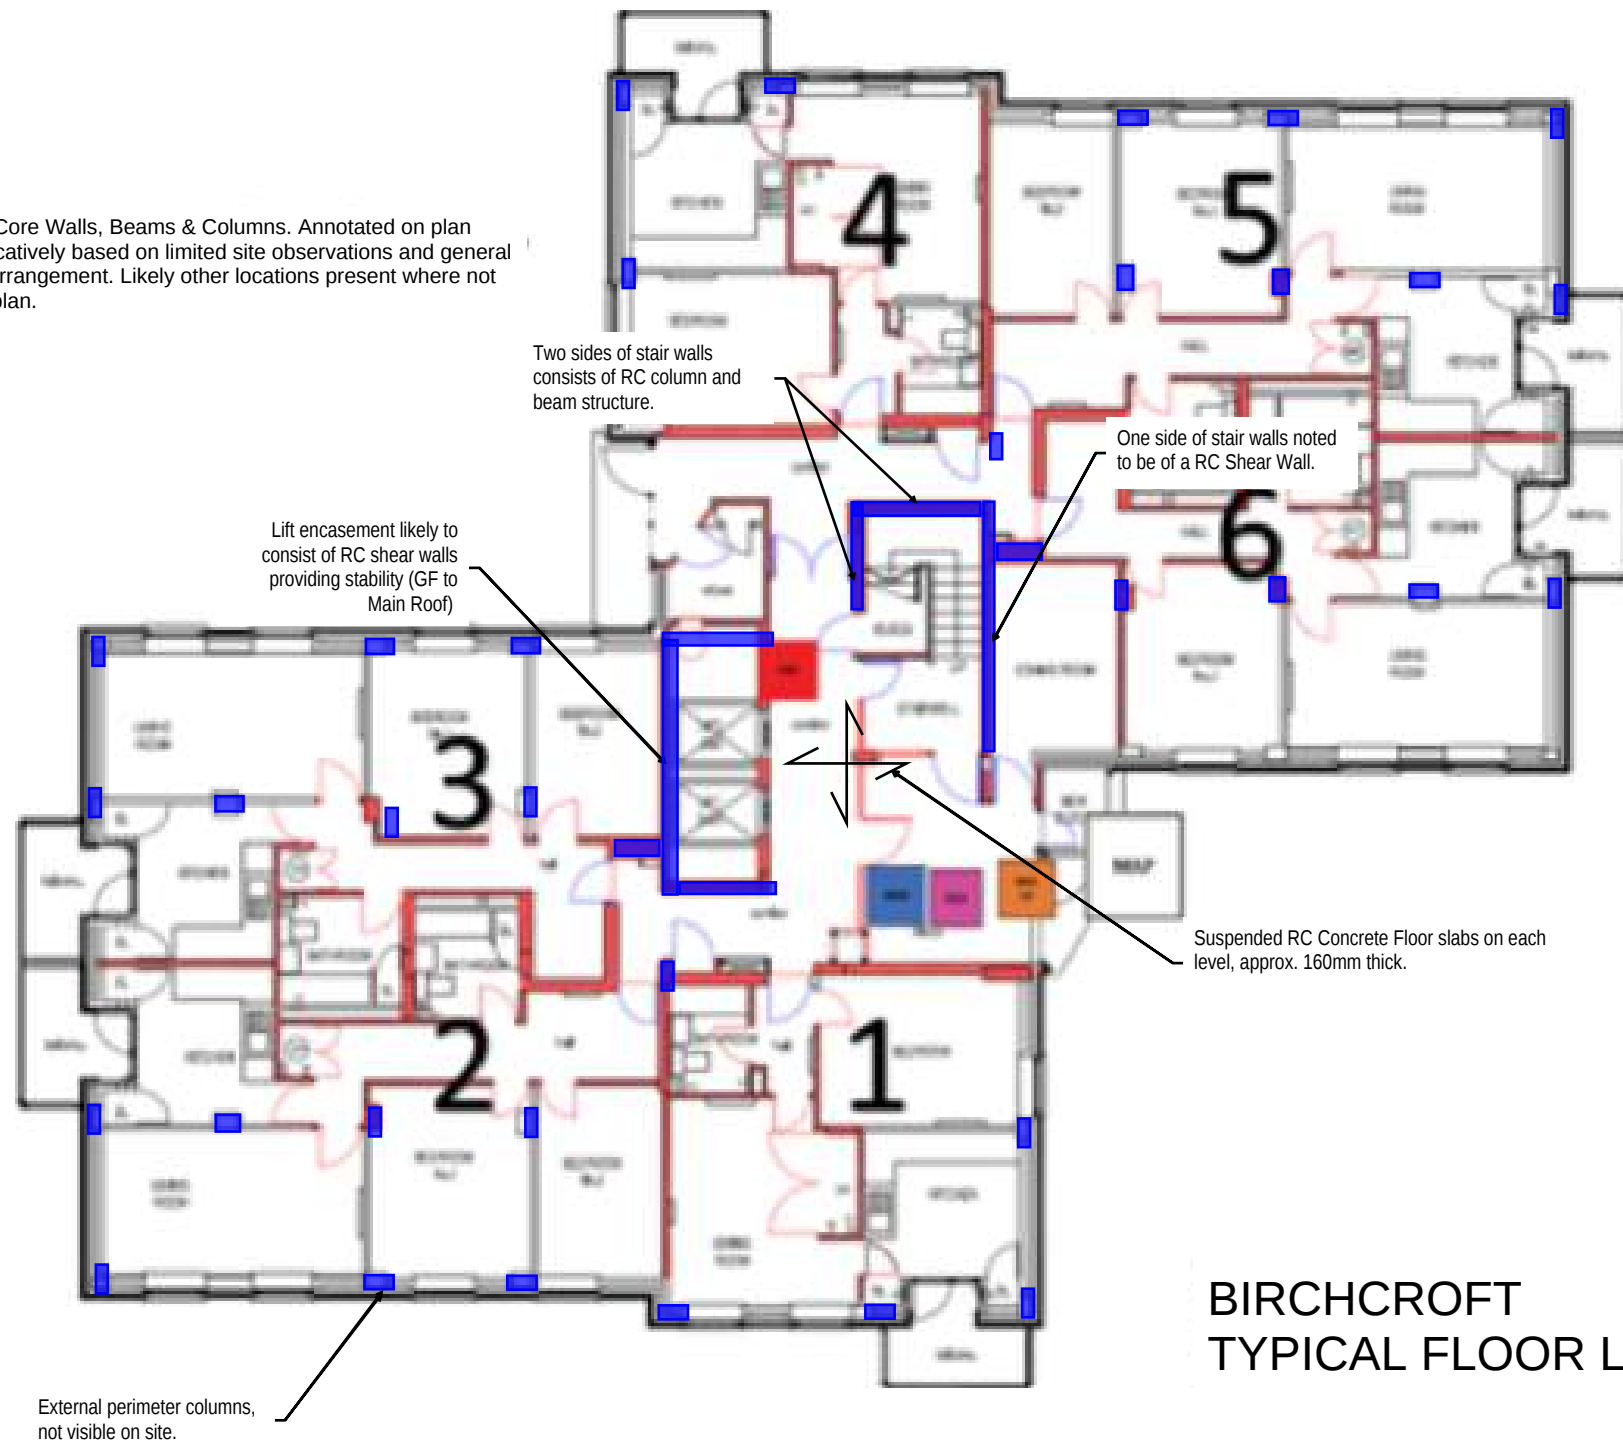
BIRCHCROFT  
TYPICAL FLOOR LAYOUT

— RC Shear/Core Walls, Beams & Columns. Annotated on plan shown indicatively based on limited site observations and general floor plan arrangement. Likely other locations present where not shown on plan.
