**FIRNTEC**  
BUILDING COMPLIANCE

VISUAL STRUCTURAL APPRAISAL

Boulton House  
Spoon Lane  
Tipton  
B70 6BJ

24<sup>th</sup> June 2025

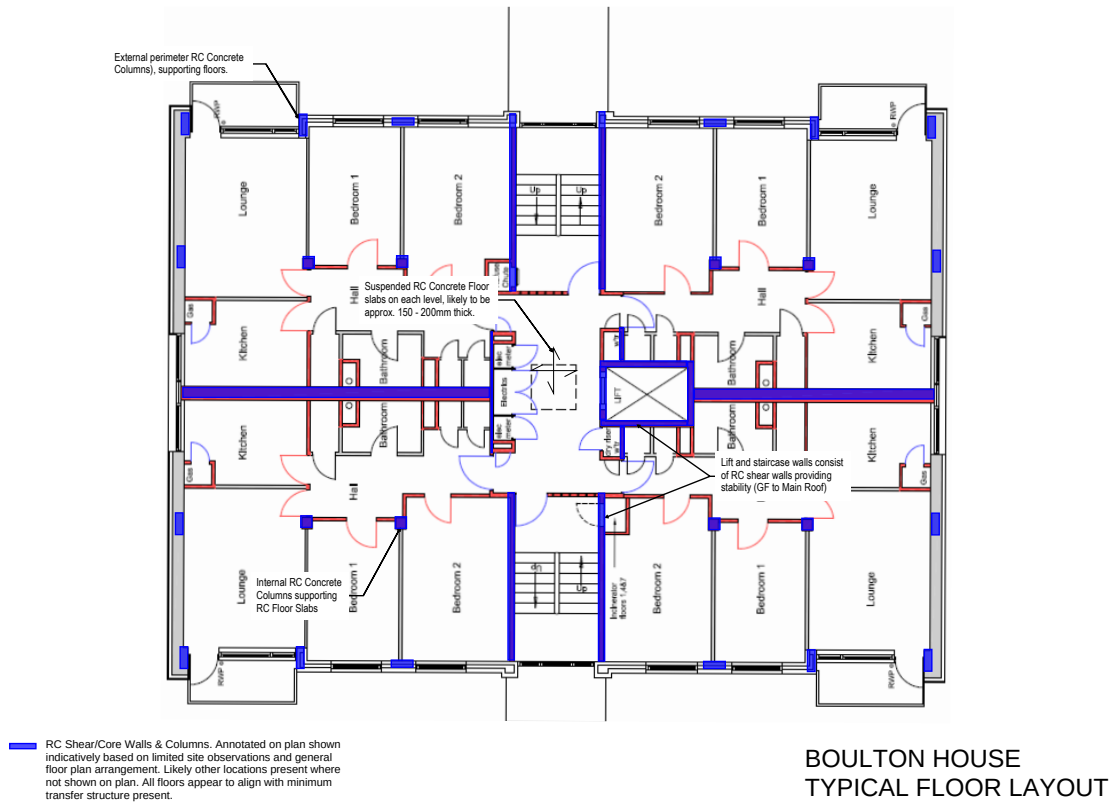
Figure 6: Diagram of typical floor plan

There were vertical concrete walls supporting the floor plates at every level. The elements visible matched the floor layout in Figure 6. The walls appear continuous from ground to roof with no transfer structure. The overall condition of the structure observed is good.
