VISUAL STRUCTURAL APPRAISAL

Braybrooke House

Moor Lane  
West Bromwich  
B70 7AW

19<sup>th</sup> December 2024

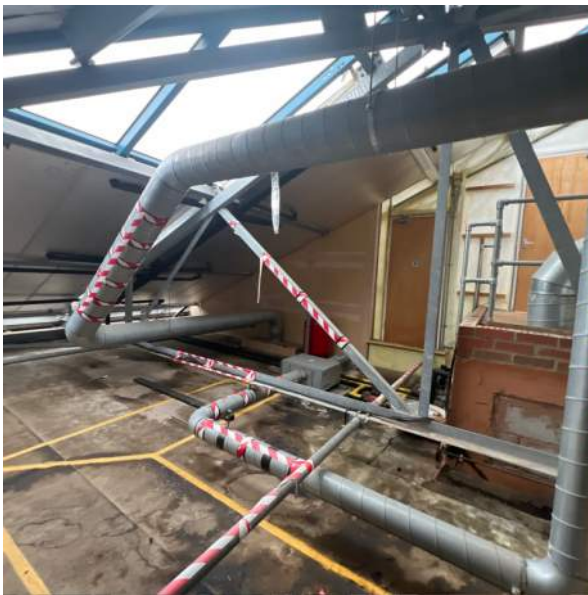
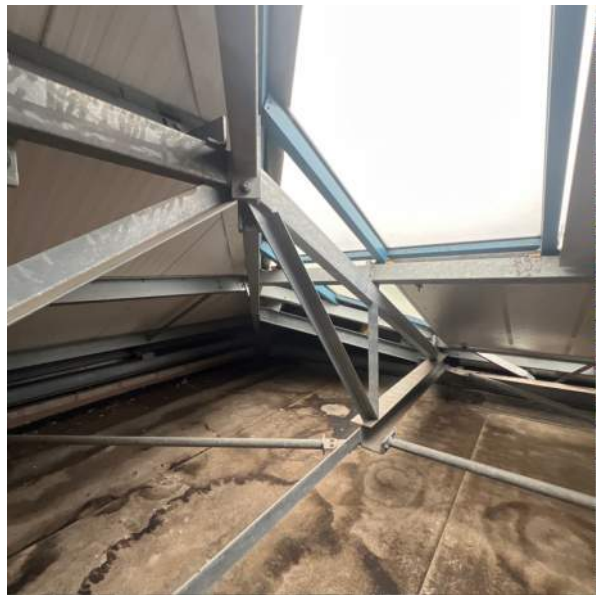
## Main Roof

Comments: A lightweight pitched roof was constructed during the refurbishment utilising beams and purlins with aluminium standing / mineral wool core profiled panels.

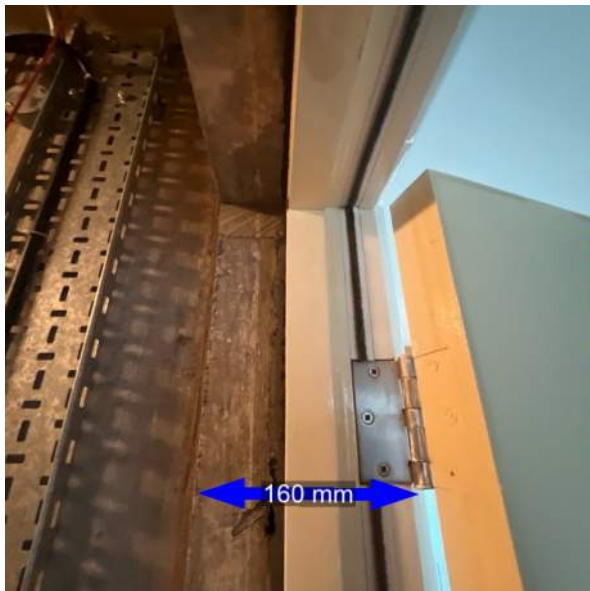
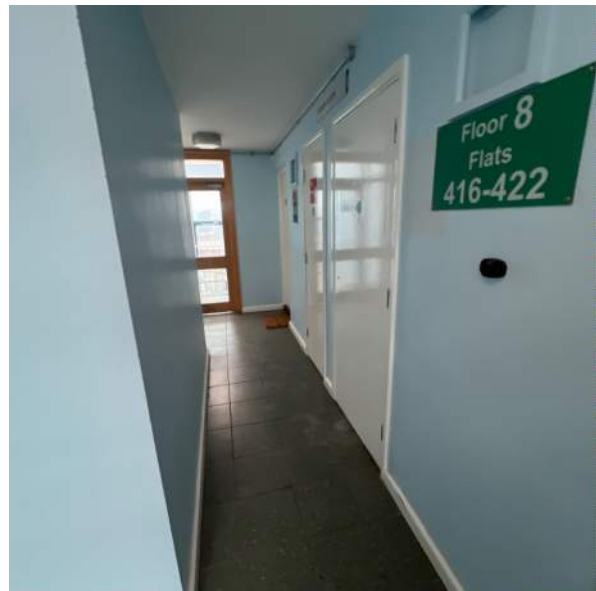
## 8th Floor Hallway

Comments: No jams or distortions noted to hallway doors to indicate any serviceability issues. Generally walls covered with finishes in hallway, likely to consist a mixture of concrete shear walls, embedded columns and masonry infill walls. Limited structure exposed. Concrete walls noted via riser cupboard and lift motor room.

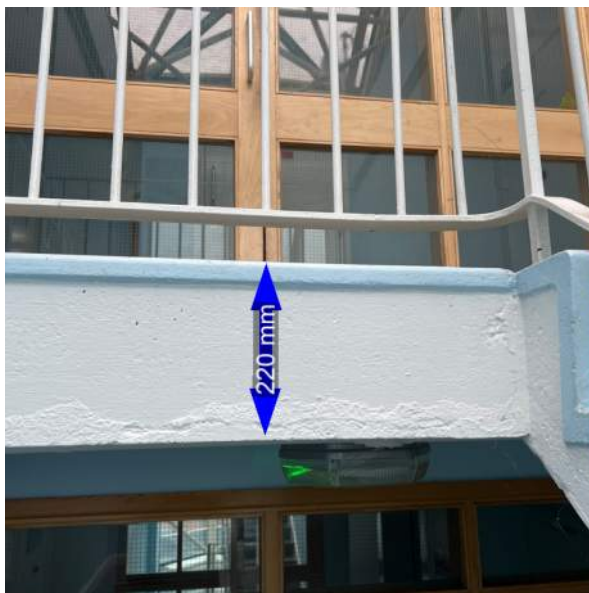
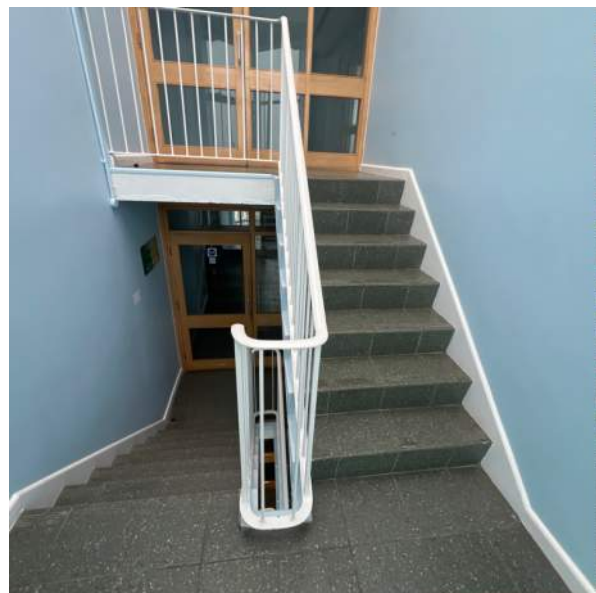
## 8th Floor Staircases

Comments: Insitu concrete stairs with steel hand railing fixed to stairs. Walls and floors appear to be fairly level.  
Stair walls covered with finishes however these would likely form the main concrete shear core walls.

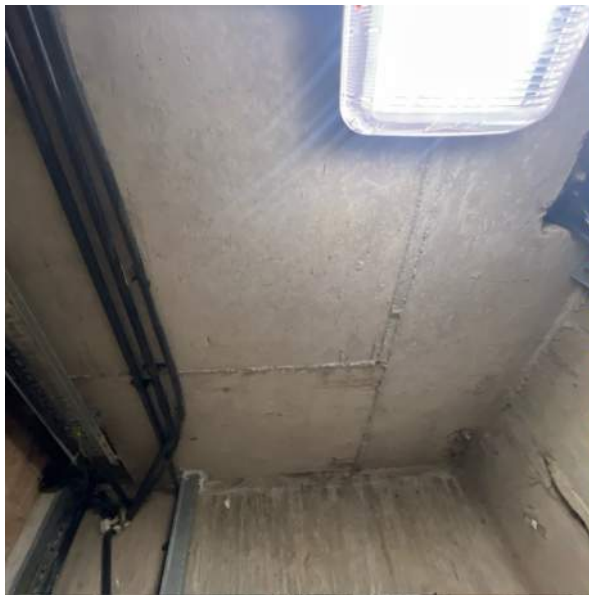
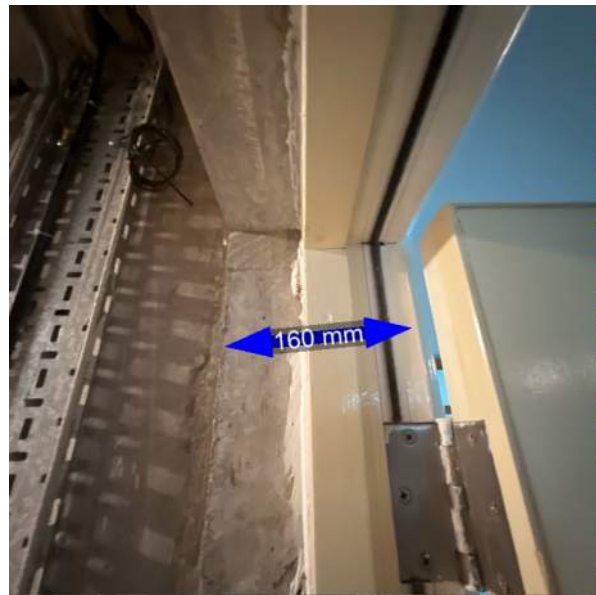
## 5th Floor Hallway

Comments: No jams or distortions noted to hallway doors to indicate any serviceability issues. Generally walls covered with finishes in hallway, likely to consist a mixture of concrete shear walls, embedded columns and masonry infill walls. Limited structure exposed. Concrete walls noted via riser cupboard. Lift walls appear to be solid concrete walls.

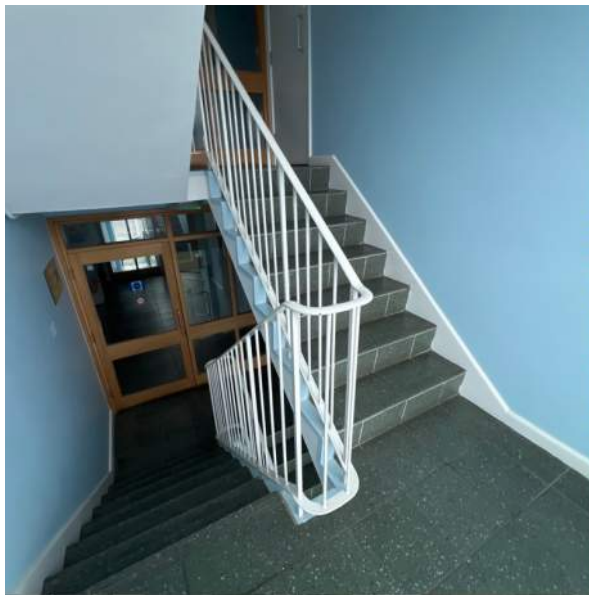
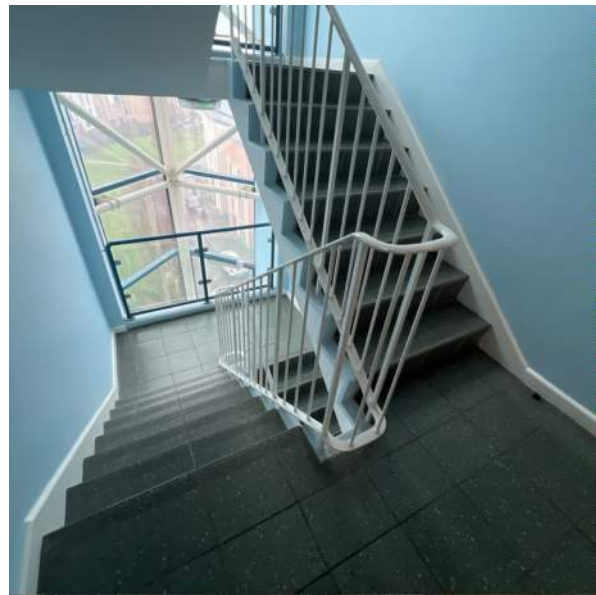
## 5th Floor Staircases

Insitu concrete stairs with steel hand railing fixed to stairs. Walls and floors appear to be fairly level.  
Stair walls covered with finishes however these would likely form the main concrete shear core walls.

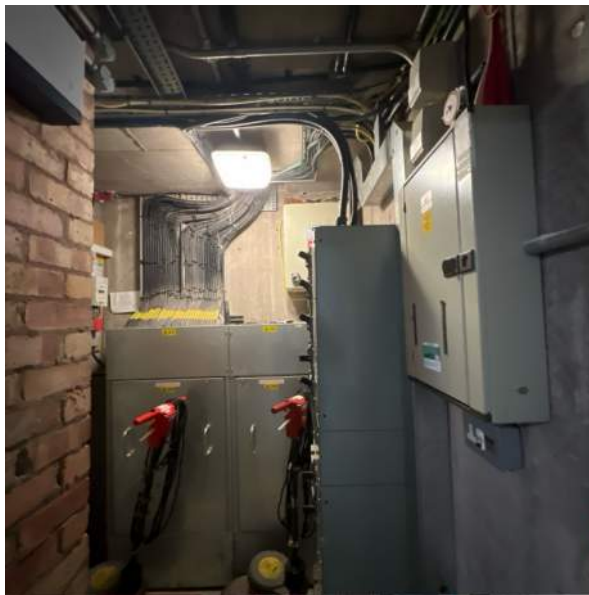
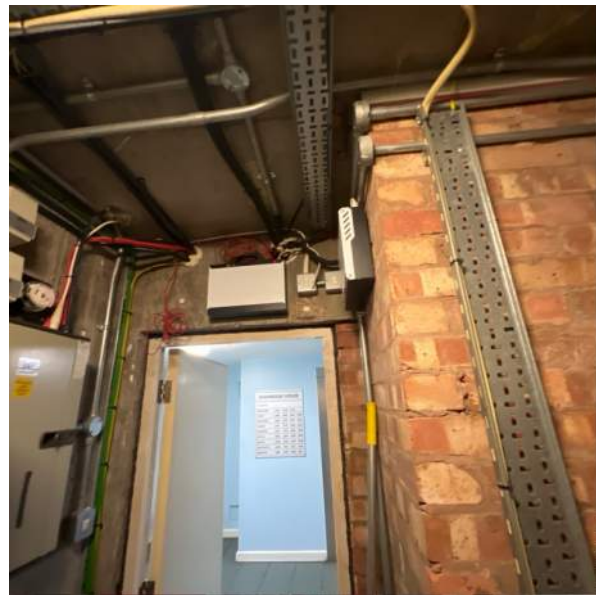
## Ground Floor Hallway

Comments: No jams or distortions noted to hallway doors to indicate any serviceability issues. Generally walls covered with finishes in hallway, likely to consist a mixture of concrete shear walls, embedded columns and block infill walls. Limited structure exposed. Partly visible concrete walls noted via electrical riser cupboard. RC columns noted in communal areas and community room.

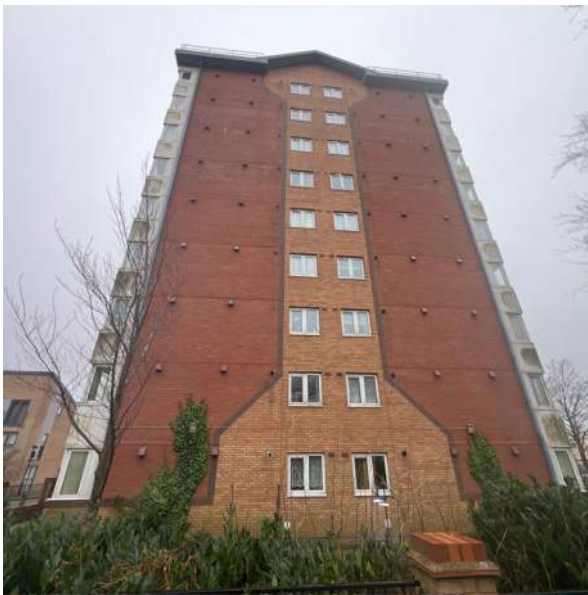
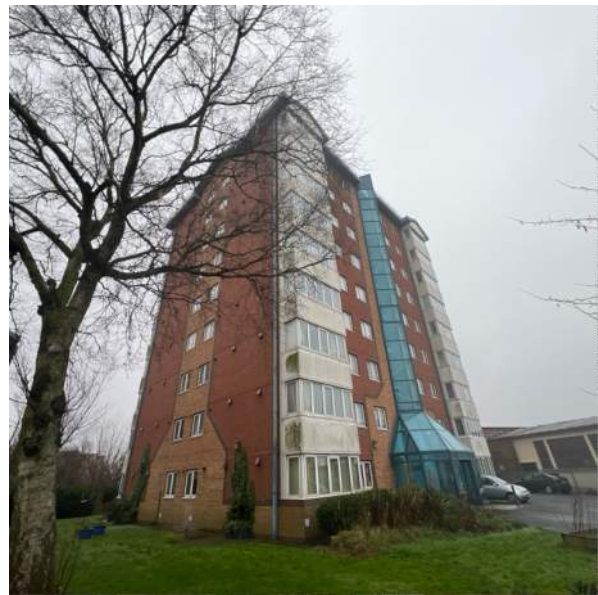
External facade consist of mainly brickwork. Balconies cladded with aluminium facade.
