VISUAL STRUCTURAL APPRAISAL

Broadmead House

Pavillion Avenue  
Smethwick  
B67 6LB

19<sup>th</sup> December 2024

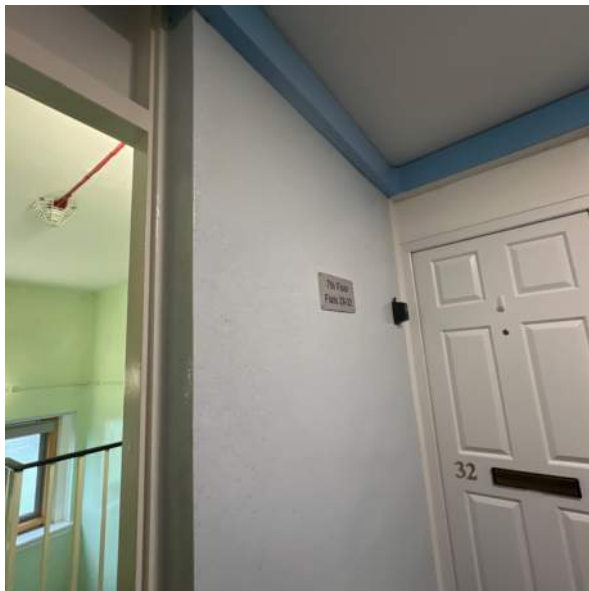
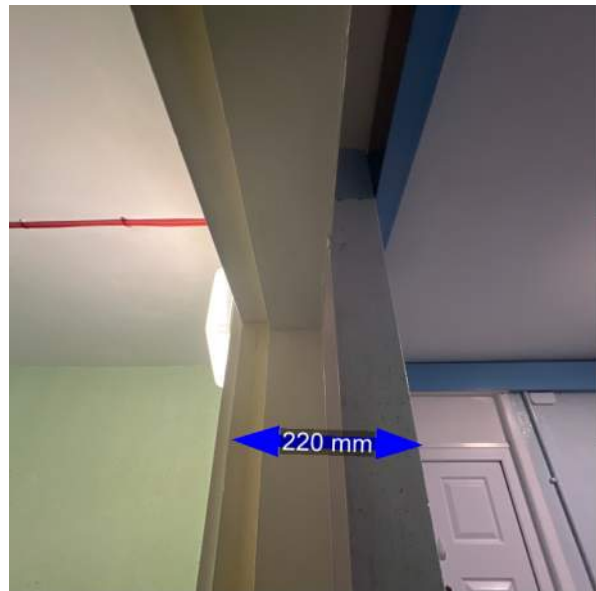
Comments: No jams or distortions noted to hallway doors to indicate any serviceability issues. Generally walls covered with finishes in hallway, appear to consist of concrete shear walls. Concrete walls noted via electrical riser cupboards but covered with finishes. Likely some infill non-load bearing masonry walls present. Concrete wall between hallway and staircase measured to be approx. 220mm thick.

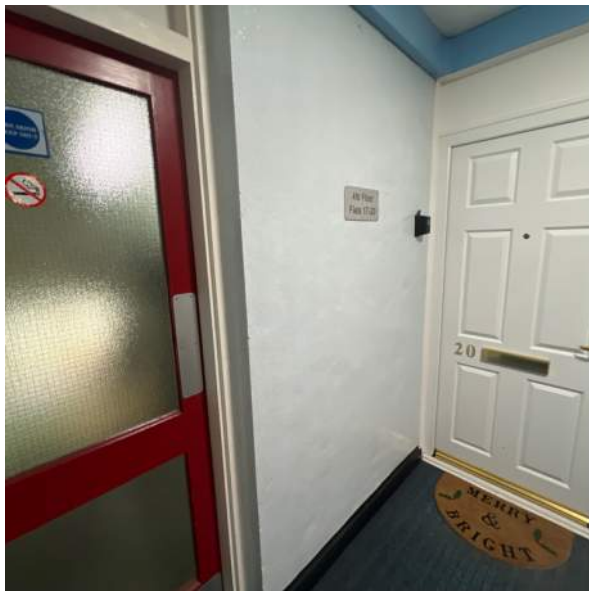
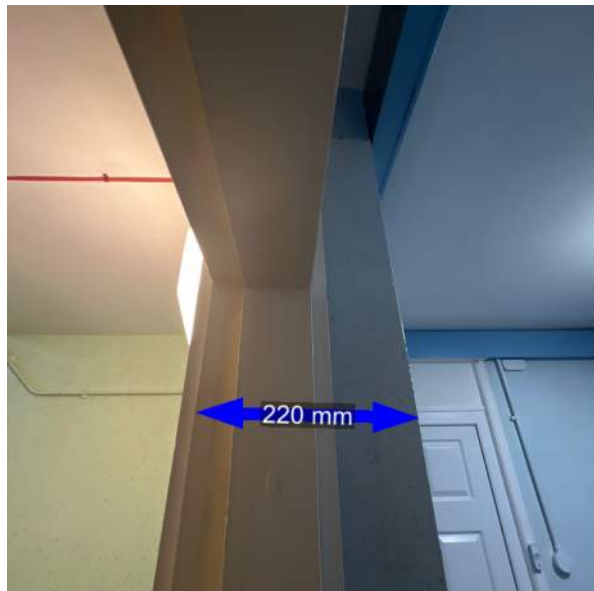
Comments: No jams or distortions noted to hallway doors to indicate any serviceability issues. Generally walls covered with finishes in hallway, appear to consist of concrete shear walls. Concrete walls noted via electrical riser cupboards but covered with finishes. Likely some infill non-load bearing masonry walls present. Concrete wall between hallway and staircase measured to be approx. 220mm thick.

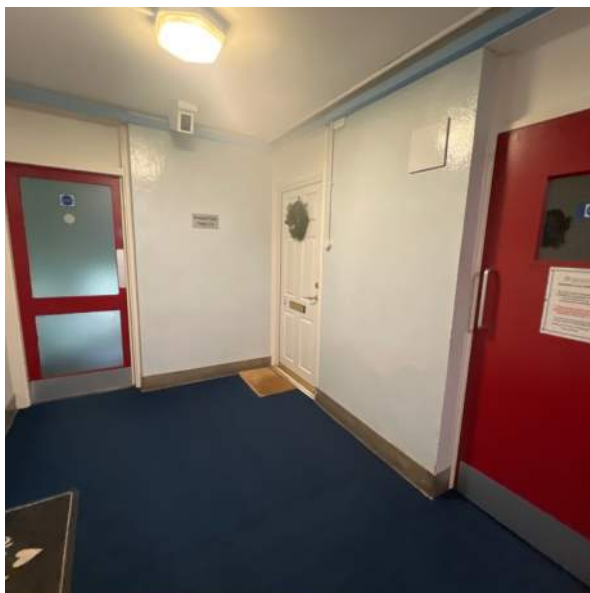
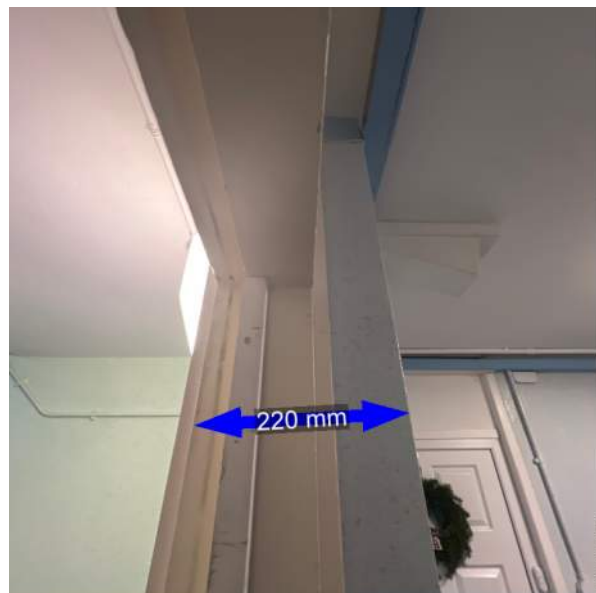
## Ground Floor Hallway

No jams or distortions noted to hallway doors to indicate any serviceability issues. Generally walls covered with finishes in hallway, appear to consist of concrete shear walls. Concrete walls noted via electrical riser cupboards but covered with finishes. Likely some infill non-load bearing masonry walls present. Concrete wall between hallway and staircase measured to be approx. 220mm thick.

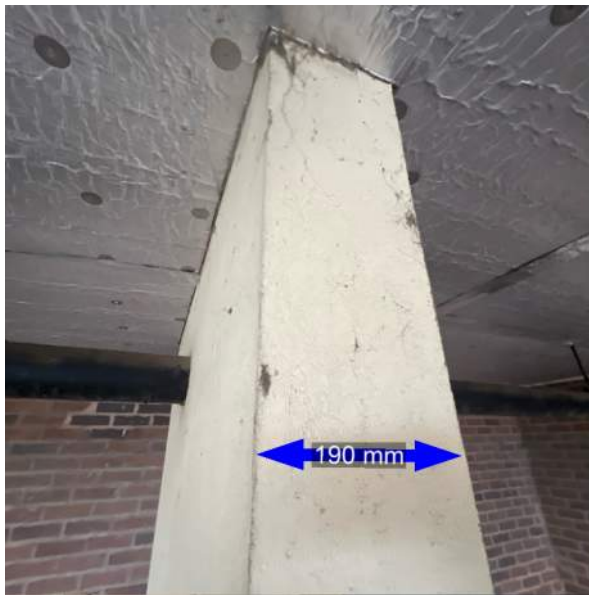
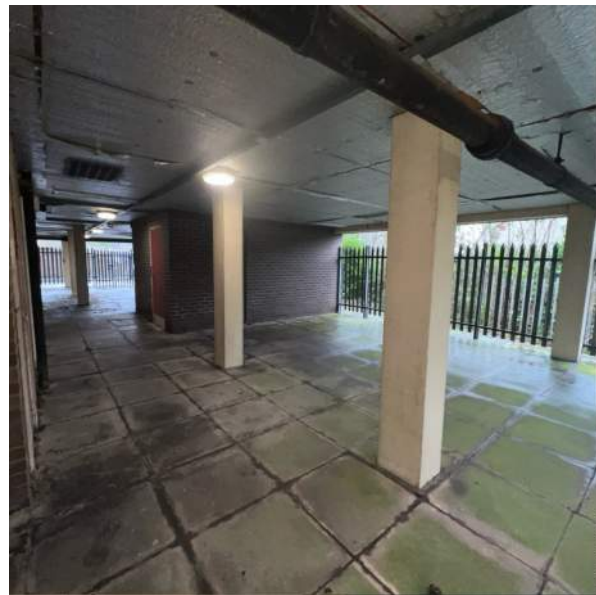
Comments: Mixture of RC Shear Walls, RC Columns and Infill non-load bearing masonry walls noted. Appears to be a transfer structure supporting the floors above.

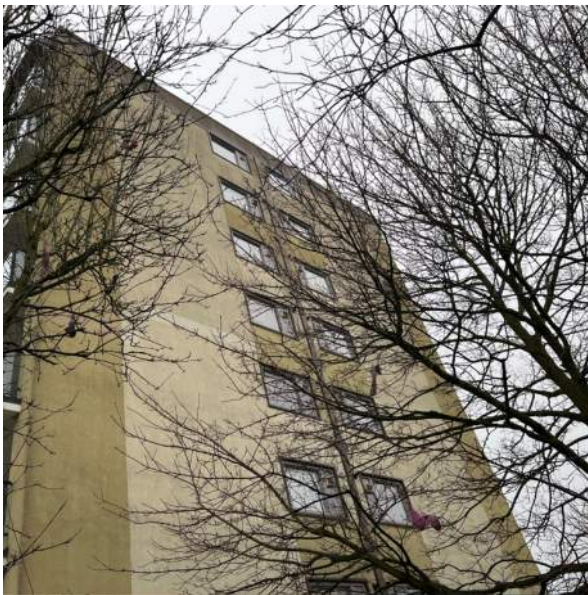
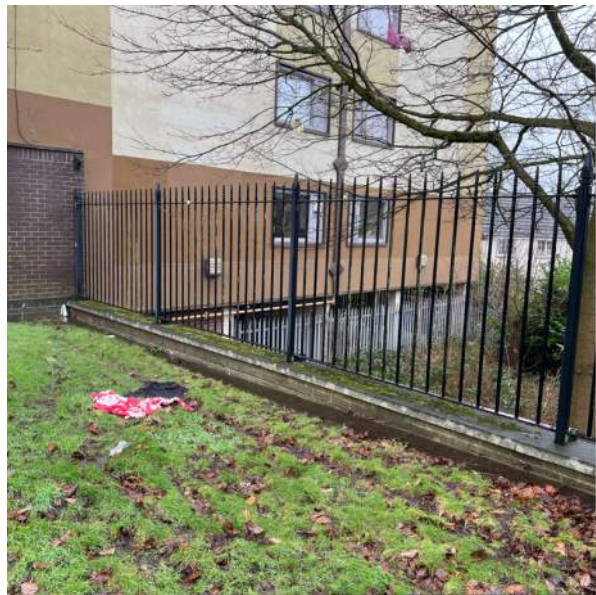
## Elevations

External facade consists of brickwork to ground floor and rendered facade to all upper floors. Cantilevered balconies noted to each level.
