VISUAL STRUCTURAL APPRAISAL

Brookview

Stanhope Road  
Smethwick  
B67 6HG

26<sup>th</sup> November 2024

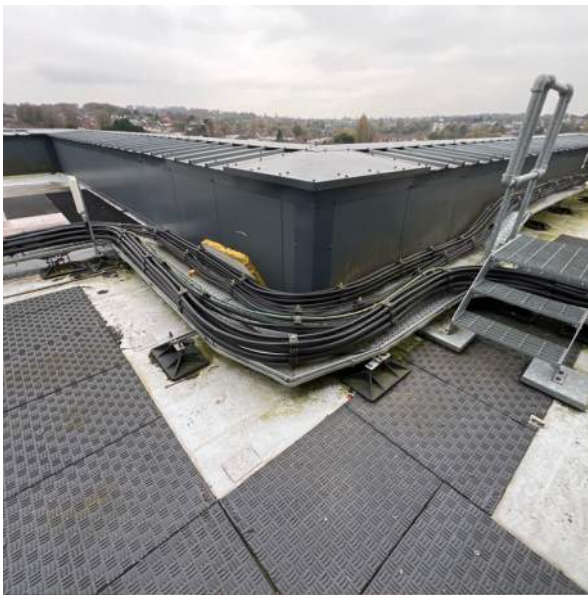
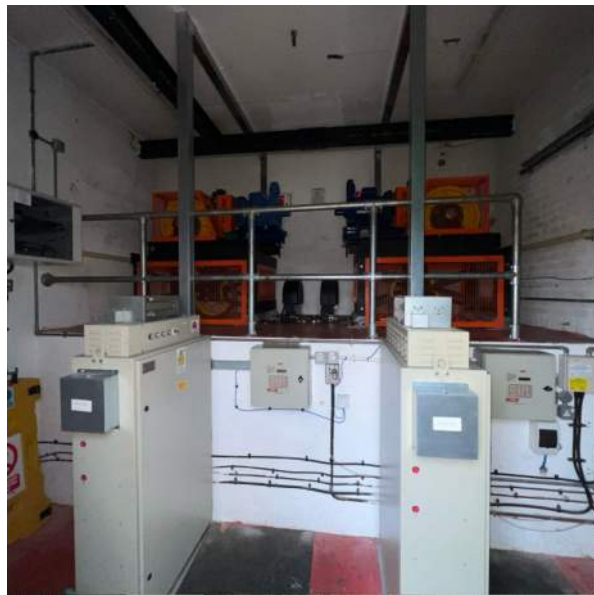
## Main Roof

Comments: Flat roof with parapet walls. RC concrete slab with insulation and roof coverings. Telecommunications equipment installed on the main roof.

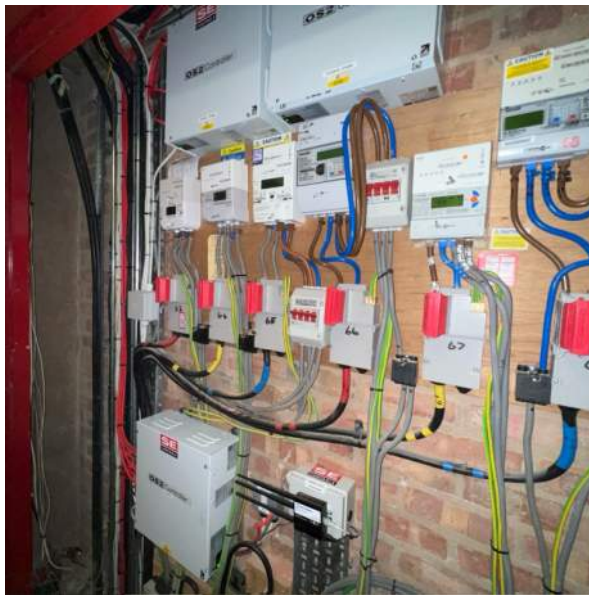
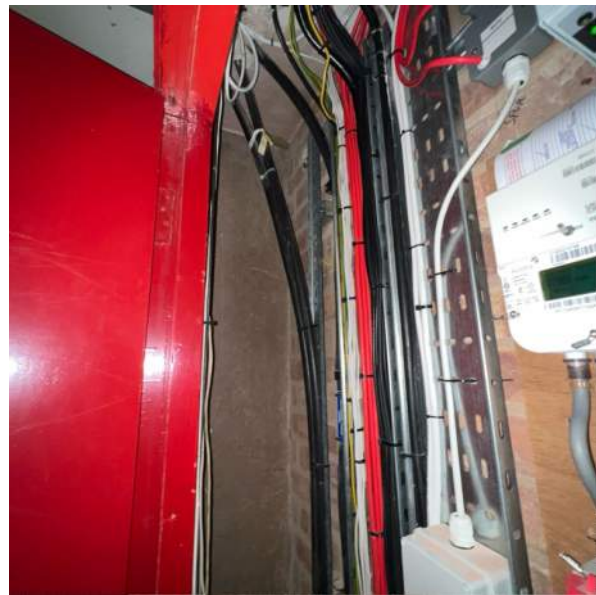
## 11th Floor Hallway

Comments: No jams or distortions noted to hallway doors to indicate any serviceability issues. Generally walls covered with finishes in hallway, likely to consist a mixture of concrete shear walls and embedded columns with internal partition walls. Riser cupboard shows infill masonry walls with a partially exposed concrete element likely an RC Column.

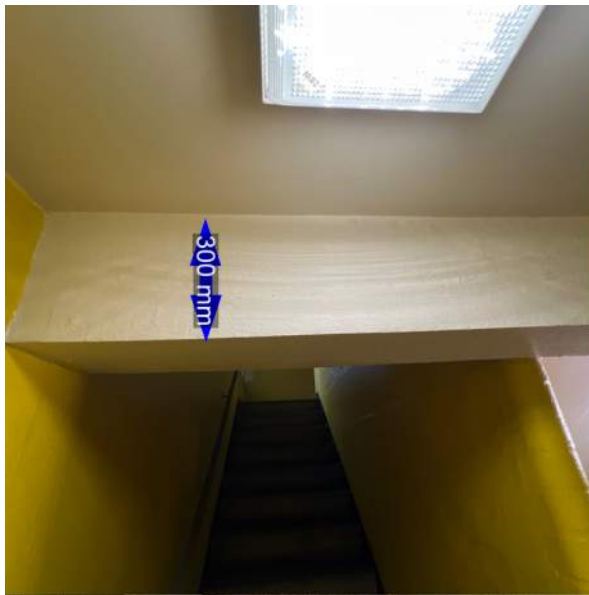
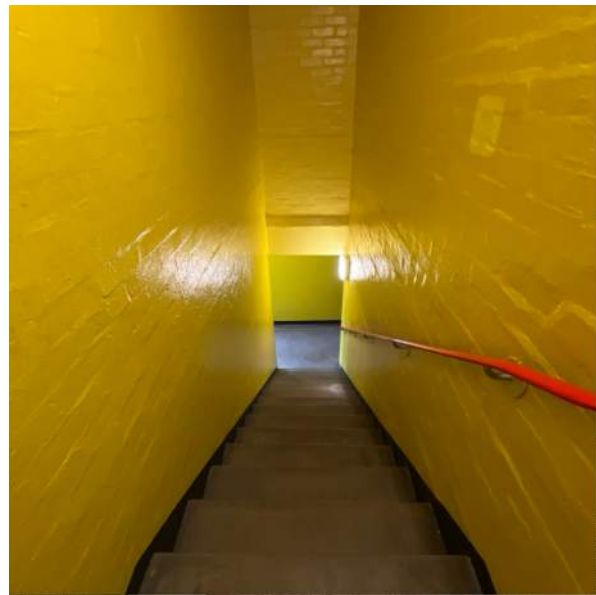
## 11th Floor Staircase

Insitu concrete stairs with steel hand railing fixed to stair walls.  
Walls and floors appear to be fairly level.  
Stair walls mainly consist of infill masonry walls (non-load bearing) and embedded RC  
Concrete beams and columns noted. One side of stair wall noted to be a concrete wall  
likely to form a main shear core wall.

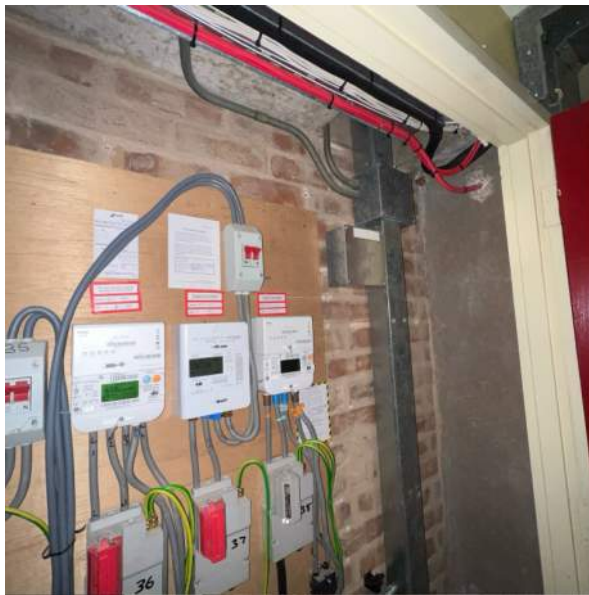
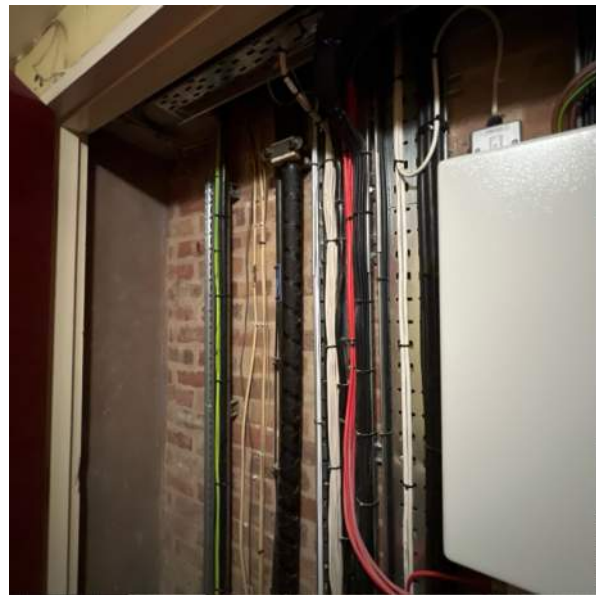
## 6th Floor Hallway

Comments: No jams or distortions noted to hallway doors to indicate any serviceability issues. Generally walls covered with finishes in hallway, likely to consist a mixture of concrete shear walls and embedded columns with internal partition walls. Riser cupboard shows infill masonry walls with a partially exposed concrete element likely an RC Column.

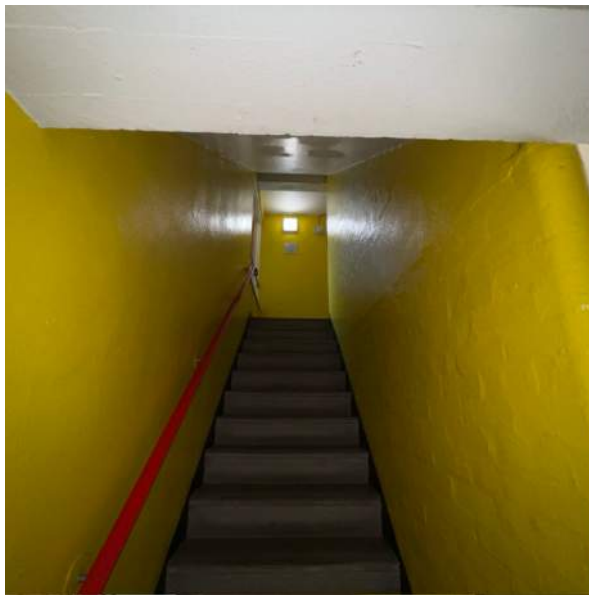
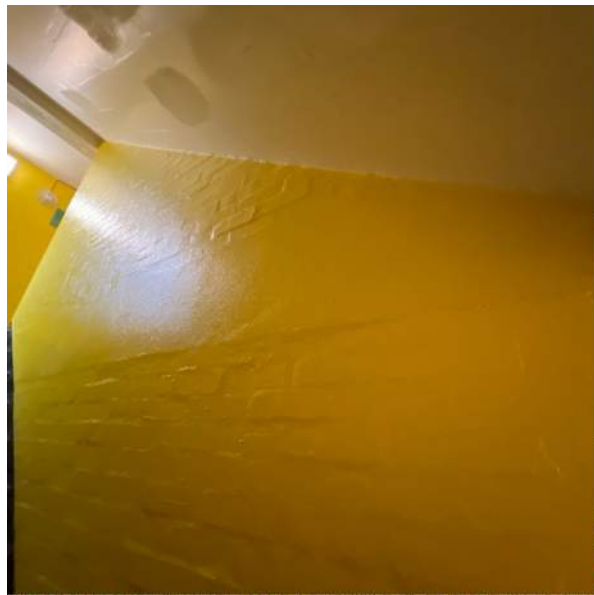
## 6th Floor Staircase

In situ concrete stairs with steel hand railing fixed to stairs. Walls and floors appear to be fairly level.

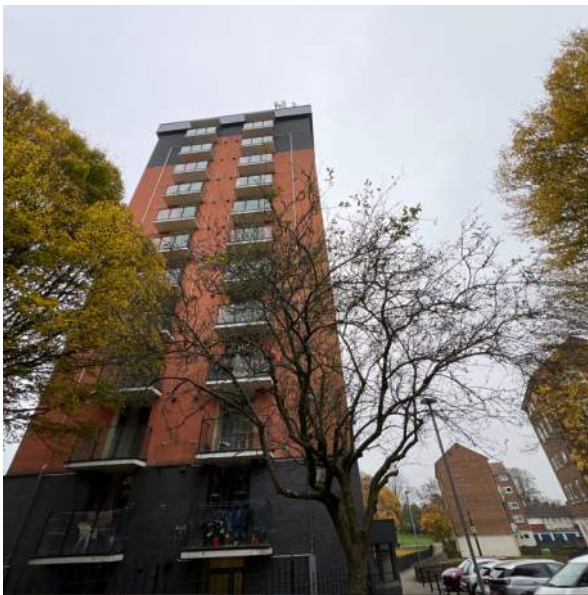
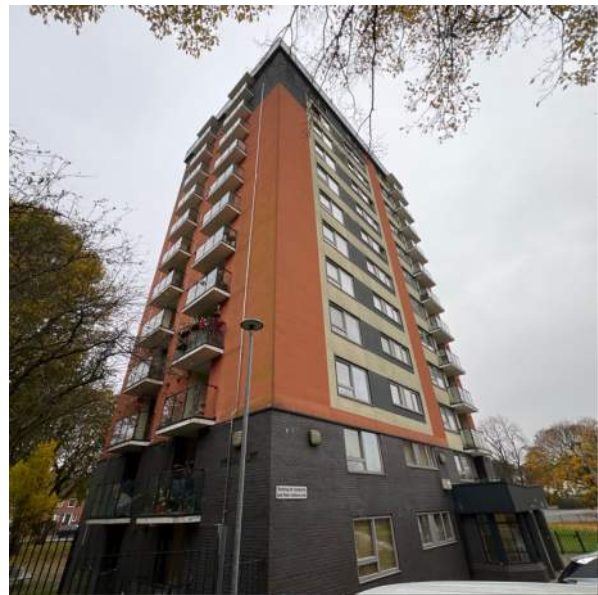
External ground and first level consists of brick work.  
Remaining floors noted to have a cladded facade to exterior.
