VISUAL STRUCTURAL APPRAISAL

Broome House

Beaconview Road  
West Bromwich  
B71 3PN

31<sup>st</sup> January 2025

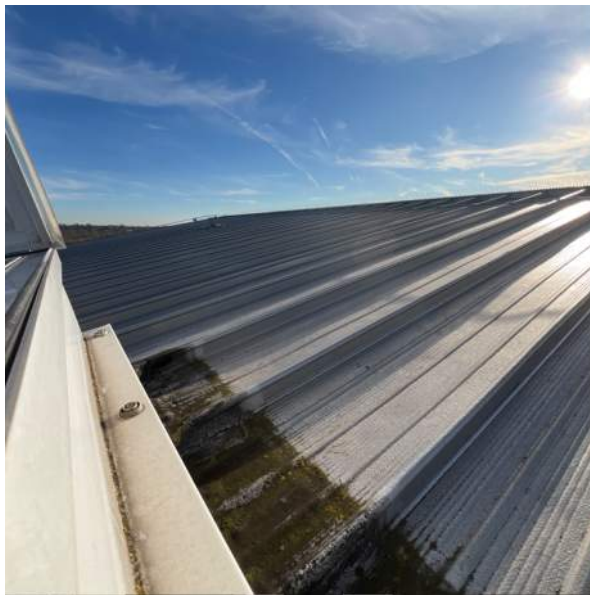
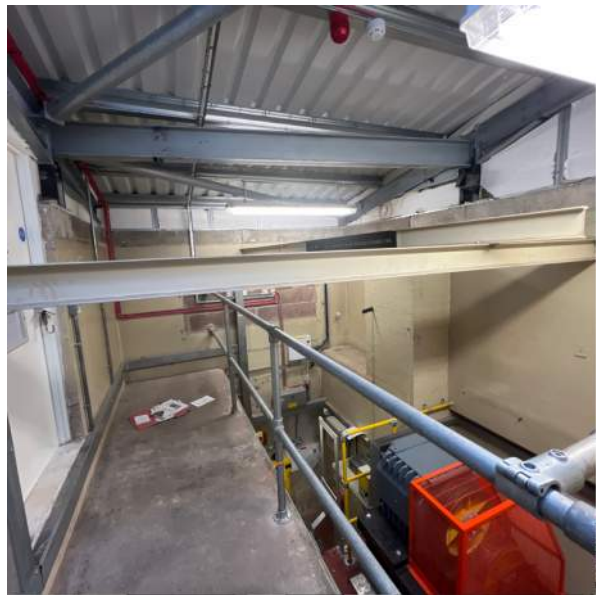
## Main Roof

Comments: A pitched roof constructed above existing original flat roof slab. Steel frame supporting purlins with aluminium standing / mineral wool core profiled panels.  
160mm thick RC core walls noted in motor room.

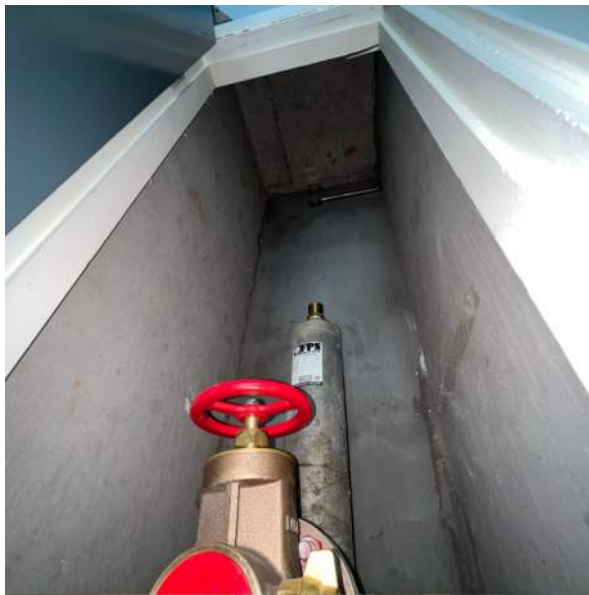
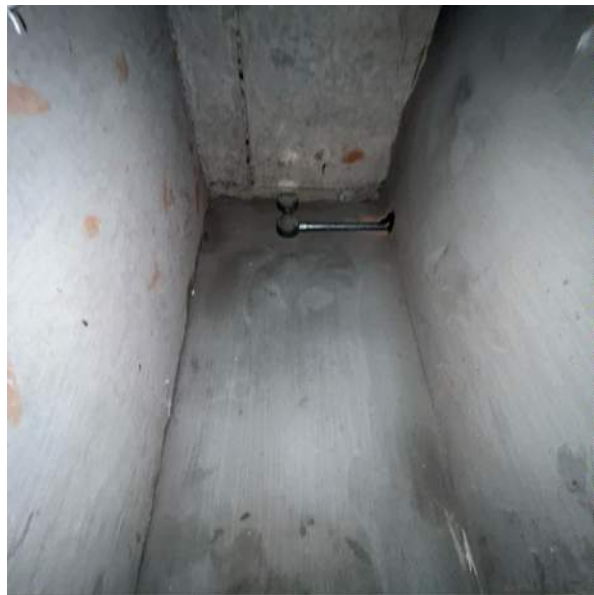
## 8th Floor Hallway

Comments: No jams or distortions noted to hallway doors to indicate any serviceability issues. Generally walls covered with finishes in hallway, likely to consist a mixture of concrete shear walls, embedded columns and masonry infill walls. Limited structure exposed. Concrete walls noted via riser cupboards.

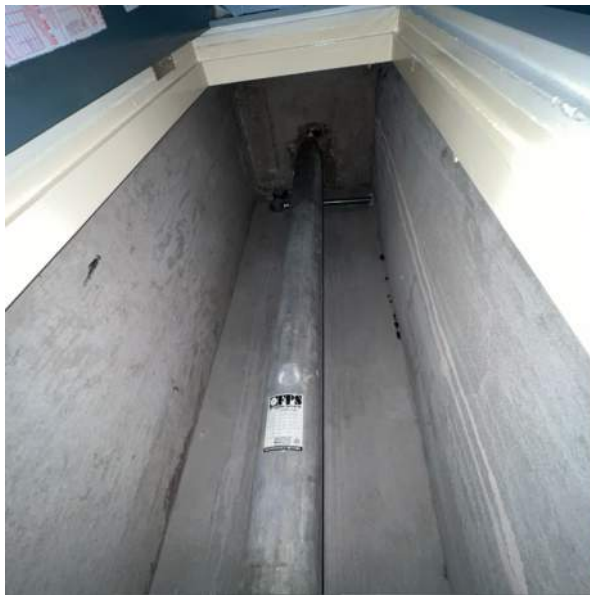
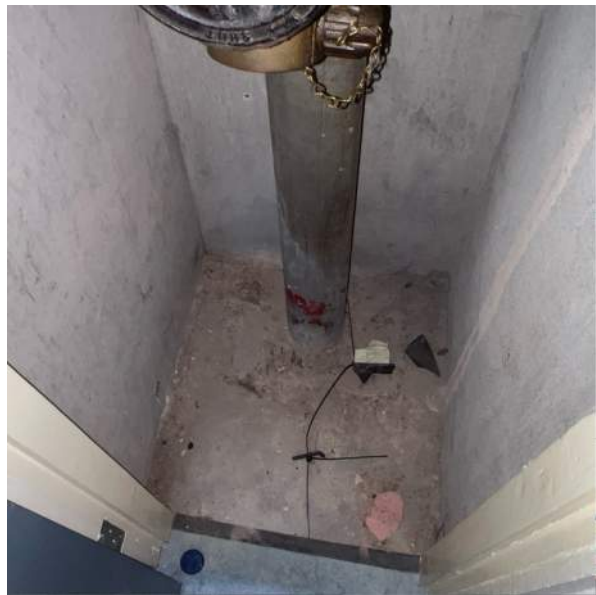
## 5th Floor Hallway

Comments: No jams or distortions noted to hallway doors to indicate any serviceability issues. Generally walls covered with finishes in hallway, likely to consist a mixture of concrete shear walls, embedded columns and masonry infill walls. Limited structure exposed. Concrete walls noted via riser cupboards.

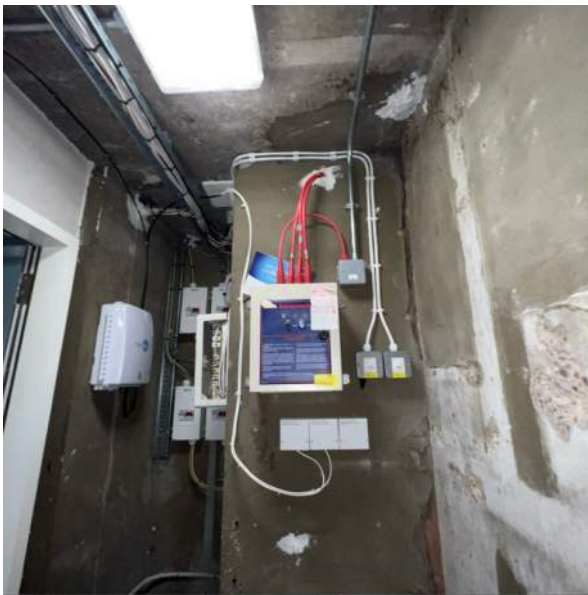
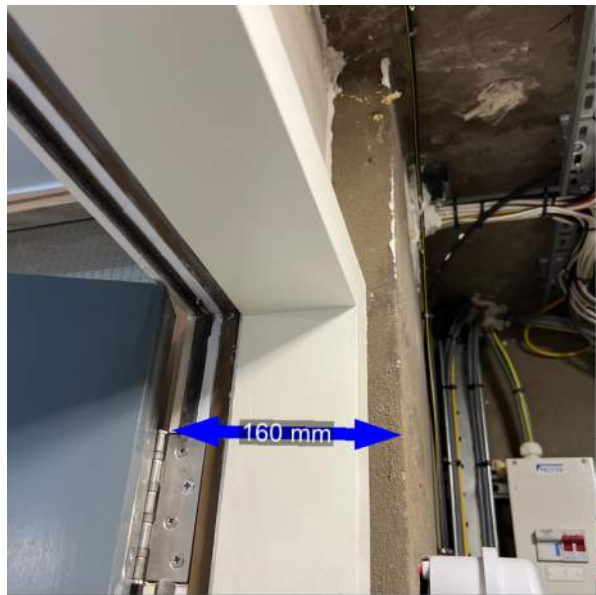
## Ground Floor Hallway

Comments: No jams or distortions noted to hallway doors to indicate any serviceability issues. Generally walls covered with finishes in hallway, likely to consist a mixture of concrete shear walls, embedded columns and block infill walls. Limited structure exposed. Partly visible concrete walls noted via electrical riser cupboards.

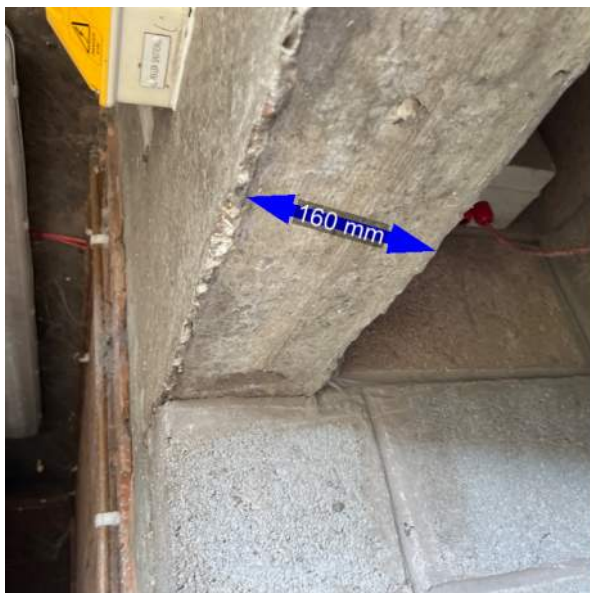
## Binstore

RC shear walls noted in binstore.

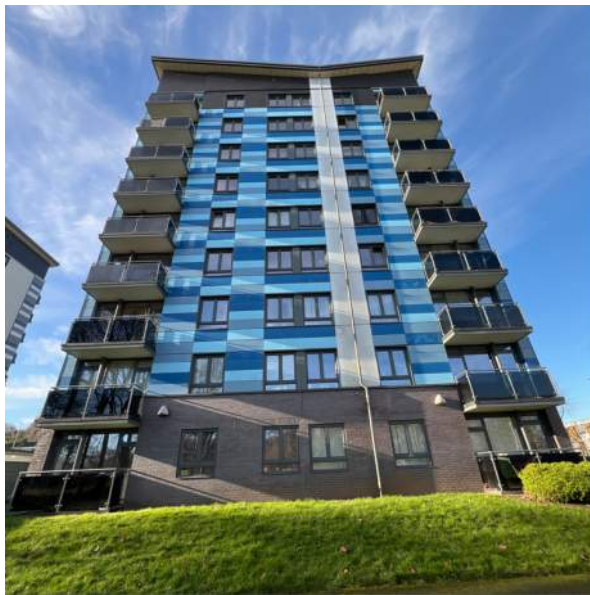
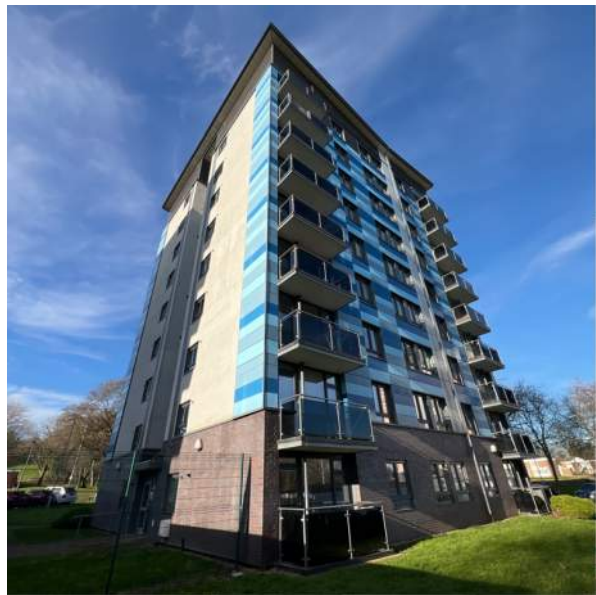
Ground floor level consists of brickwork. Remaining elevations consist of a mixture of rendered and cladded facade.

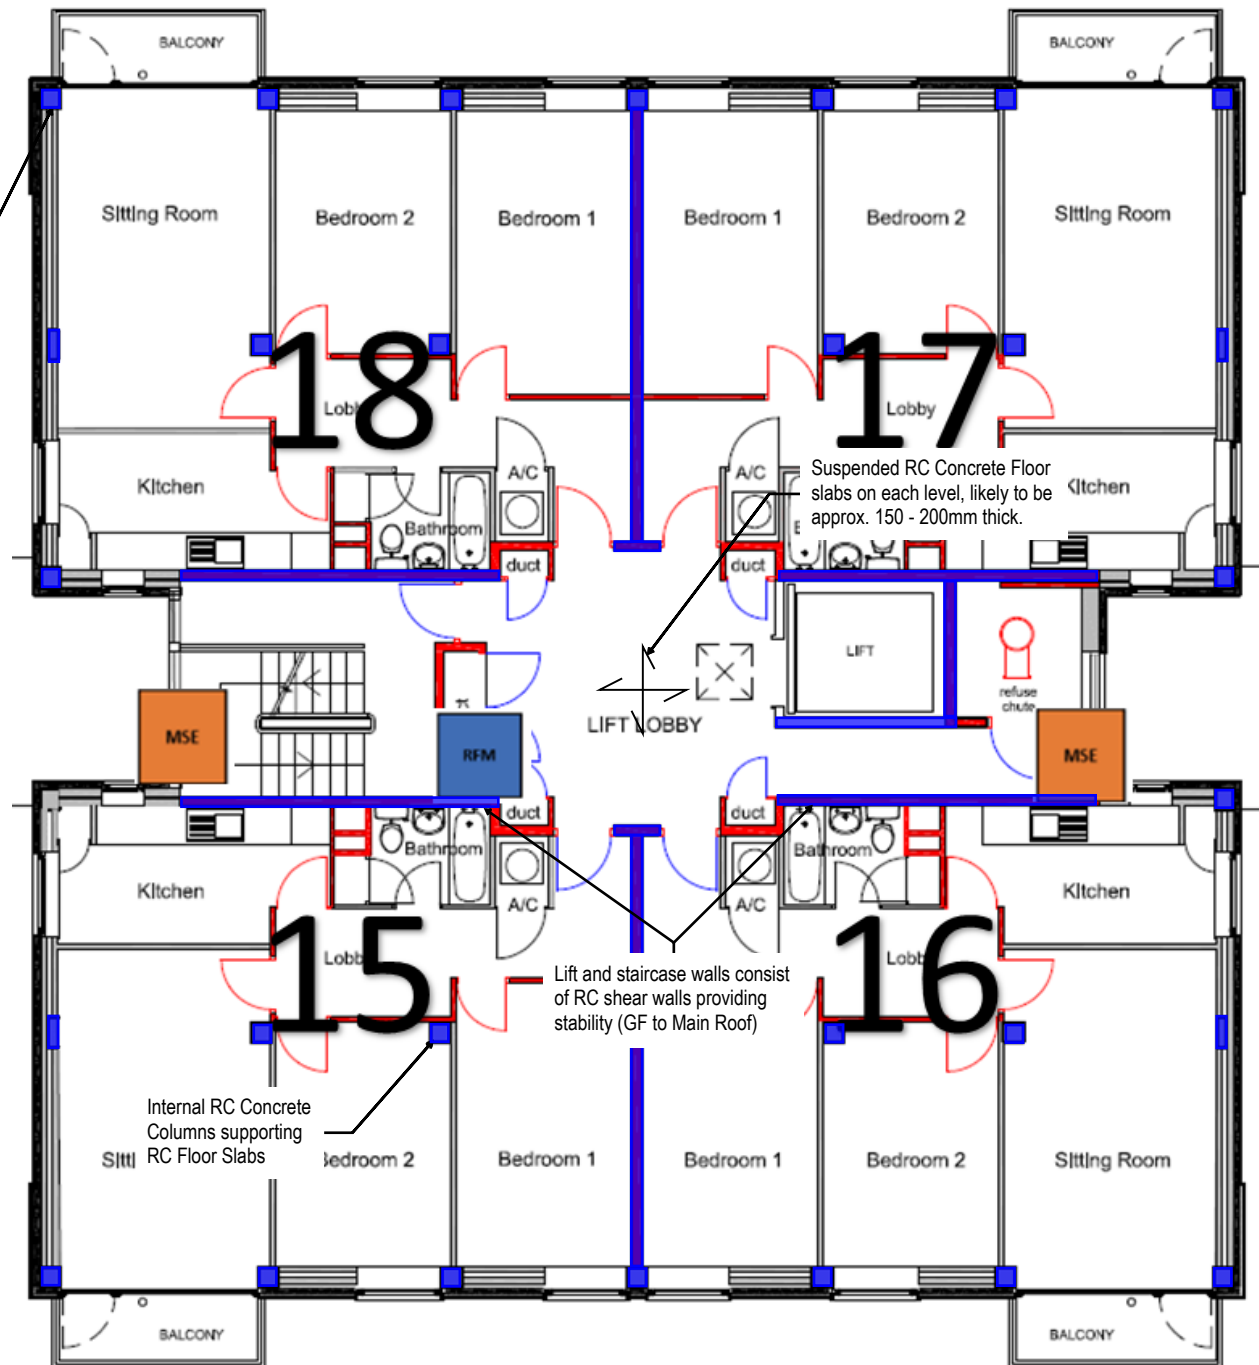
External perimeter RC Concrete Columns), supporting floors.

Lift and staircase walls consist of RC shear walls providing stability (GF to Main Roof)

Suspended RC Concrete Floor slabs on each level, likely to be approx. 150 - 200mm thick.
