**FIRNTEC**  
BUILDING COMPLIANCE

VISUAL STRUCTURAL APPRAISAL

1-90 Elmcroft

Windmill Lane  
Smethwick  
B66 3LN

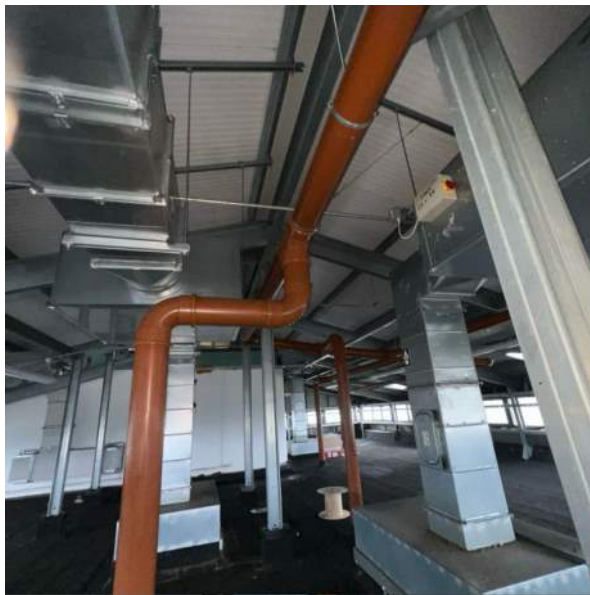
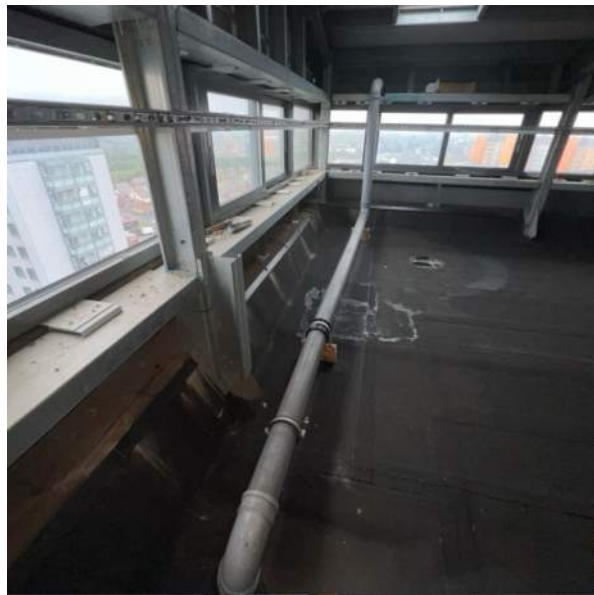
## Main Roof

Comments: Roof structure is formed of a concrete slab with a Lightweight SFS (appear to be cold rolled) frame with a pitched roof fixed on to main roof structure. Frame columns fixed to perimeter of roof.  
Some historical staining to roof coverings noted, potential leaks in pitched roof coverings.

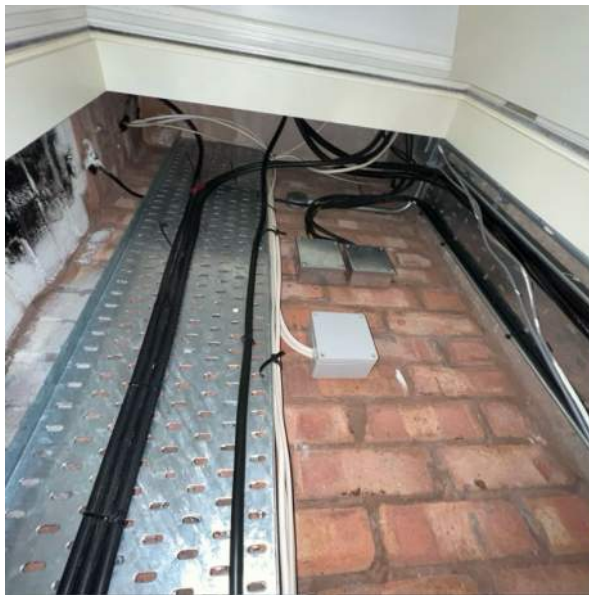
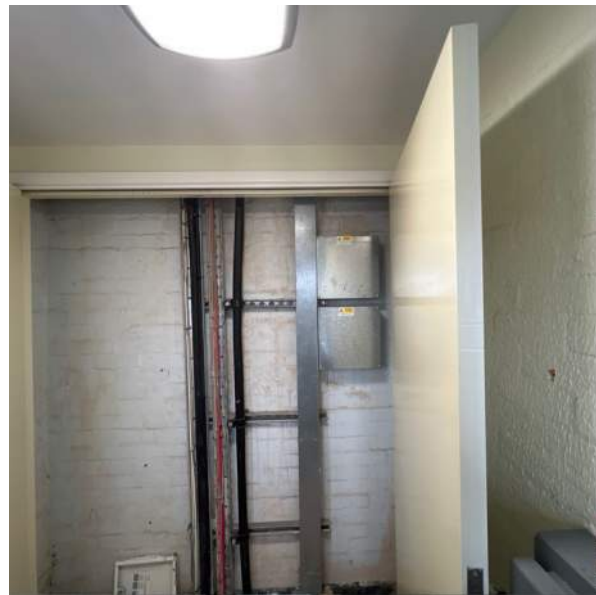
## 14th Floor Hallway

Comments: No jams or distortions noted to hallway doors to indicate any serviceability issues. Generally walls covered with finishes in hallway, likely to consist a mixture of concrete shear walls and embedded columns with internal partition walls. Riser cupboard shows infill masonry walls with partially exposed concrete elements which appears RC Columns.

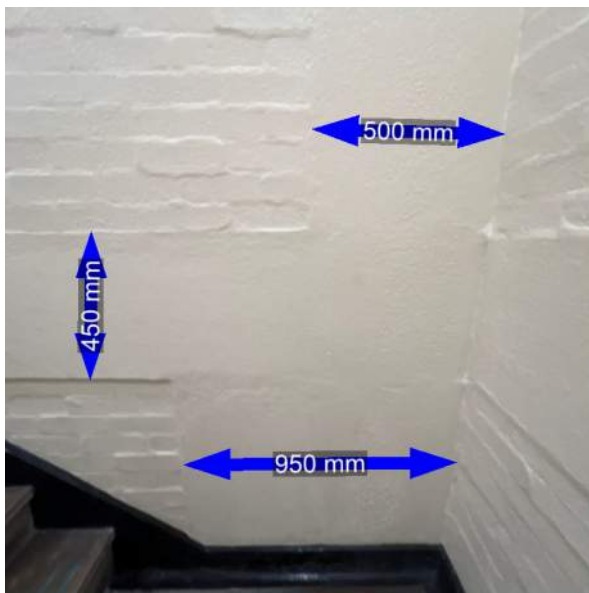
## 14th Floor Staircase

Comments:

Insitu concrete stairs with steel hand railing fixed to stairs. Walls and floors appear to be fairly level.

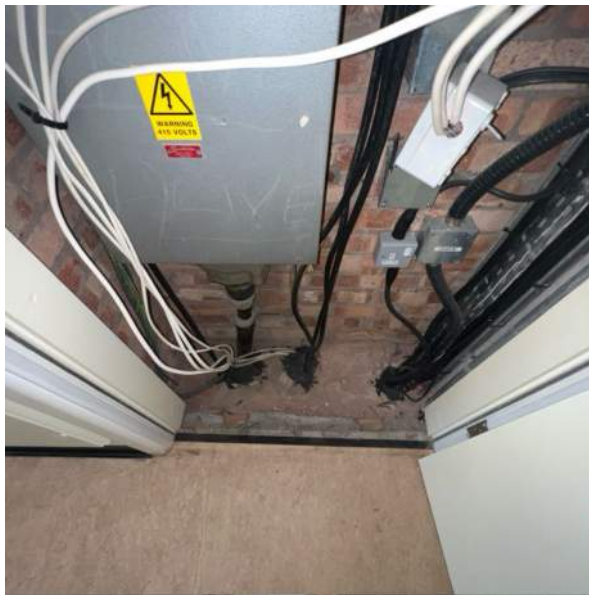
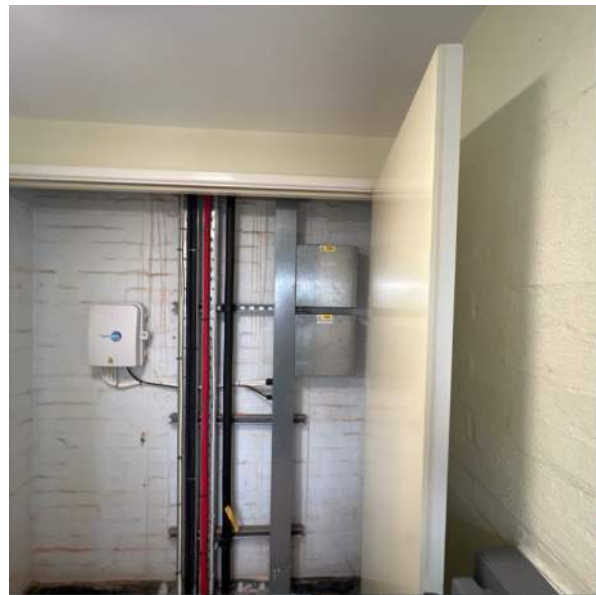
## 8th Floor Hallway

Comments: No jams or distortions noted to hallway doors to indicate any serviceability issues. Generally walls covered with finishes in hallway, likely to consist a mixture of concrete shear walls and embedded columns with internal partition walls. Riser cupboard shows infill masonry walls with partially exposed concrete elements appears to be RC Columns.

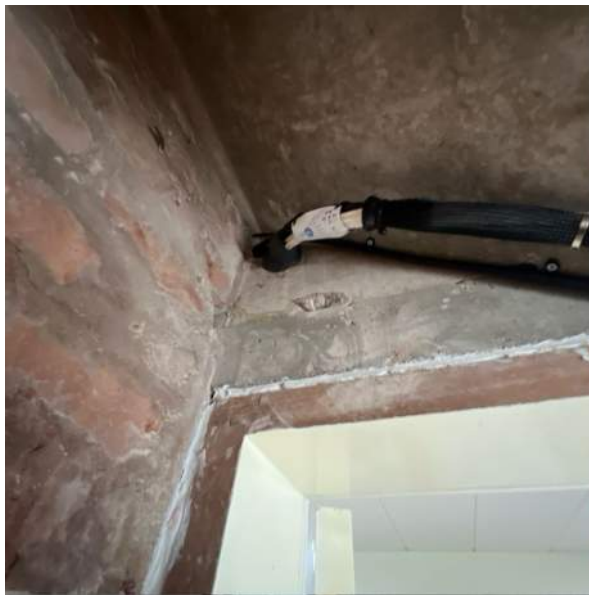
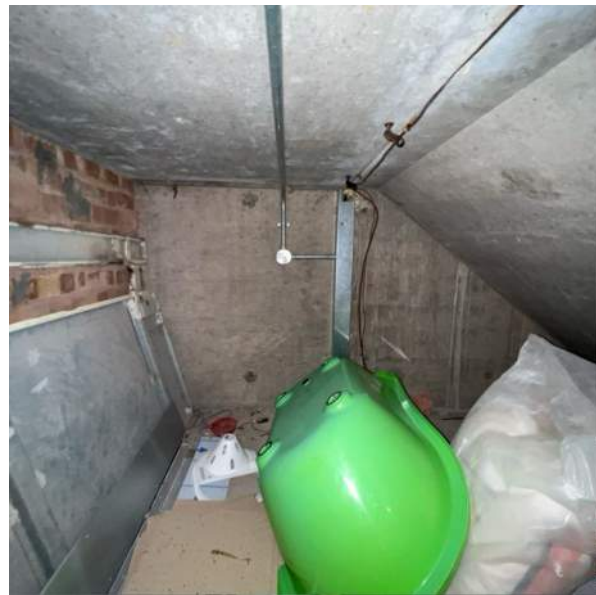
Comments: 24 Jul 2024 at 12:27 PM  
 No jams or distortions noted to hallway doors to indicate any serviceability issues.  
 Generally walls covered with finishes in hallway, likely to consist a mixture of concrete shear walls and embedded columns with internal partition walls.  
 Riser cupboard shows infill masonry walls with a partially exposed concrete element likely an RC Column.  
 Storage room under ground floor staircase shows embedded RC concrete beam and column in infill masonry walls. One side of stair wall noted to be an RC concrete wall likely forming a shear core wall of the structure.

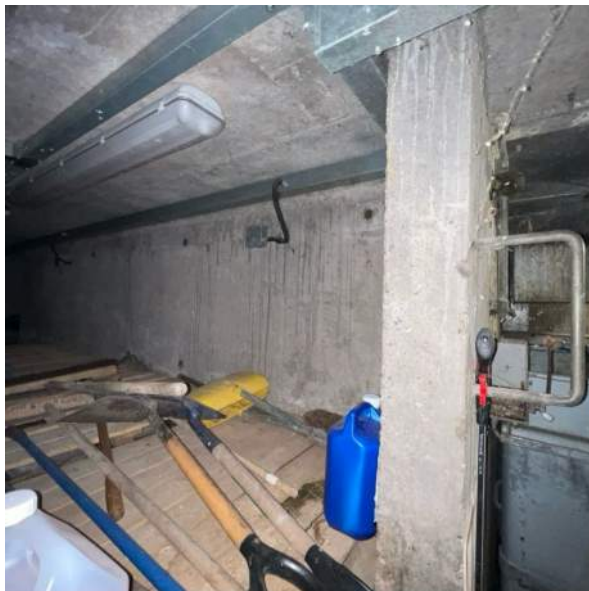
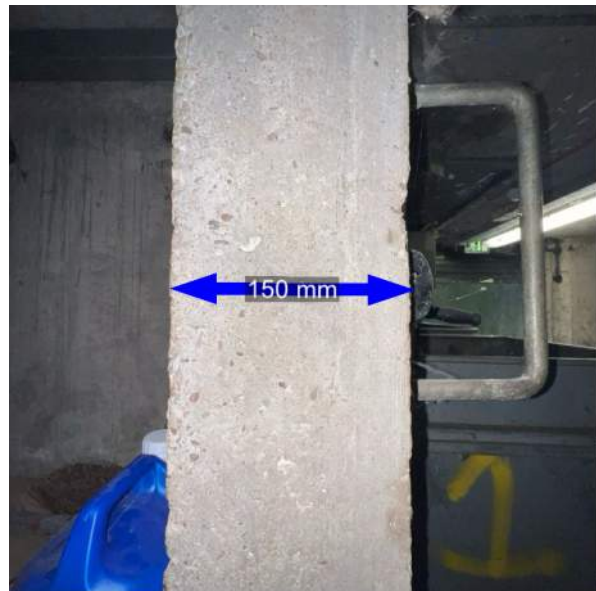
## Bin Store

Bin store located at basement level with a retaining wall leading up to bin store entrance. RC frame structure exposed forming of concrete beams, columns (230x600mm) and shear walls.  
Floor slab measured from bin store entrance noted to be approx. 160mm dp.

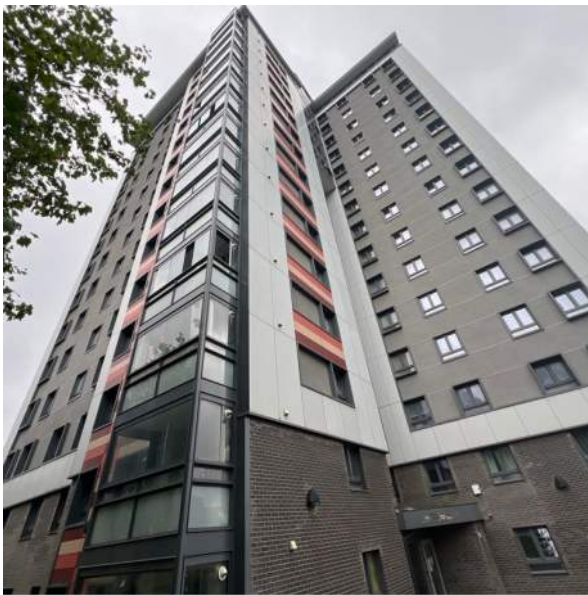
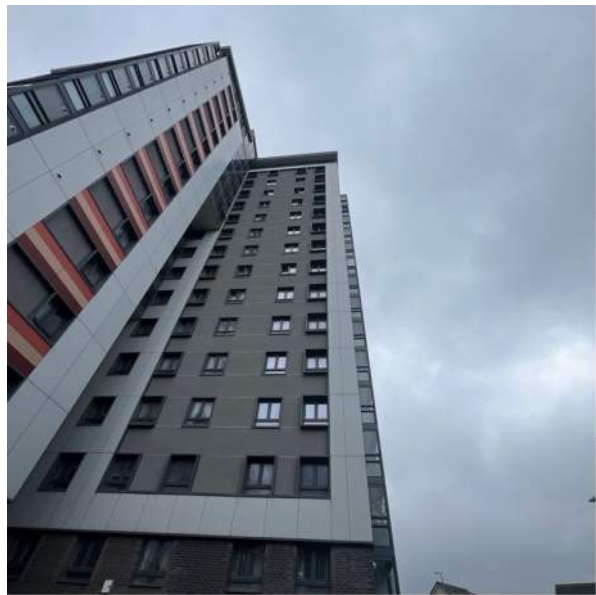
External ground and first level consists of brick work.  
Remaining floors noted to have a cladded facade to exterior.
