VISUAL STRUCTURAL APPRAISAL

Farley St

Farley St  
West Bromwich  
DY4 7LA

30<sup>th</sup> April 2025

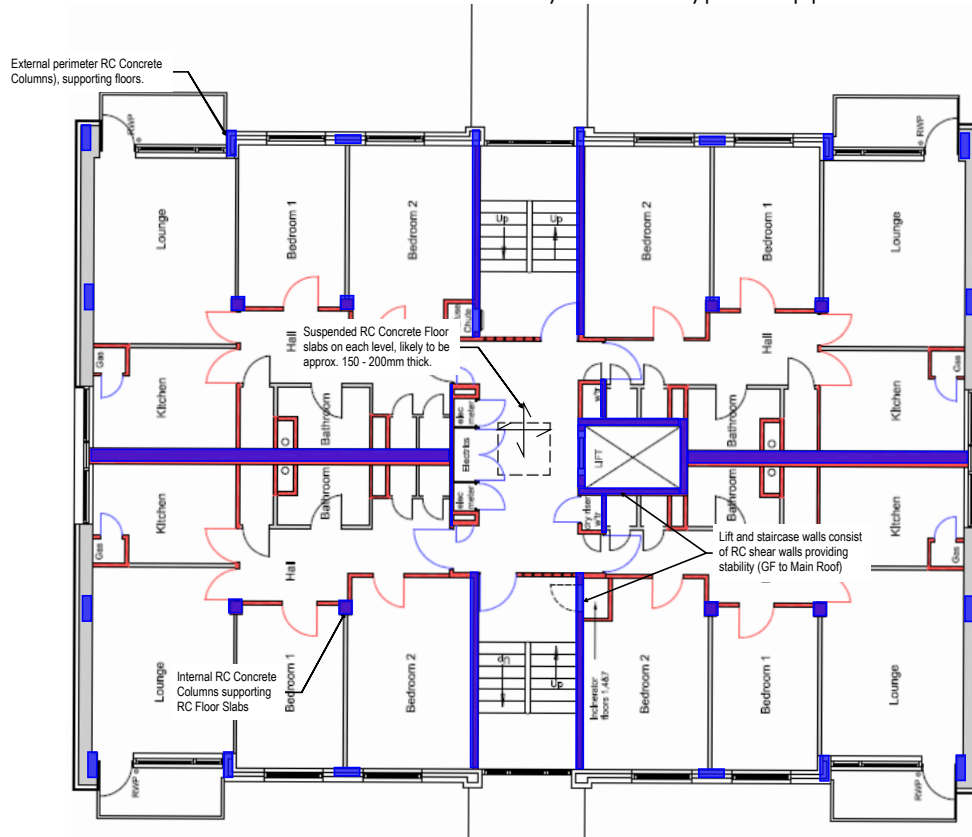
Figure 6: Diagram of typical floor plan 97-128 FARLEY STREET  
TYPICAL FLOOR LAYOUT

RC Shear/Core Walls & Columns. Annotated on plan shown indicatively based on limited site observations and general floor plan arrangement. Likely other locations present where not shown on plan. All floors appear to align with minimum transfer structure present.

There were vertical concrete walls supporting the floor plates at every level. The elements visible matched the floor layout in Figure 6. The walls appear continuous from ground to roof with no transfer structure. The overall condition of the structure observed is good.

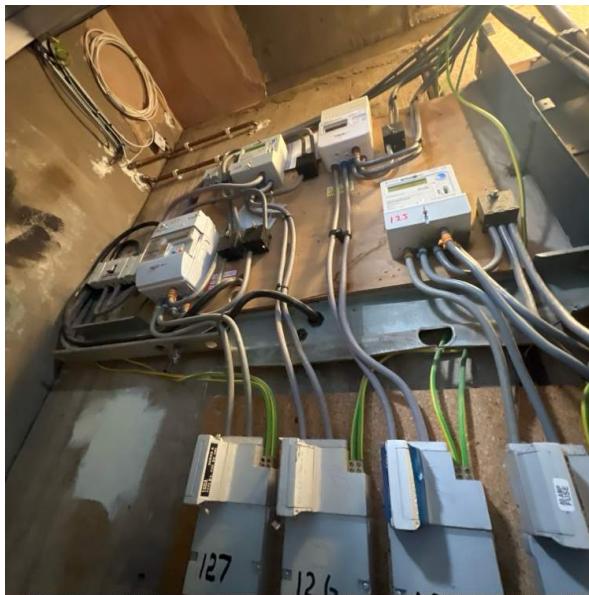
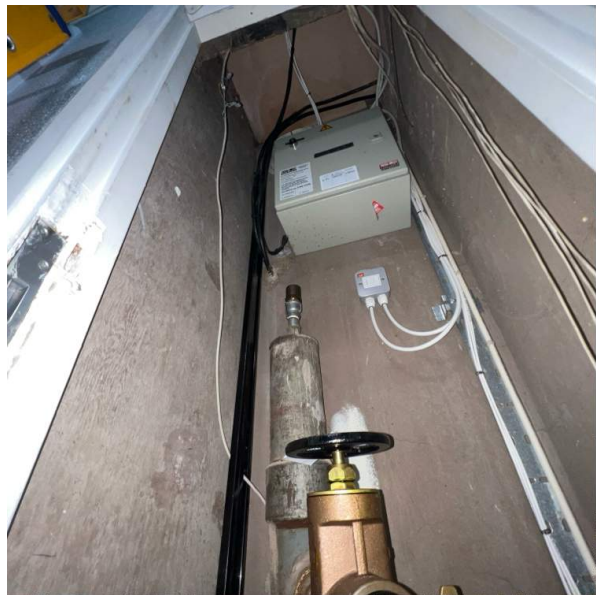
## 7th Floor Hallway

Comments: No jams or distortions noted to hallway doors to indicate any serviceability issues. Generally walls covered with finishes in hallway, likely to consist a mixture of concrete shear walls, embedded columns and masonry infill walls. Limited structure exposed. Concrete walls and infill masonry (non-load bearing) walls noted in riser cupboards.

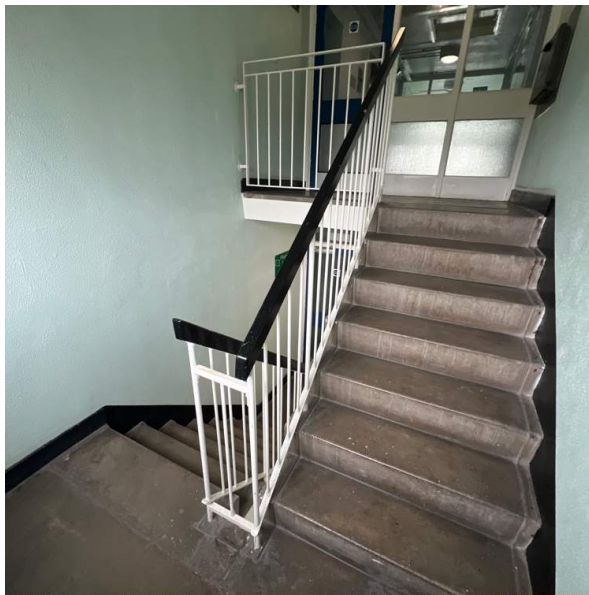
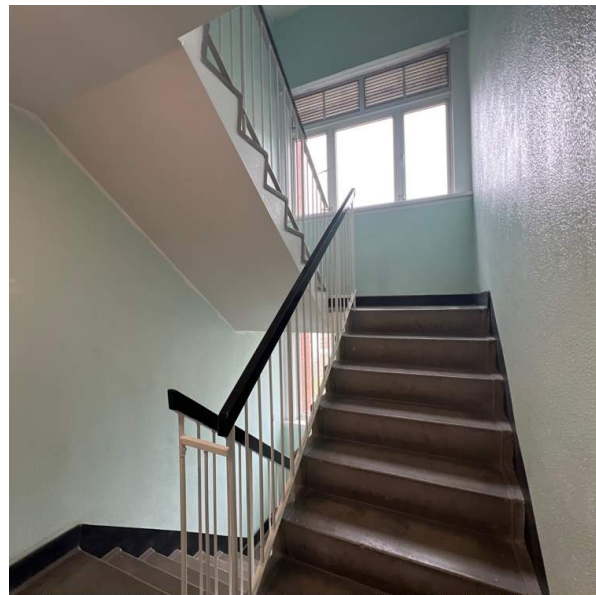
## 7th Floor Staircases

Comments: Insitu concrete stairs with steel hand railing fixed to stairs. Walls and floors appear to be fairly level.  
Stair walls covered with finishes however these would likely form the main concrete shear core walls.

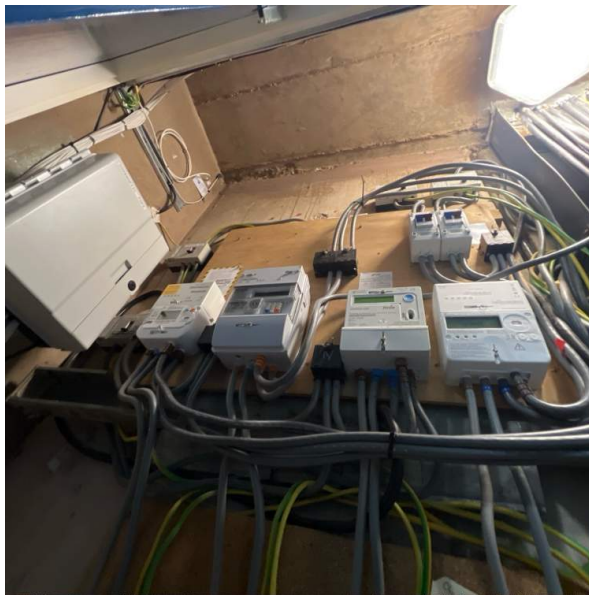
## 4th Floor Hallway

Comments: No jams or distortions noted to hallway doors to indicate any serviceability issues. Generally walls covered with finishes in hallway, likely to consist a mixture of concrete shear walls, embedded columns and masonry infill walls. Limited structure exposed. Concrete walls and infill masonry (non-load bearing) walls noted in riser cupboards.

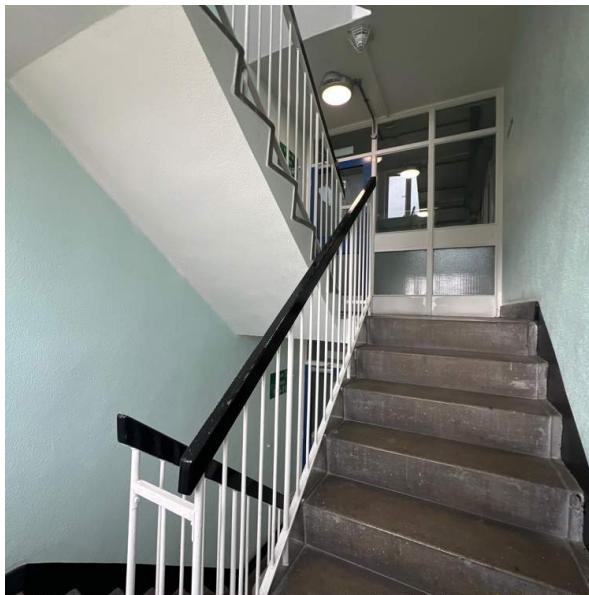
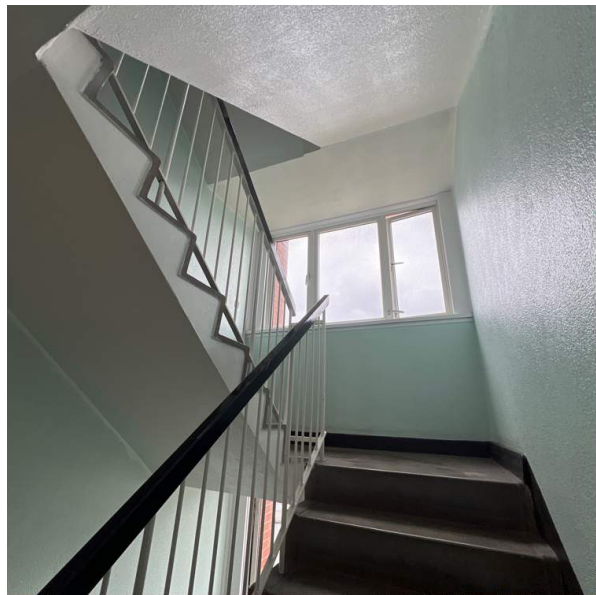
## 4th Floor Staircases

Comments: Insitu concrete stairs with steel hand railing fixed to stairs. Walls and floors appear to be fairly level.  
Stair walls covered with finishes however these would likely form the main concrete shear core walls.

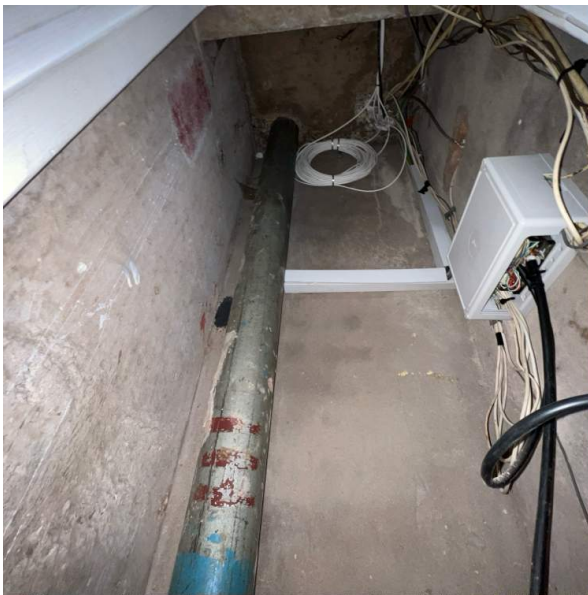
## Ground Floor Hallway

Comments: No jams or distortions noted to hallway doors to indicate any serviceability issues. Generally walls covered with finishes in hallway, likely to consist a mixture of concrete shear walls, embedded columns and masonry infill walls. Limited structure exposed. Concrete walls and infill masonry (non-load bearing) walls noted in riser cupboards.

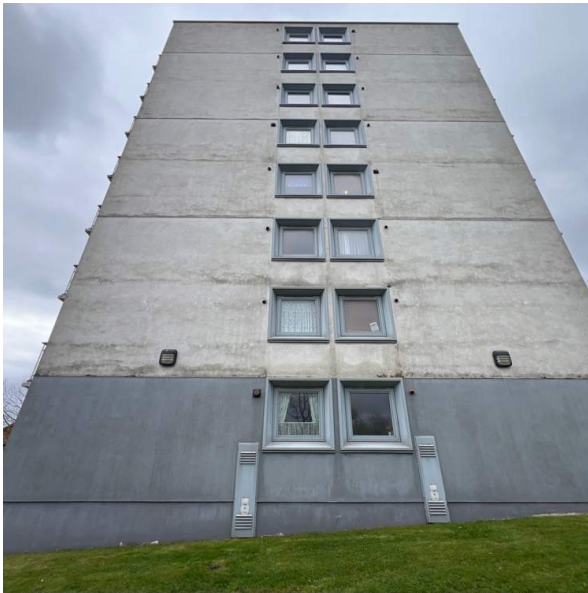
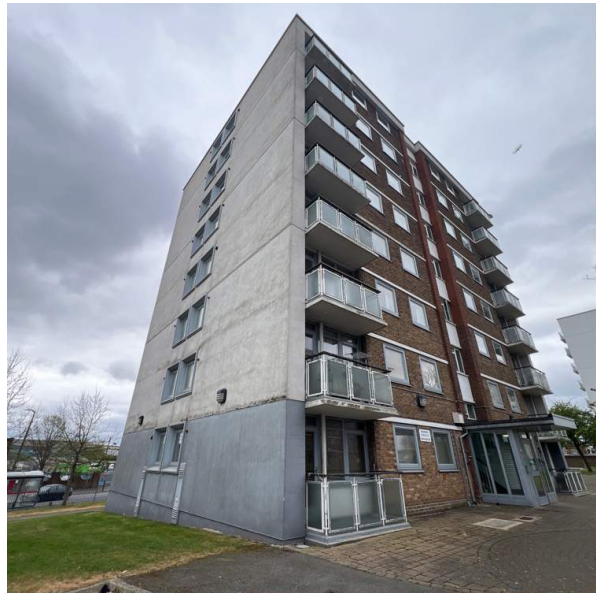
Comments: External facade consists of brick work on all levels to front and rear elevations with cantilevered balconies situated on corners. Side elevations consist of render to full height of walls.
