VISUAL STRUCTURAL APPRAISAL

Greenford House

Maria Street  
West Bromwich  
B70 6DX

29<sup>th</sup> November 2024

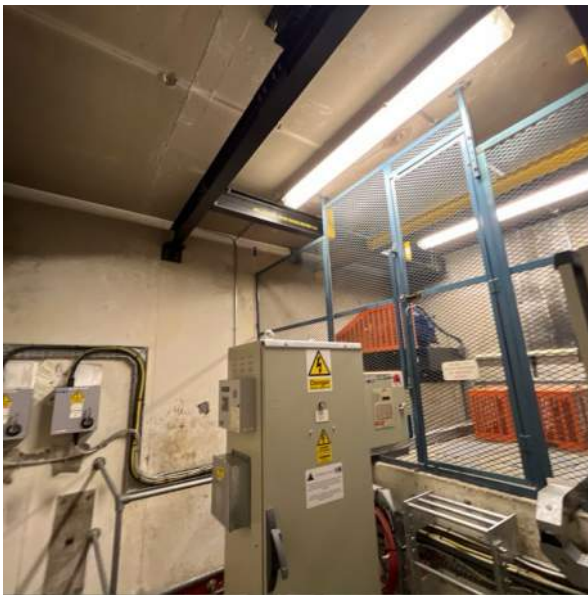
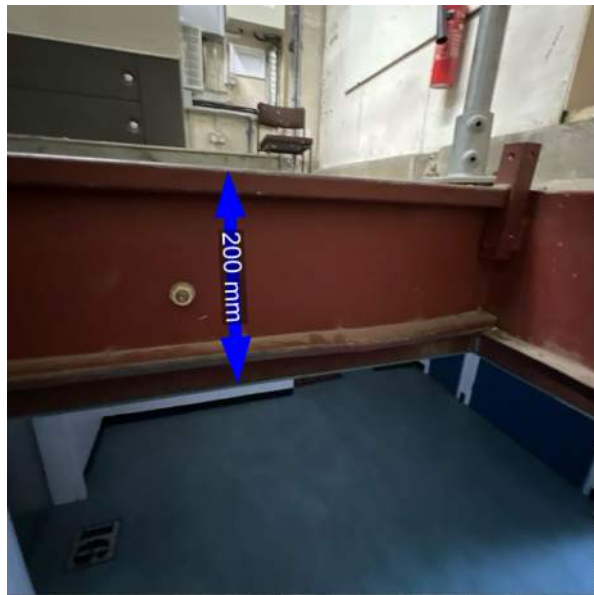
## Main Roof

Lift motor room located on roof formed of masonry walls.  
Parapet walls noted to perimeter of roof.  
Insitu concrete roof slab with insulated PIR Boad and roof coverings.

The roof has a single ply membrane finish. The exact build-up of the roof finishes were not accessible at the time of inspection. It is recommended an intrusive survey of the roof finishes is completed by a specialist surveyor to assess the condition of the roof covering.

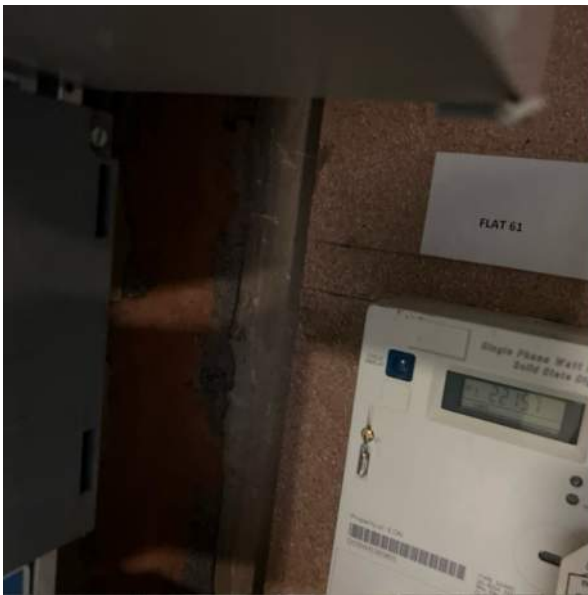
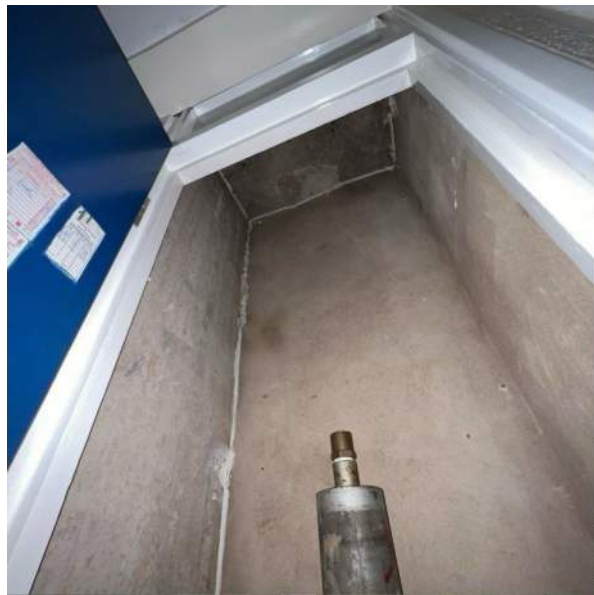
## 16th Floor Hallway

Comments: No jams or distortions noted to hallway doors to indicate any serviceability issues.  
Generally walls covered with finishes in hallway, likely to consist a mixture of concrete shear walls, embedded columns and block infill walls.  
Electrical cabinet shows infill blockwork with render on top.  
Dry riser cupboard shows some exposed concrete (likely embedded concrete column).

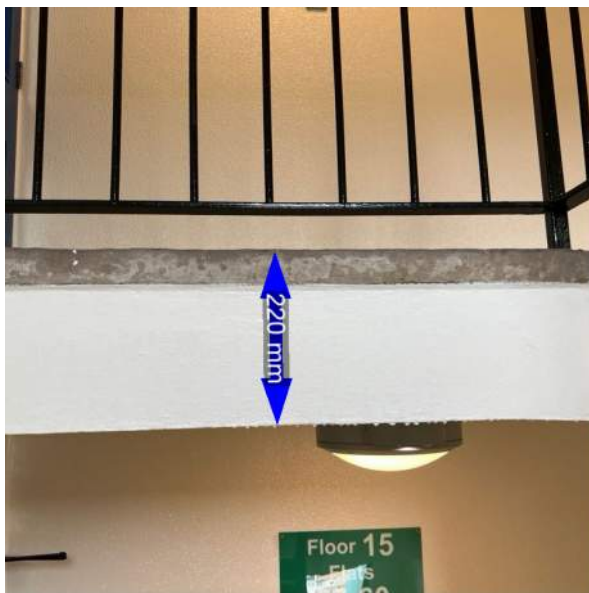
## 16th Floor Staircase

Insitu concrete stairs with steel hand railing fixed to stairs. Walls and floors appear to be fairly level.  
Stair walls covered with finishes however these would likely form the main concrete shear core walls.  
Floor slab measures from stair platform appears to be approx. 220mm thick.

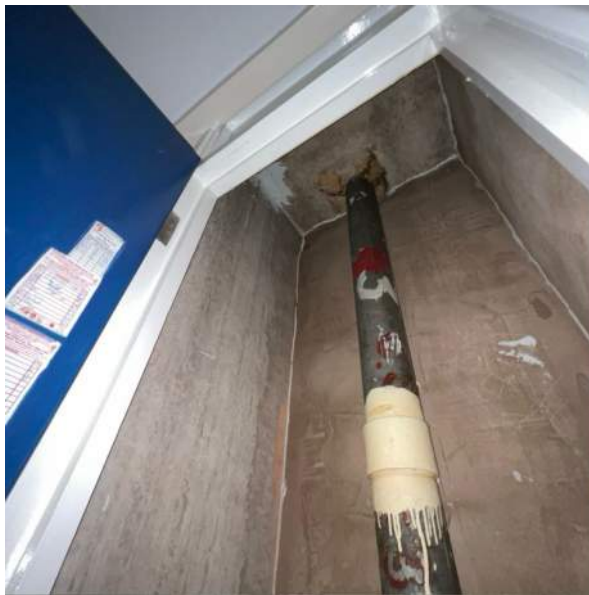
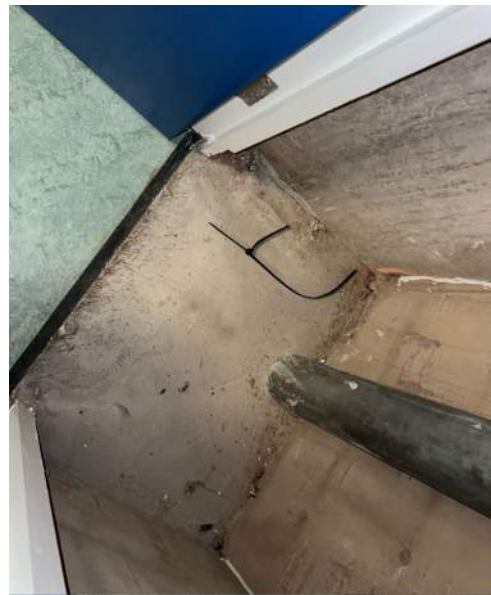
Comments: No jams or distortions noted to hallway doors to indicate any serviceability issues.  
Generally walls covered with finishes in hallway, likely to consist a mixture of concrete shear walls, embedded columns and block infill walls.  
Electrical cabinet shows infill blockwork with render.  
Dry riser cupboard shows exposed concrete likely to form part of stair shear core wall.

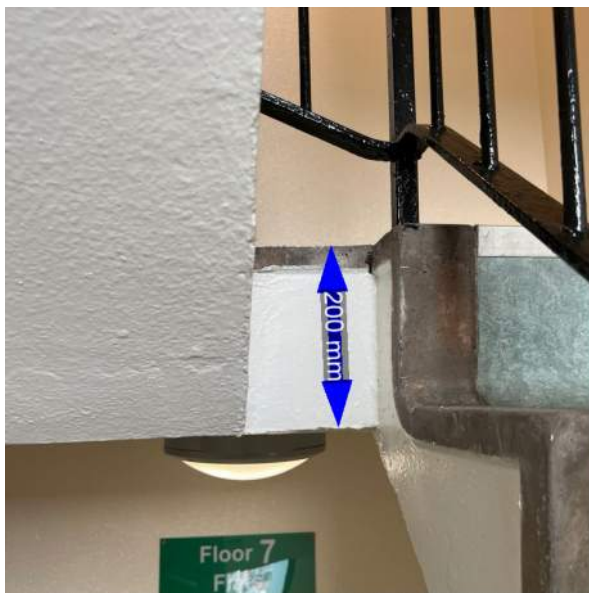
## 8th Floor Staircase

In situ concrete stairs with steel hand railing fixed to stairs. Walls and floors appear to be fairly level.

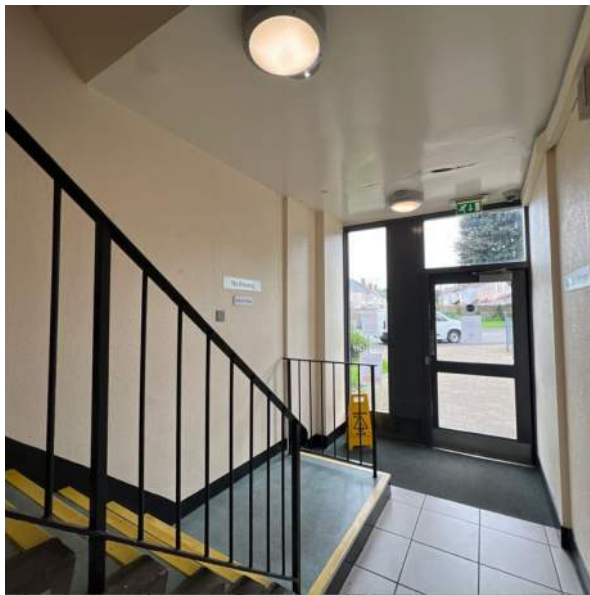
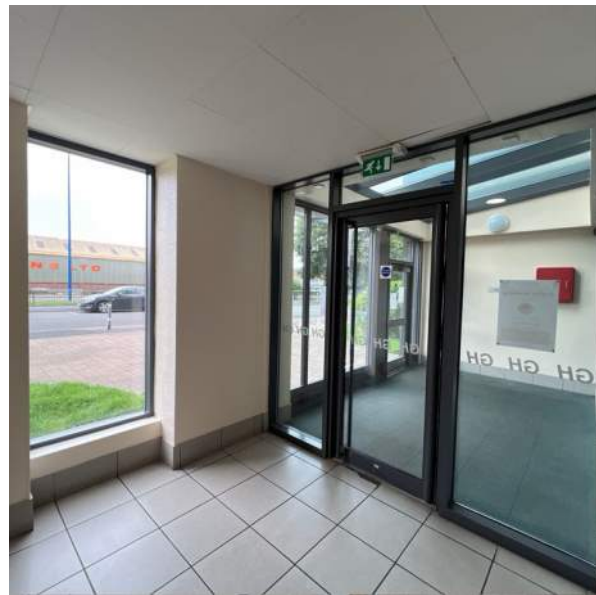
Comments: No jams or distortions noted to hallway doors to indicate any serviceability issues. Generally walls covered with finishes in hallway, likely to consist a mixture of concrete shear walls, embedded columns and block infill walls. RC Concrete Shear Core wall of lift visibly noted from riser cupboard and meterage room. Other internal main walls noted to solid concrete walls, these are likely to be shear core walls forming part of the primary structural elements.

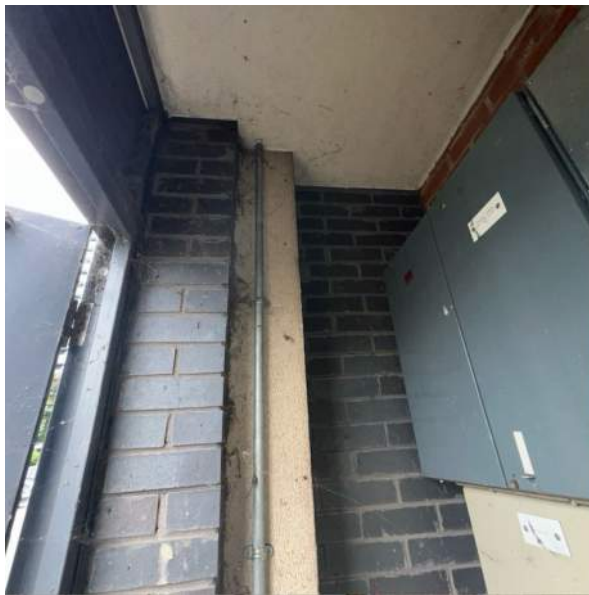
## Bin Store

Shear concrete walls (300mm wide including finishes) and embedded concrete columns (approx. 300mm wide) noted in bin store and storage areas. Concrete infill (non-load bearing walls) noted.

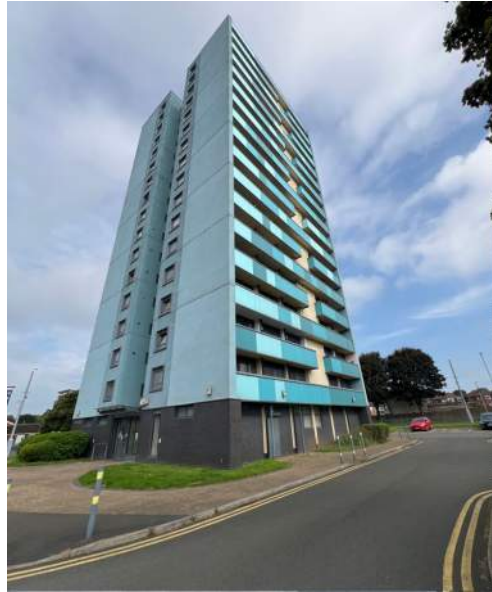
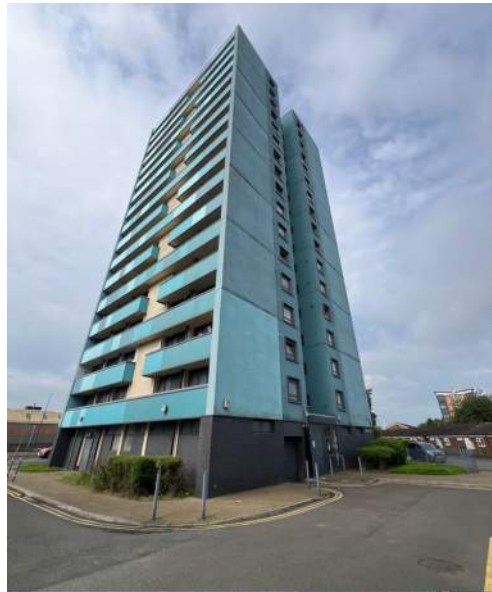
## Elevations

External ground floor level consists of brick work.  
Upper floors noted to have a rendered facade and cladding to balconies.  
Concrete columns (300mm wide) noted to perimeter which form part of the primary structural elements of the building.  
Staircase exterior appears to have a concrete panel facade feature.
