**FIRNTEC**  
BUILDING COMPLIANCE

VISUAL STRUCTURAL APPRAISAL

1-73 Hackwood House

Hartlebury Rd  
Oldbury  
B69 1EG

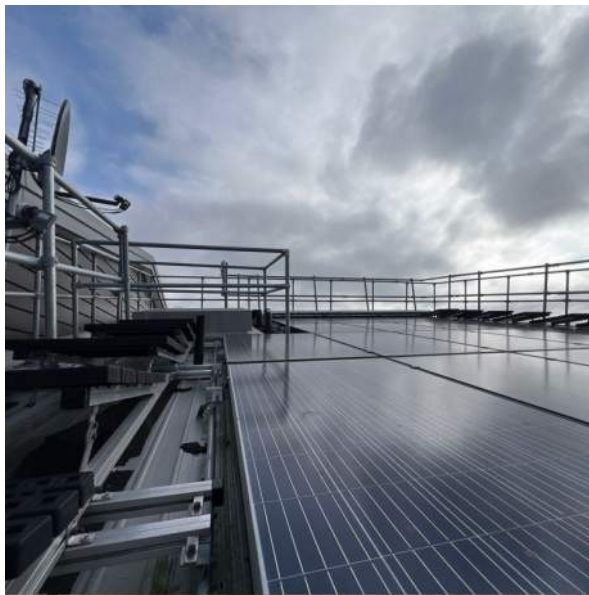
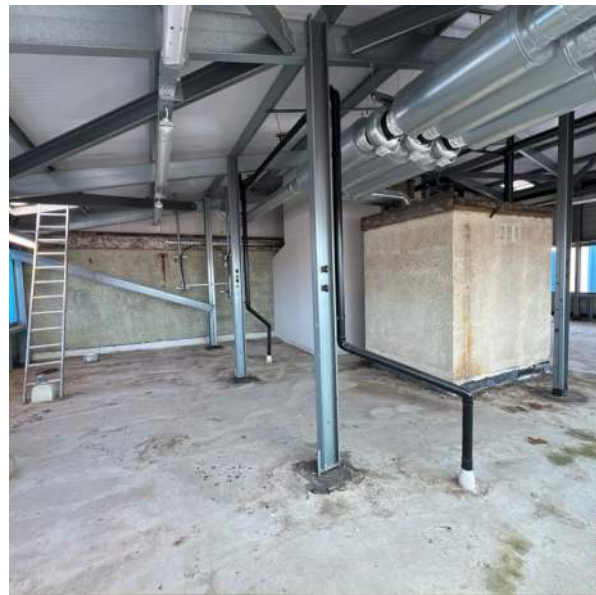
## Main Roof

Comments: Roof structure consists of a lower and higher section and is formed of a concrete slab with a Lightweight SFS (appear to be cold rolled) frame with a pitched roof fixed on to main roof structure. Frame columns fixed to perimeter of roof. Some historical staining to roof slab.

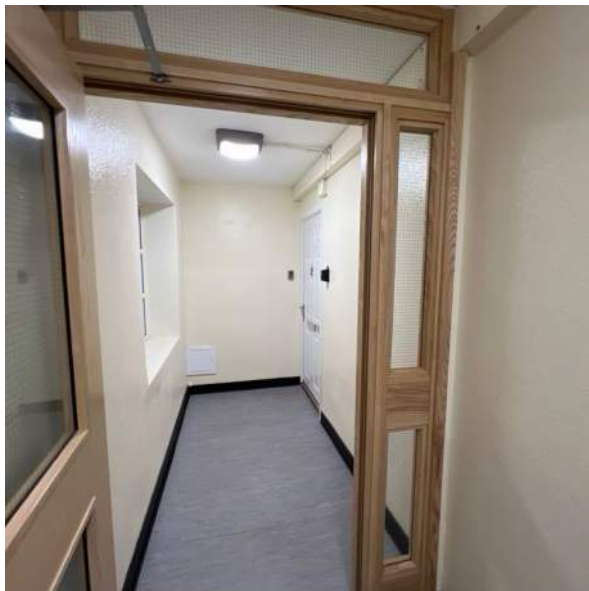
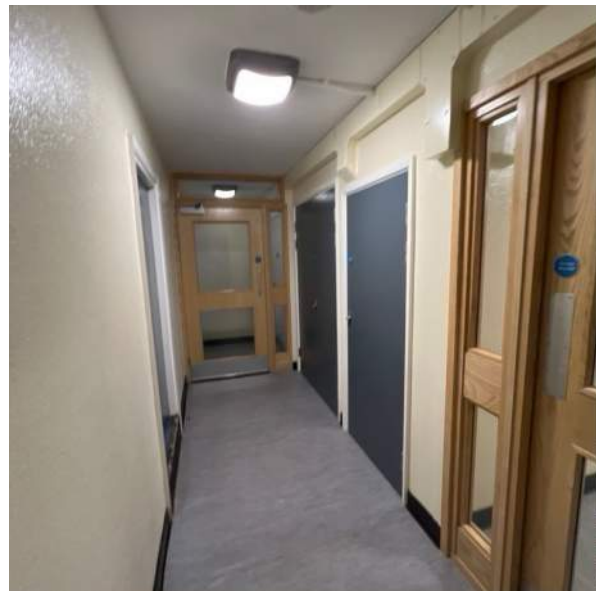
## 12th Floor Hallway

Comments: No jams or distortions noted to hallway doors to indicate any serviceability issues. Generally walls covered with finishes in hallway, likely to consist a mixture of concrete shear walls and embedded columns with internal partition walls. Visible concrete elements (RC Beams and Columns) noted via lift room. Some infill (non-load bearing) masonry noted, some of which are rendered.

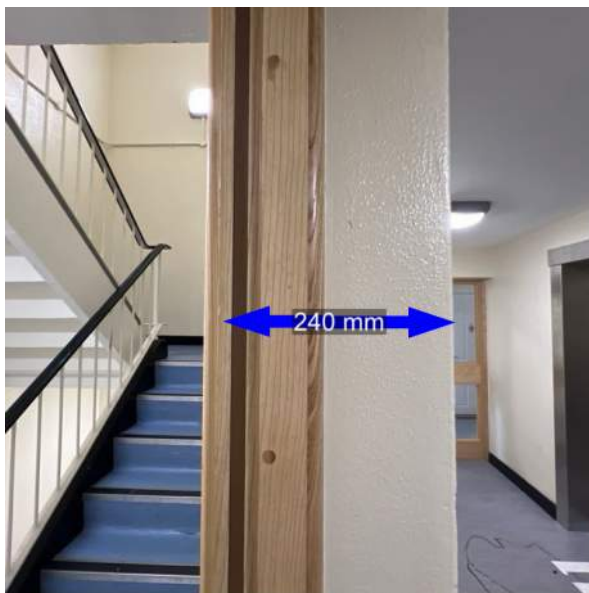
## 12th Floor Staircase

In situ concrete stairs with steel hand railing fixed to stairs. Walls and floors appear to be fairly level.

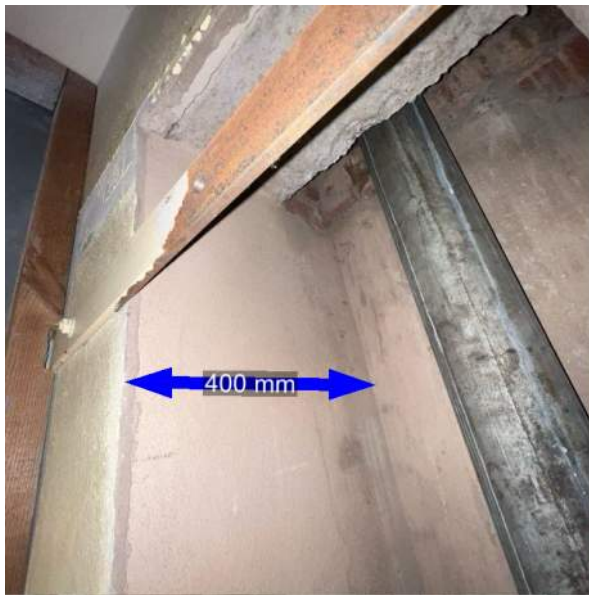
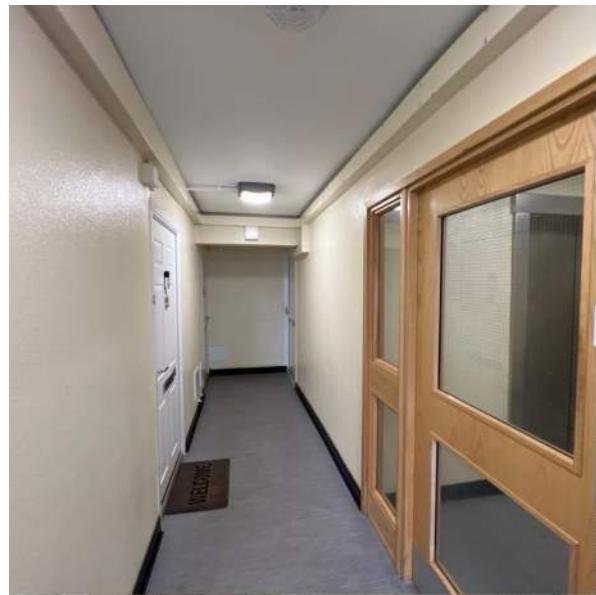
## 6th Floor Hallway

No jams or distortions noted to hallway doors to indicate any serviceability issues. Generally walls covered with finishes in hallway, likely to consist a mixture of concrete shear walls and embedded columns with internal partition walls. Possible concrete walls noted via riser cupboard. Some infill (non-load bearing) masonry noted some of which are rendered.

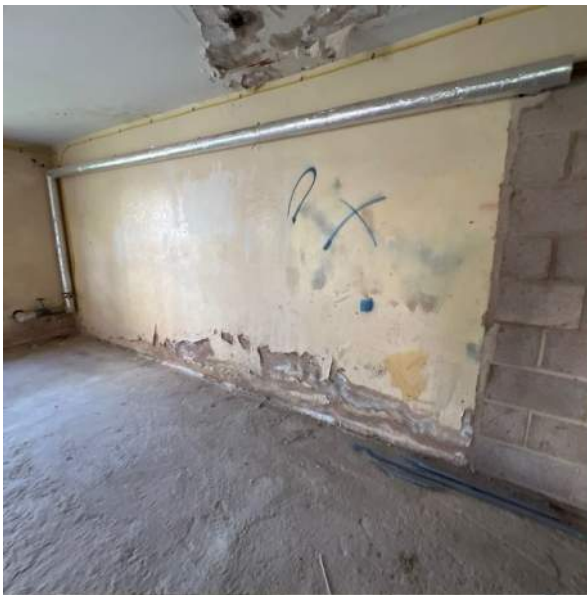
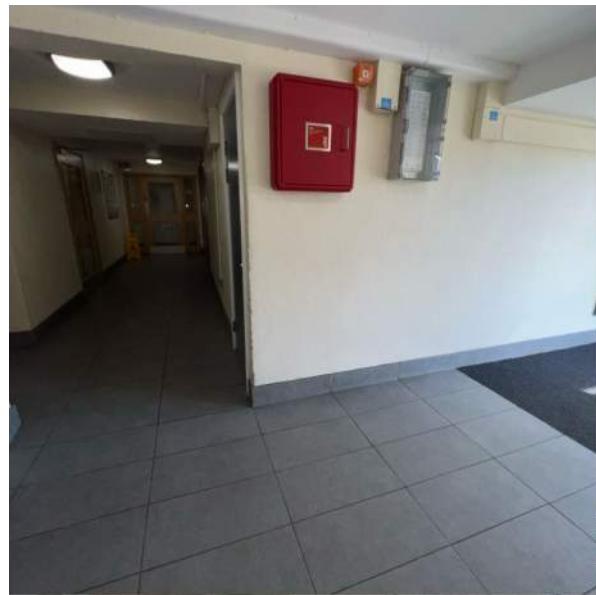
## Ground Floor Hallway

No jams or distortions noted to hallway doors to indicate any serviceability issues. Generally walls covered with finishes in hallway, likely to consist a mixture of concrete shear walls and embedded columns with internal partition walls. Concrete frame consisting of RC columns, Shear Walls and RC Beams noted in visible areas of ground floor rooms. Infill (non-load bearing) walls noted. Perimeter walls noted to have RC columns/walls and No-fines concrete infill walls.

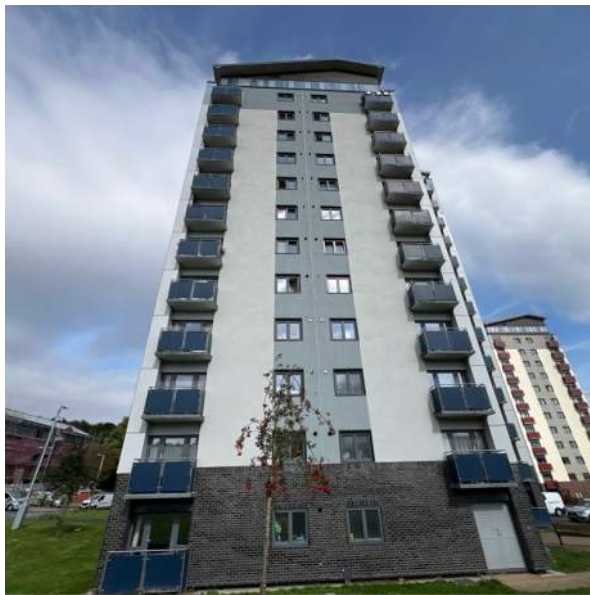
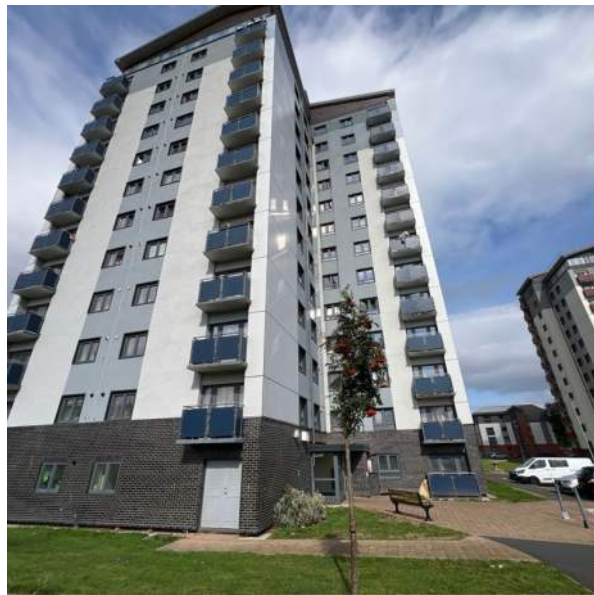
External ground floor level consists of brick work.  
Remaining floors noted to have a cladded facade to exterior. Balconies noted.
