**FIRNTEC**  
BUILDING COMPLIANCE

VISUAL STRUCTURAL APPRAISAL

Hamstead House

Coniston Crescent  
Hamstead  
B43 5NU

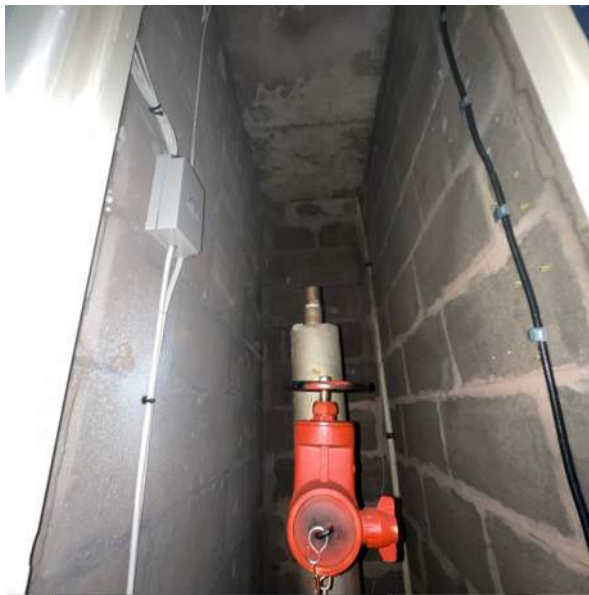
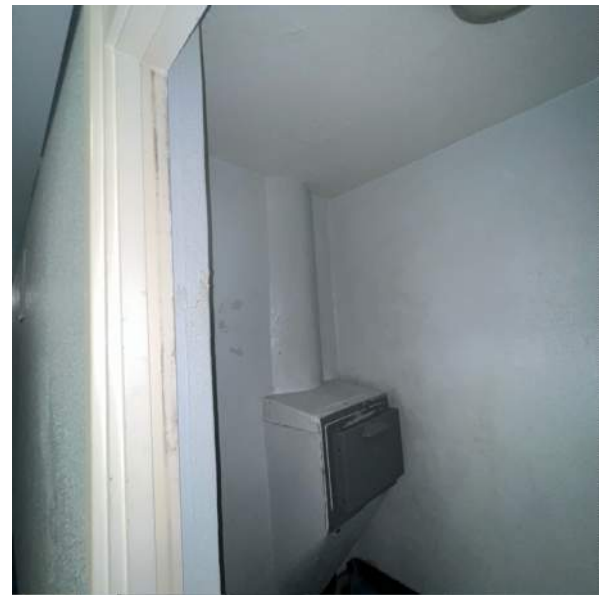
## 10th Floor Hallway

Comments: No jams or distortions noted to hallway doors to indicate any serviceability issues. Generally walls covered with finishes in hallway, likely to consist a mixture of concrete shear walls, embedded columns and masonry infill walls. Limited structure exposed. Concrete column/walls noted in electrical cupboard. Masonry block infill (non-load bearing) walls noted in riser cupboard.

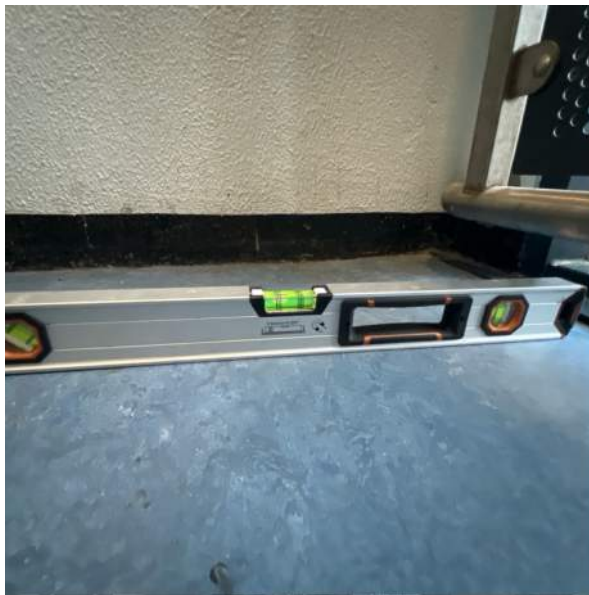
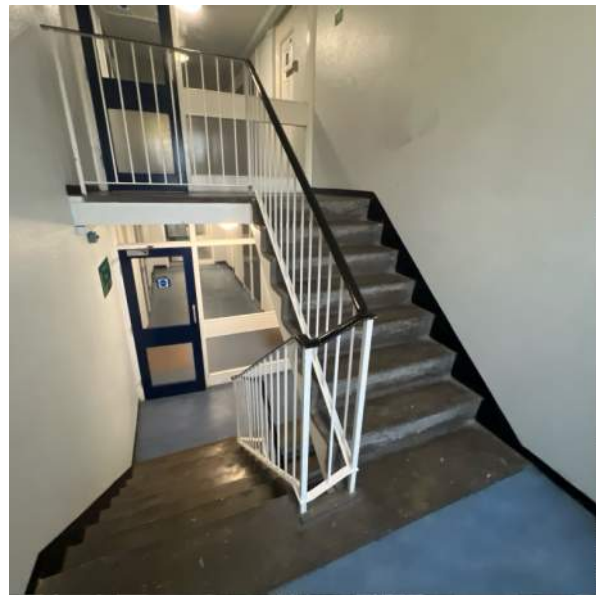
## 10th Floor Staircases

Comments: Insitu concrete stairs with steel hand railing fixed to stairs. Walls and floors appear to be fairly level. Locally sloping stair platform however this does not appear to be structural.  
Stair walls covered with finishes however these would likely form the main concrete shear core walls.

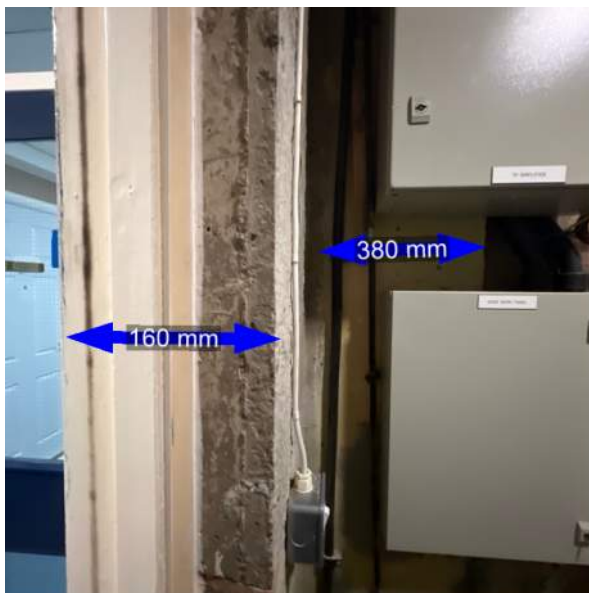
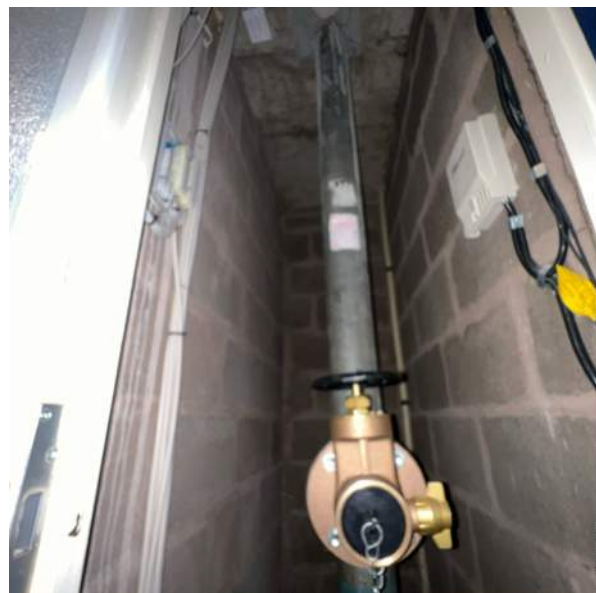
## 5th Floor Hallway

Comments: No jams or distortions noted to hallway doors to indicate any serviceability issues. Generally walls covered with finishes in hallway, likely to consist a mixture of concrete shear walls, embedded columns and masonry infill walls. Limited structure exposed. Concrete column/walls noted in electrical cupboard. Masonry block infill (non-load bearing) walls noted in riser cupboard.

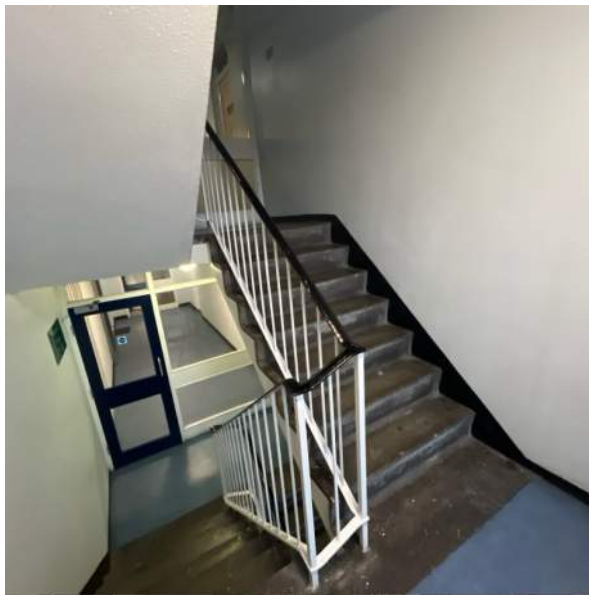
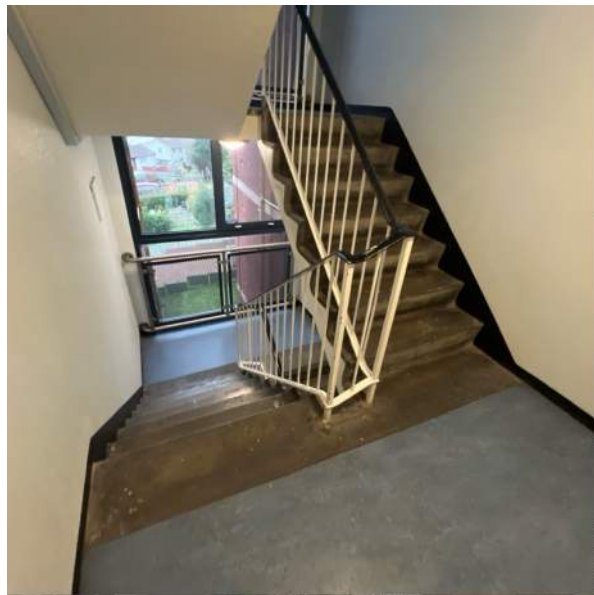
## 5th Floor Staircases

Insitu concrete stairs with steel hand railing fixed to stairs. Walls and floors appear to be fairly level.

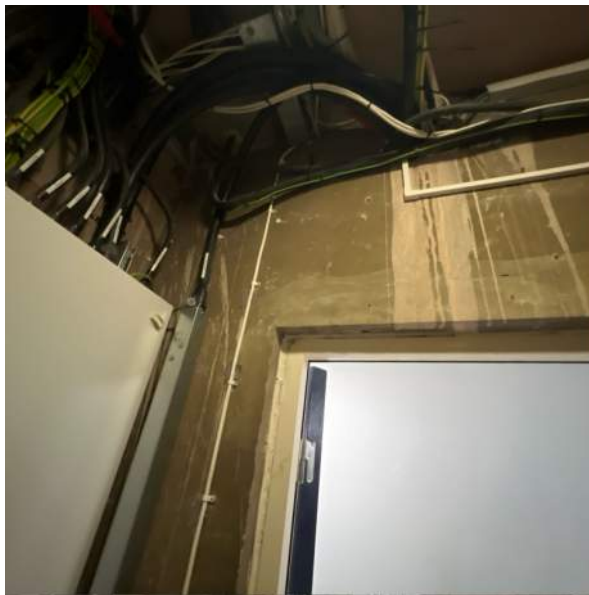
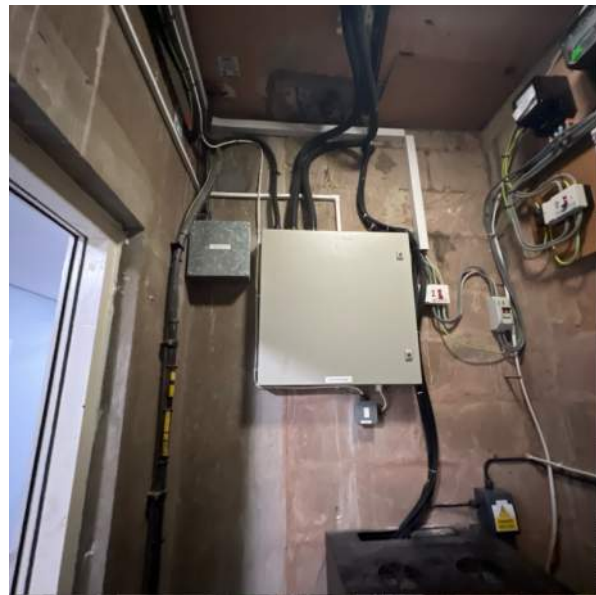
## Ground Floor Hallway

Comments: No jams or distortions noted to hallway doors to indicate any serviceability issues. Generally walls covered with finishes in hallway, likely to consist a mixture of concrete shear walls, embedded columns and block infill walls. Limited structure exposed. RC columns noted in community room.

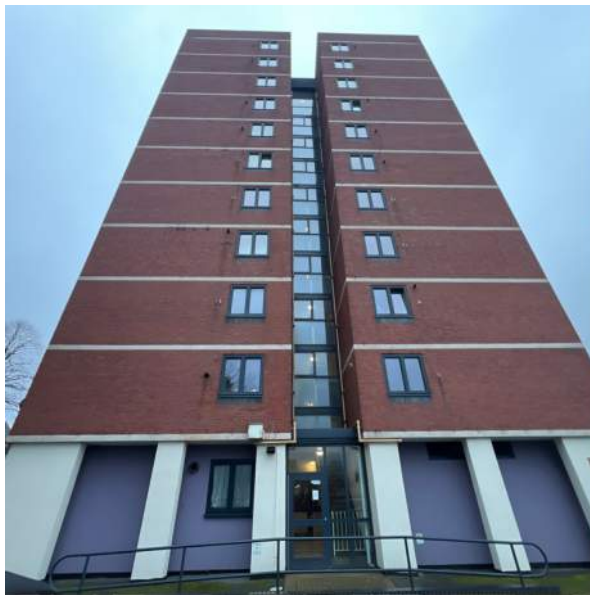
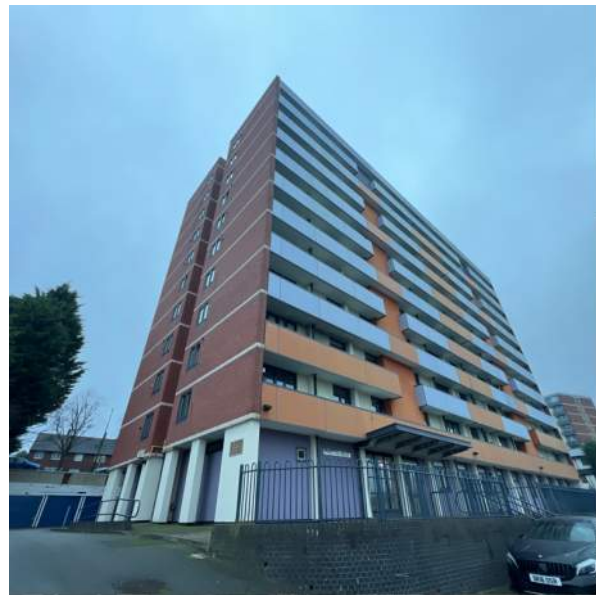
Comments: Rendered facade to front and rear elevations. Brickwork to side elevations. Balconies noted at each level, cladded.
