**FIRNTEC**  
BUILDING COMPLIANCE

VISUAL STRUCTURAL APPRAISAL

Heronville House  
Sedgeley Road East  
Tipton  
DY4 7TX

24<sup>th</sup> June 2025

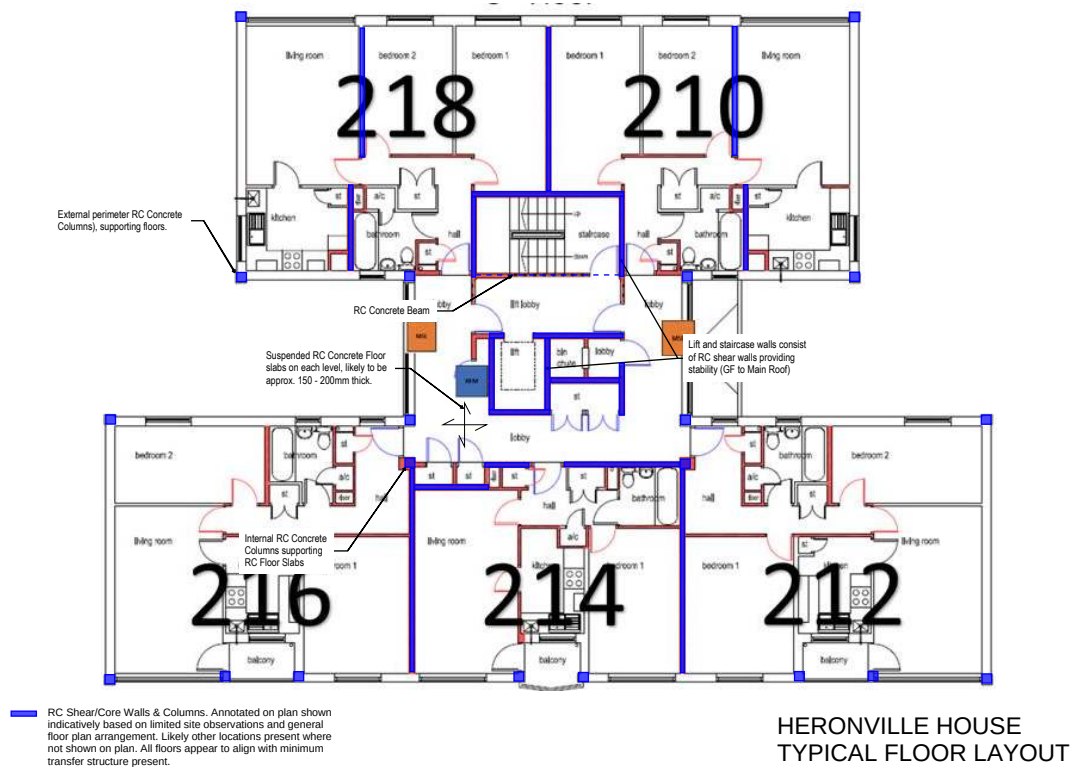
Figure 6: Diagram of typical floor plan

Figures 6 indicates the assumed structural layout for a typical upper floor level.

There were vertical concrete walls supporting the floor plates at every level. The elements visible matched the floor layout in Figure 6. The walls appear continuous from ground to roof with no transfer structure. The overall condition of the structure observed is good.
